HOUSES OF BEIRUT 1860-1925
Restoration manual

Restoration manual

under the direction of Nathalie Chahine and Fadlallah Dagher

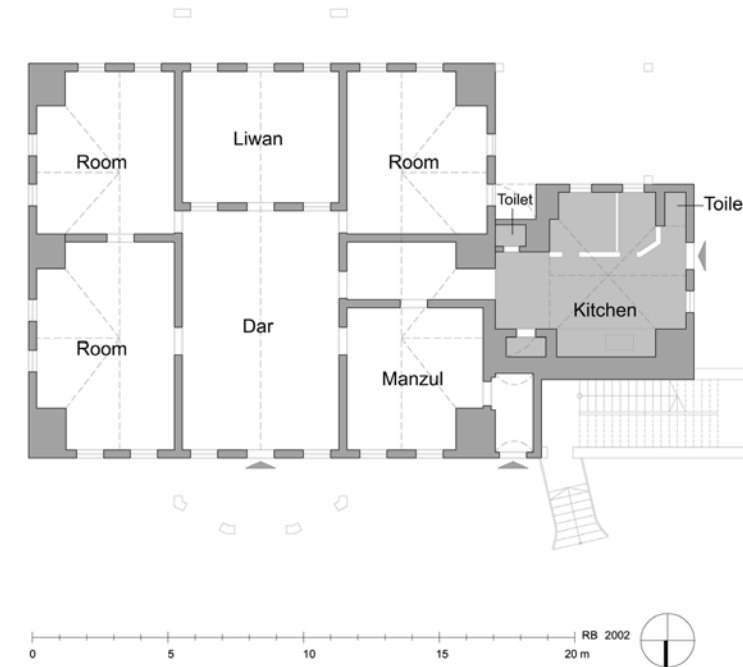
4

Bayt Saadeh (Zokak el-Blat 122): ground floor plan of an early, yet fully-articulated central-hall house that was erected en bloc during the 1850s. Built entirely in vault construction, it features a manzūl with triple access, a kitchen annex, and a līwān module as integral part of the new construction.

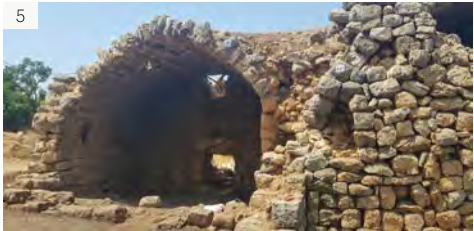
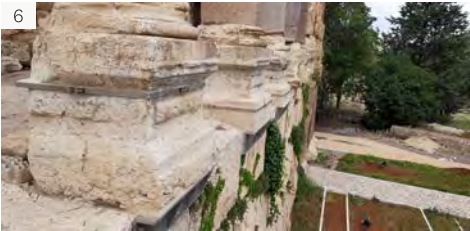
Deir Bella, Batroun - Liban

Propylaea, Baalbek temple - Liban

5, 6: Heterogeneity and components of a masonry structure

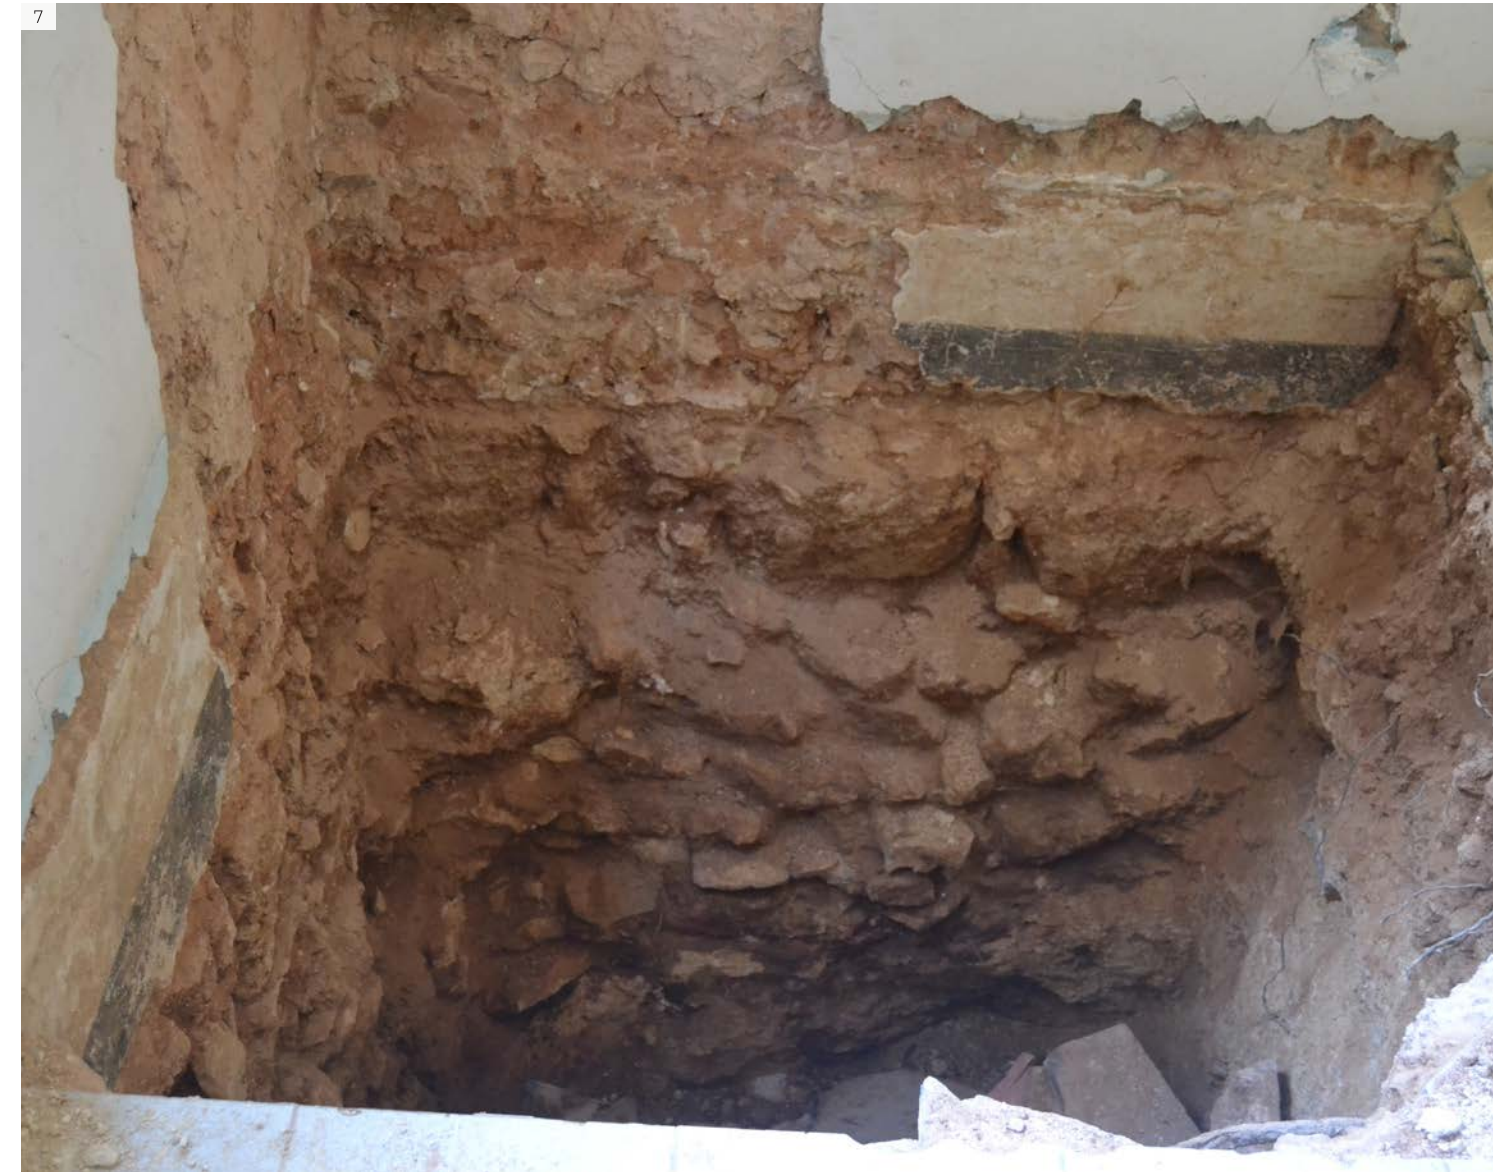
7

Main types of masonry footings in Beirut's historical buildings

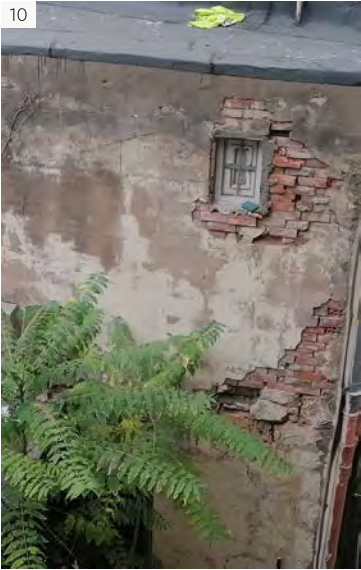
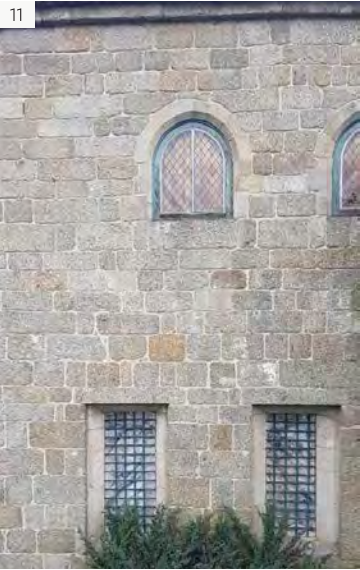
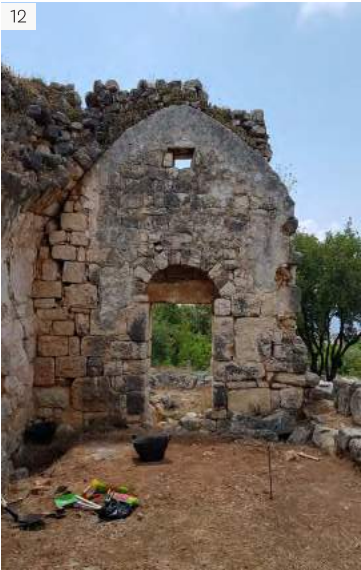
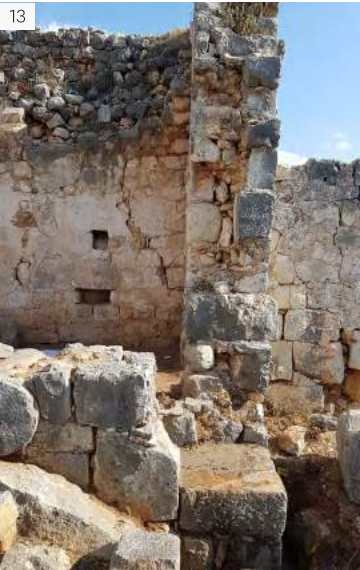
Periodic, Burj Abi Haidar Beirut - Lebanon

Quasi-periodic, Guimarães - Portugal

Rubble, Eddeh - Jbeil - Lebanon

Double-leaf, Behdaydet - Jbeil - Lebanon

10, 11, 12, 13: Typical geometry of masonry walls

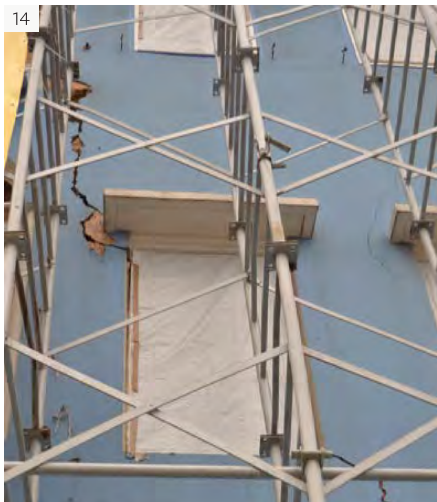
Single inclined IP crack

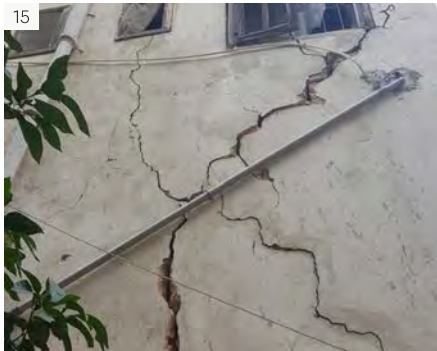
X shape IP crack

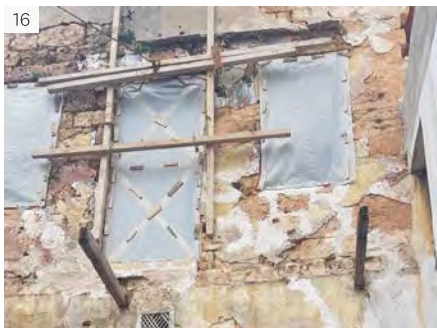
Hazardous IP cracking pattern

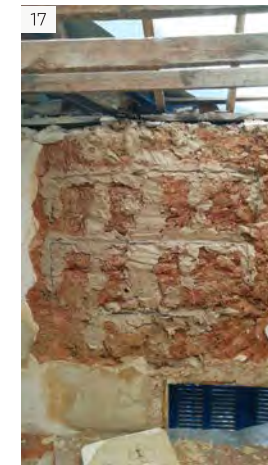
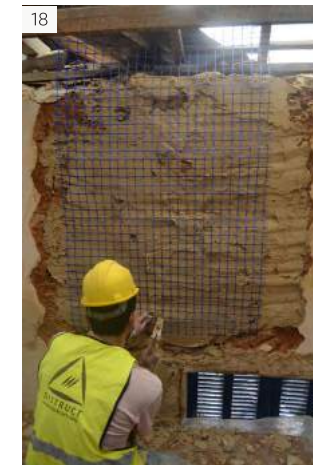
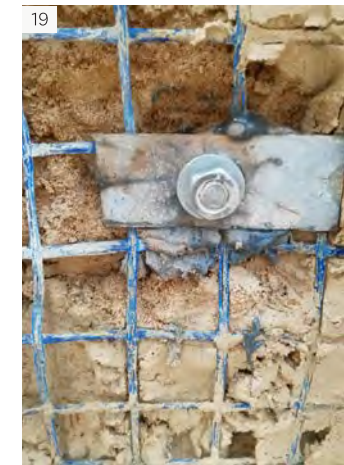
17, 18, 19: IP cracks stitching technique 1, Rmeil 474 - Beirut: plaster around cracks stripped, U shape stainless steel 316 L flat strips introduced inside the joints followed by a structural mesh installation

Stitching may be applied using two different techniques. The first one is related to masonry with parallel bed joints (periodic and quasi-periodic, 17, 18, 19). It consists of the following steps:

- Cut slots into the horizontal bed mortar joints with an electric saw to a depth of at least 50 mm.
- Clean the whole treated area with pressurized air or a vacuum.
- Spray the treated area with normal water.
- Bead a first layer of a high fluid lime mortar grout (volume: 1/2 NHL5 to 1/2 sand) into the back of the slot using a grout gun or an appropriate pump.
- Insert a U shape flat stainless-steel 316 L strip inside the joints (minimum dimensions: 30 mm x 3 mm). The metal strip edges are hooked with a minimum length of 50 mm and embedded vertically inside the head joints. GFRP or CFRP may also be used instead of metal.
- Bead a second layer of grout over the iron strip. The mortar depth covering the metal strip must be at least 30 mm. In the case of a brick wall, the mortar grout may contain crashed red tile product (volume: 1/2 NHL5, 1/4 sand, 1/4 crashed red tile).

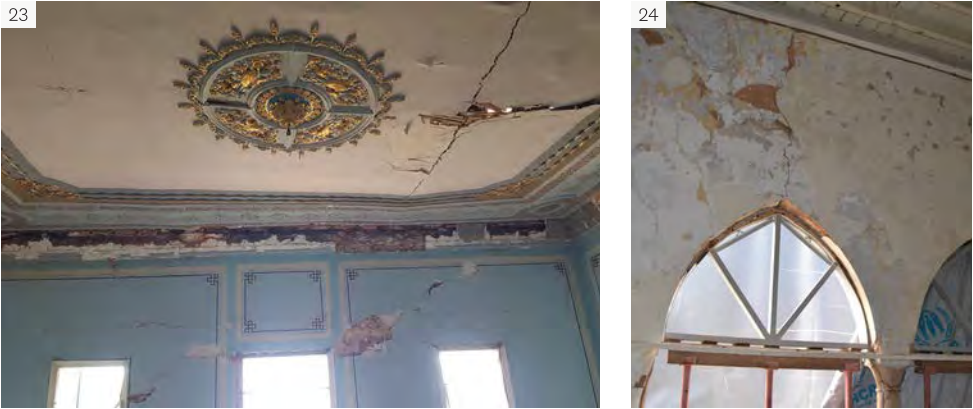
23, 24: IP damage mechanisms around doors, windows, arches and lintels

25: Repair of a broken lintel or an arched opening

When the IP damage mechanism arises in an arched opening, one must check if the crack is taking place in a joint. If so, it is sufficient to fill the joint with an injected grout. Otherwise, i.e., when a crack is crossing a masonry block, it is necessary to apply at least two diagonal stitches perpendicular to the arch's intrados, linking the separated parts of the broken stone (25).

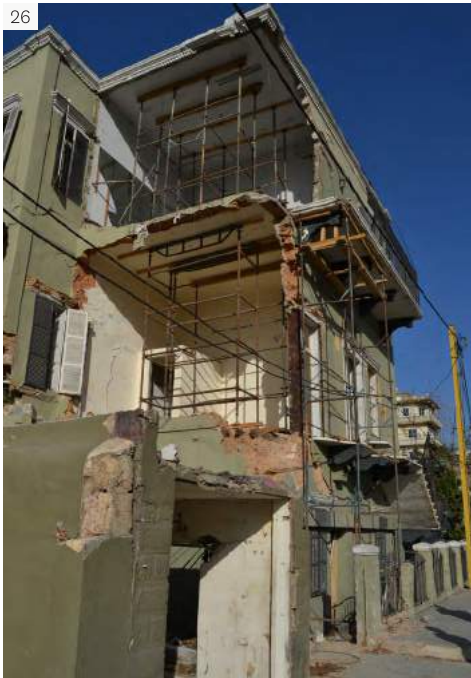
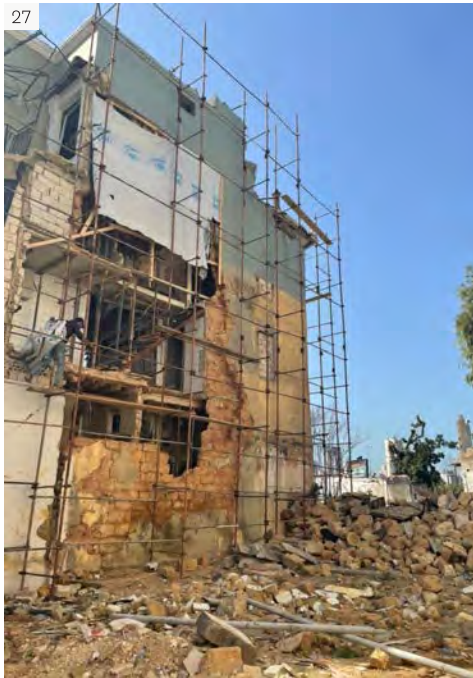
26, 27: OOP partial collapse of peripheral walls, Medawar 201 – Beirut

- partial collapse of peripheral walls (26, 27).
- partial collapse of peripheral walls, interior walls, and triple or double arch façade (28, 29).
- end-walls overturning (30).

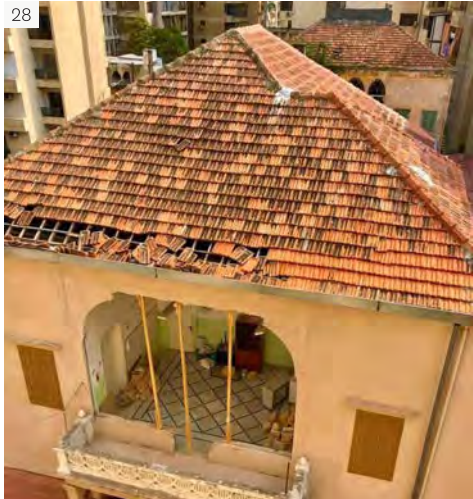
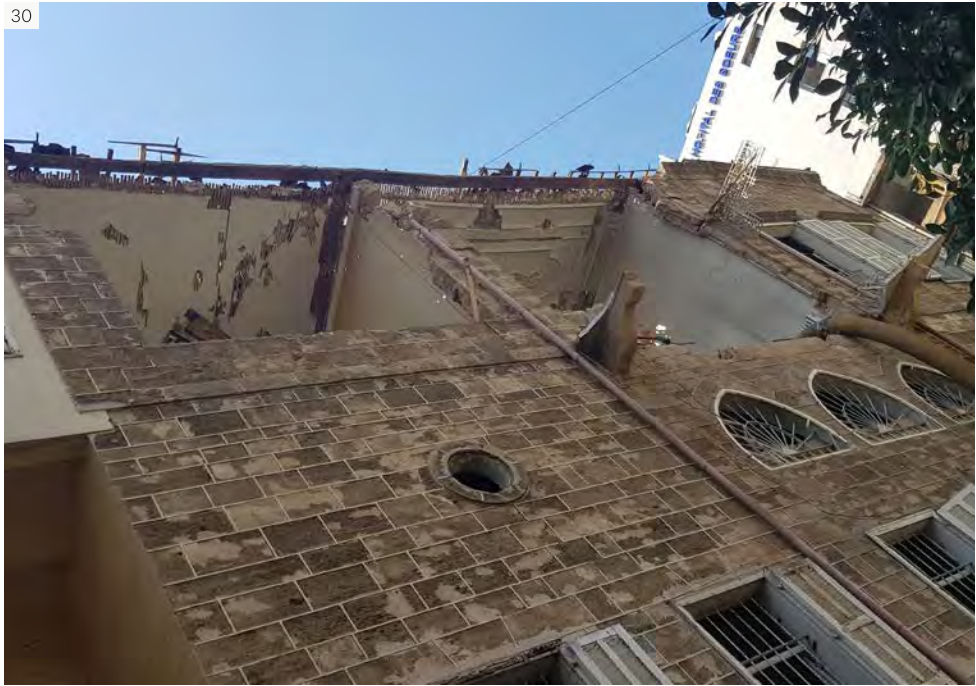
28, 29: OOP partial collapse of peripheral walls, interior walls, and triple arch façade

30: End-walls overturning

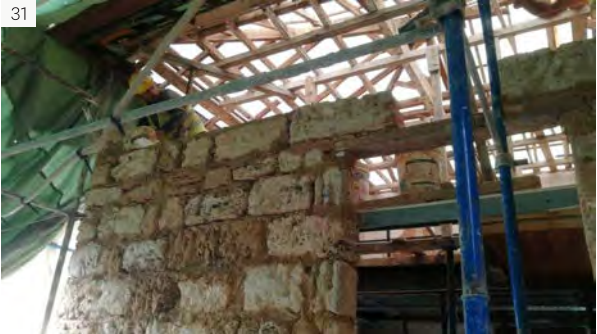
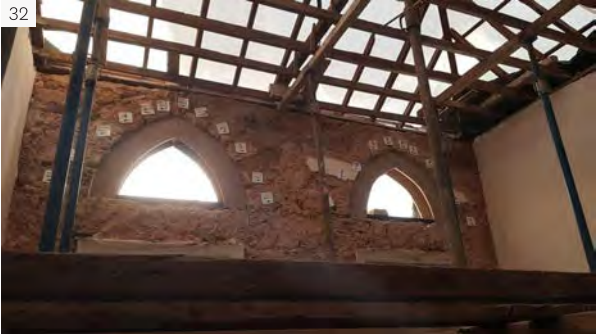
31: Reconstruction of a totally collapsed end-wall beneath attic, Rmeil 474 - Beirut

32: Reconstruction of a partially collapsed double arch façade, Rmeil 474 - Beirut

- The reconstruction of a triple arch façade depends on the damage level of its columns and arches. In most of the observed cases, triple arch columns were utterly detached from their place. If the damage is minor, it is possible to reposition the columns to their initial state (*refer to the paragraph “Columns and arches”*). However, when the arches and the area above are highly damaged or absent altogether, a complete operation should be done to recreate the missing area and ensure the attic's support.

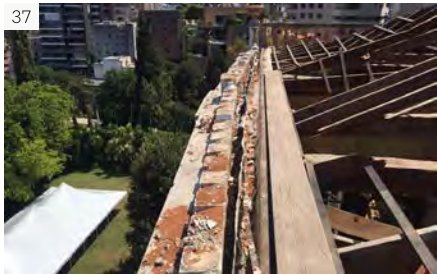
Hybrid In-plane damage (IP) and Out-of-plane deformation (OOP)

Earthquakes and blasts generate bending moments in walls in addition to IP stresses. If the lateral pressure or the inertia forces induced by a blast or an earthquake is high, failure lines appear on the walls' surfaces accompanied by OOP deformations.

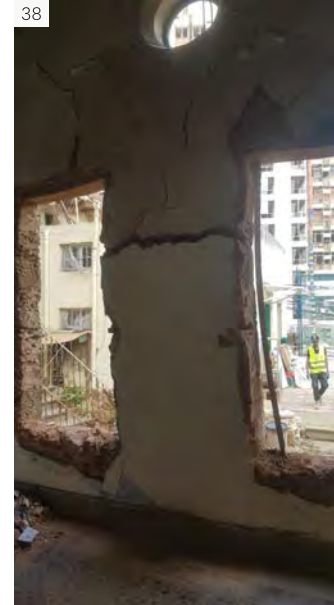
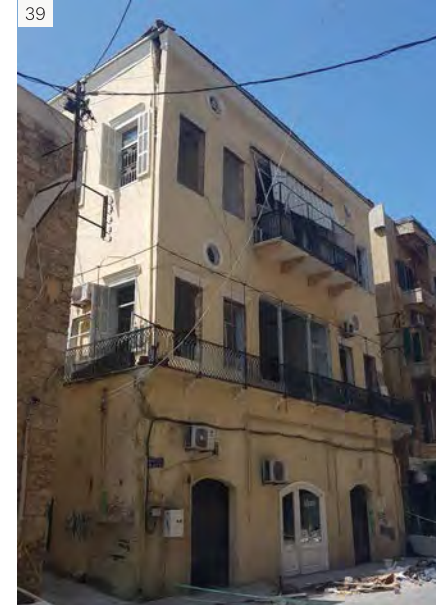
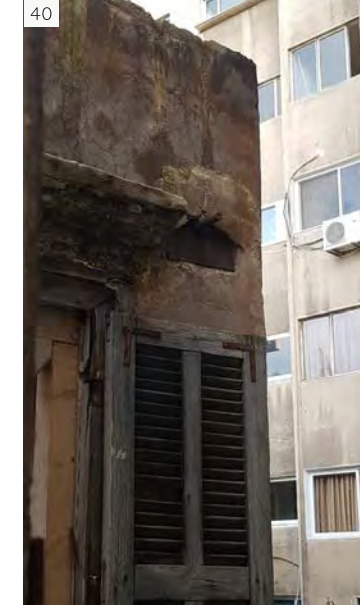
36, 37 : IP trapezoidal crack pattern above two adjacent openings and OOP excessive deformation of end walls, Rmeil 358 - Sursok palace - Beirut

38: IP cracks between two adjacent openings and inward excessive wall bulging, Rmeil 300 - Beirut

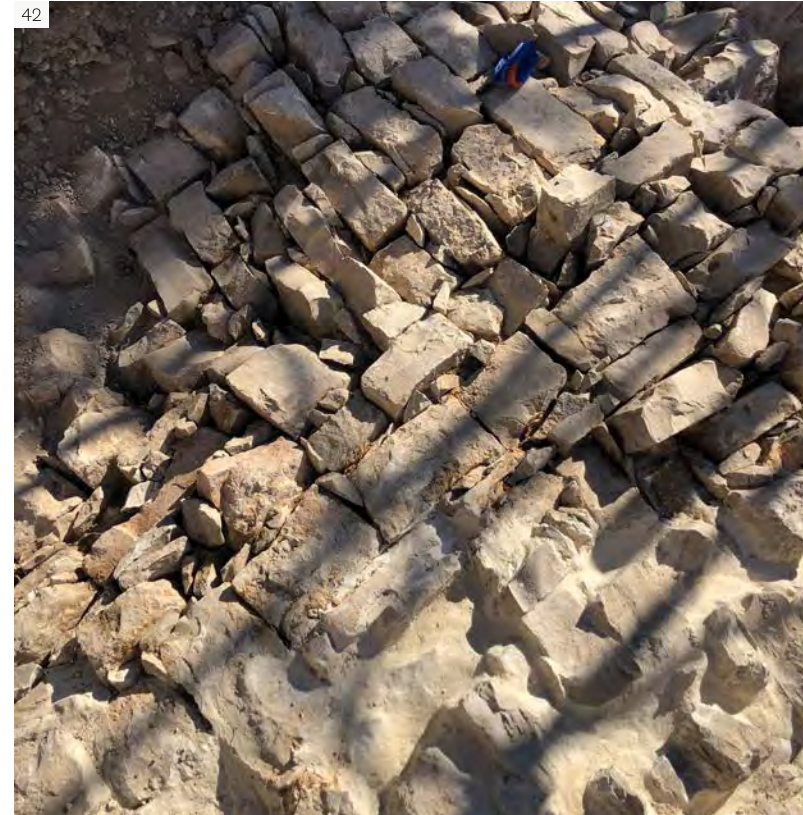
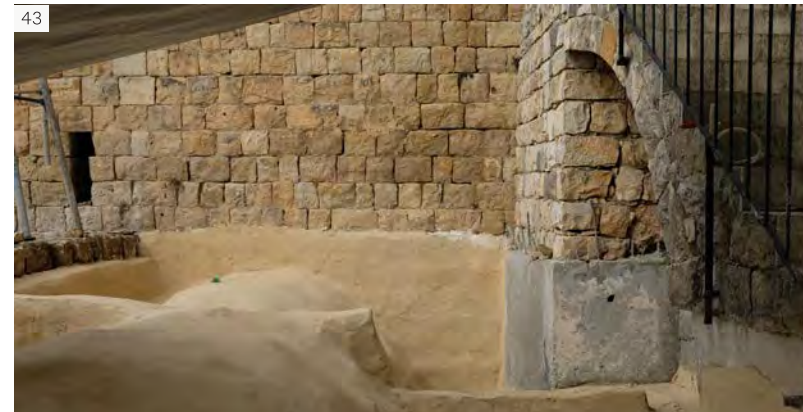
42, 43: Structural treatment of a cross vault extrados, Baz palace Deir Al Qamar-Lebanon

- The vaults should be first propped with a homogenous distribution of props, perpendicularly to their circumference.
- Filling material over the extrados surface of the vault should be removed.
- Joints should be cleaned, and a deep repointing process should be conducted with lime mortar (volume: 1/3 lime NHL 5, 2/3 sand, and crashed sandstone powder).
- Attach fiberglass, resin, or polypropylene meshing over the whole area of the extrados surface with non-corrosive connectors that must be anchored up to 1/3 of the vault thickness.
- Two layers of structural lime plaster mixed with fibers should be applied over the meshing grid (volume: 1/3 lime NHL 5, 2/3 sand, and crashed sandstone powder).
- Fill the volume over the vaults with fine gravel material.

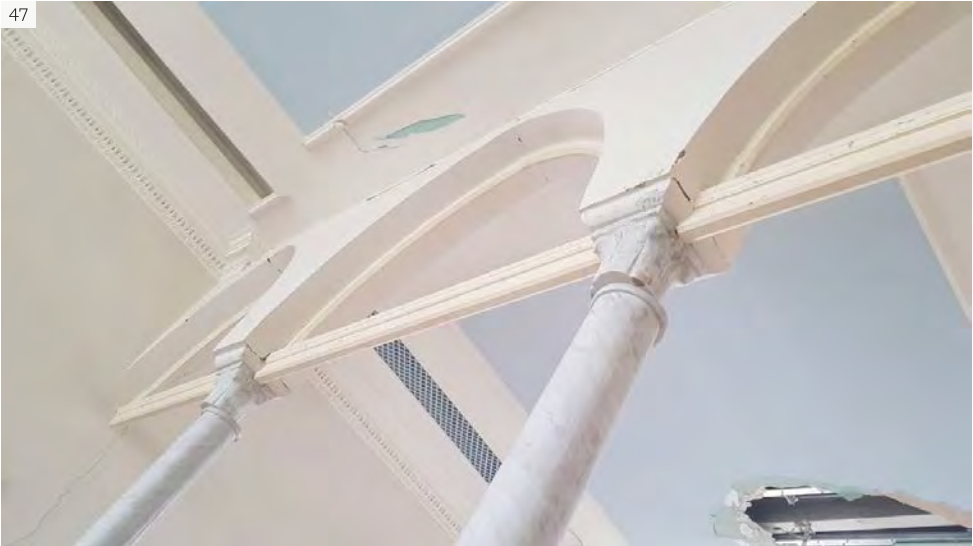
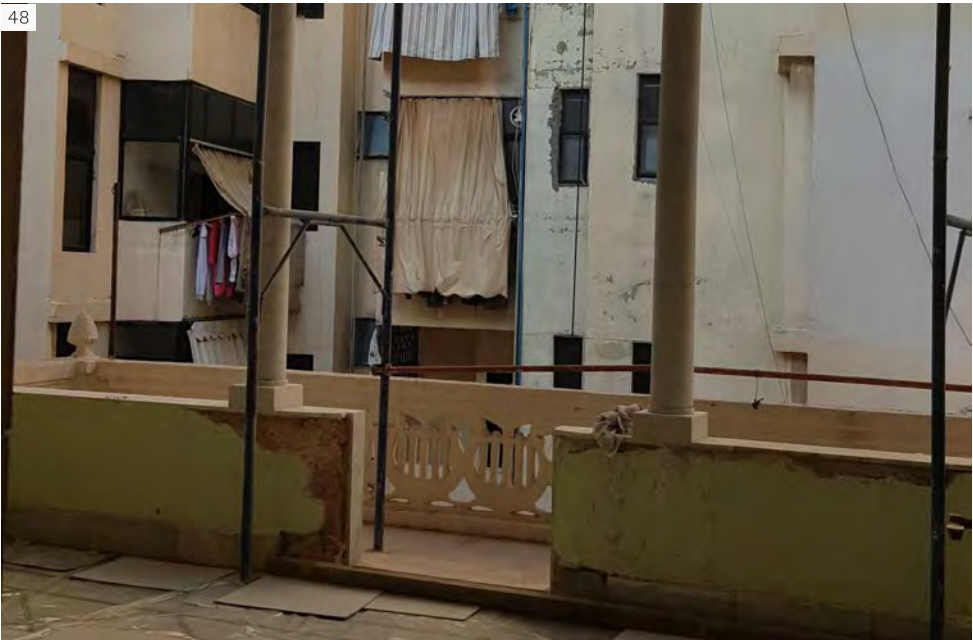
47, 48: Tilting and excessive deformation of a triple arch column head, Beirut – Lebanon

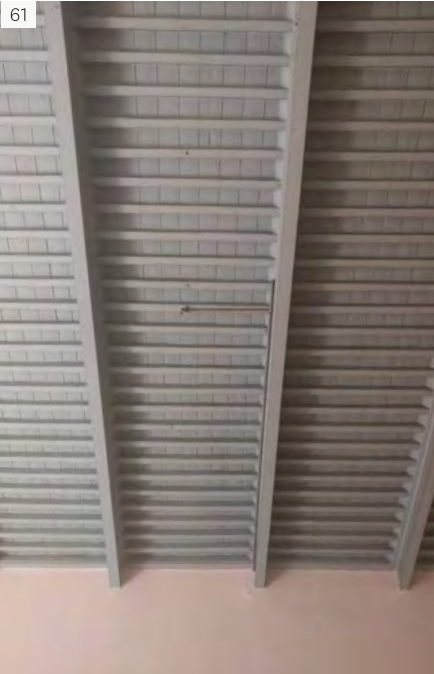
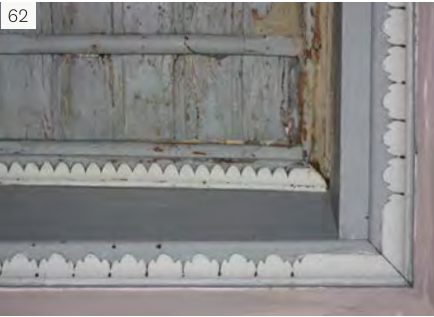
Moisture (63, 64, 65)

- Moisture is often owing to a leak, poor maintenance, or condensation. High moisture leads to the colonization of micro-organisms such as bacteria and fungi (dry rot for example) or wood-boring insects (such as woodworm and deathwatch beetle). The action of these micro-organisms reduces the overall strength of the wood.
- Moisture will cause deformations due to the expansion and shrinkage of the wood.
- Increased moisture levels are mainly found at the end of the beams and on the edge of the beams on their wall-facing side where it is mainly caused by moisture entering through the exterior walls.

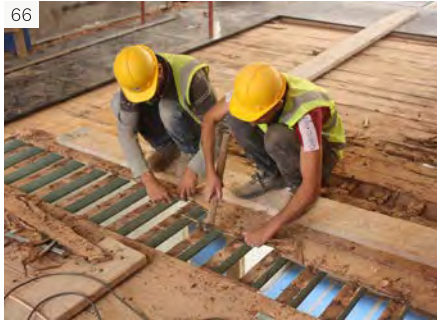
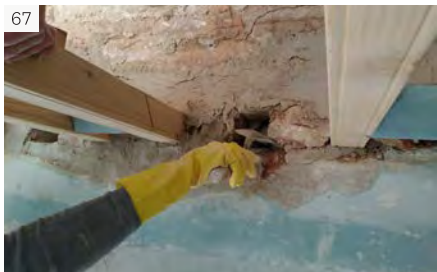
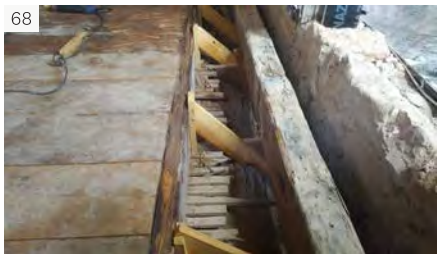
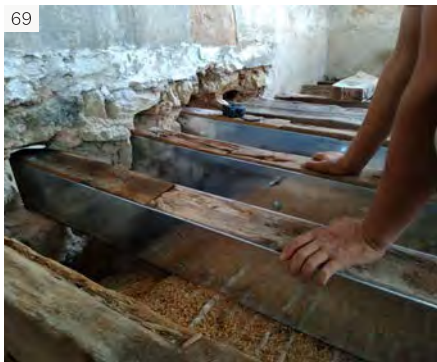
Reparation of the end of the timber beams

Rotting timber is the main cause for repair interventions on historical timber structures. Repair is typically needed for the end of the timber beam and on unprotected areas (timber-to-stone masonry connection). As a general rule, damaged areas need to be cut off 30 cm behind the last visible damage (66).

- Remove the existent paint and repaint the beams with a breathable, thin-film, anti-moisture, and antifungal paint.
- Clear and level the cavity where the end is installed.
- Close the gaps around beam heads with lime mortar in addition to stone chips when needed (67).

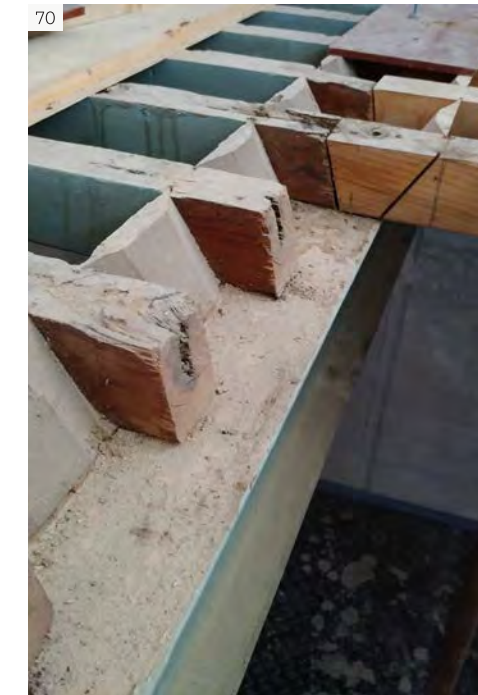
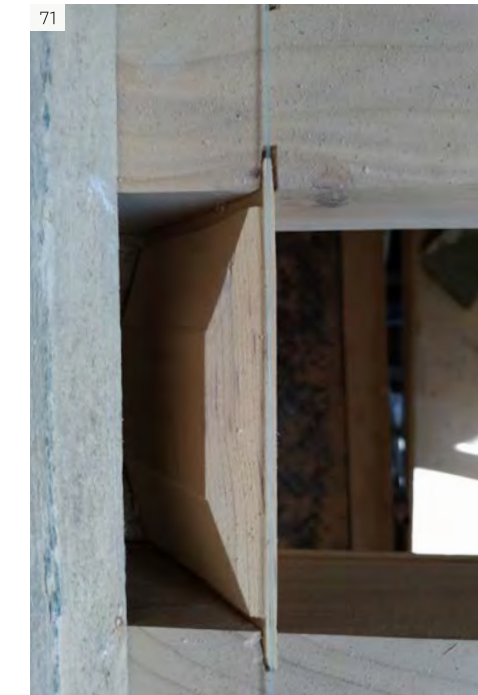
Reparation of a timber beam rupture and structural deterioration

This defect is the typical result of the blast's high, impulsive loading. Structural girders failed when their connection with the wall lost their efficacy.

- One solution consists of using a stainless-steel plate screwed in the timber girders. Pairs of pre-drilled “L” section stainless-steel plates are screwed on both the bottom edges.
- Where beams need a little more assistance, flitch plates can be inserted along the length of the beam. This method involves cutting a slot into the timber and making the beam a composite of steel and timber.
- Timber-Resin Splice technique (TRS): This technique consists of connecting timber prostheses to the damaged beam using smooth or ribbed stainless-steel rods, connectors, bars, or carbon fiber rods. These are usually fixed with an epoxy resin. The letting-in phase can involve cutting slots or drilling holes lengthwise from the end of the timber or diagonally across cracks.

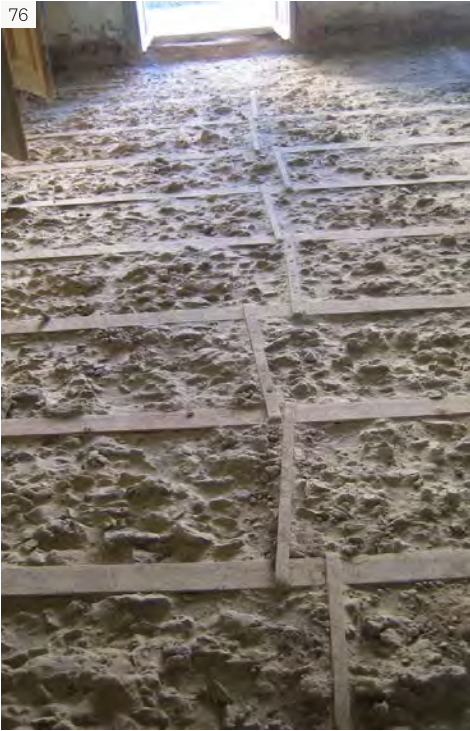
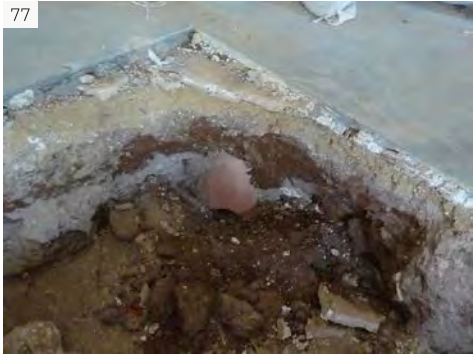
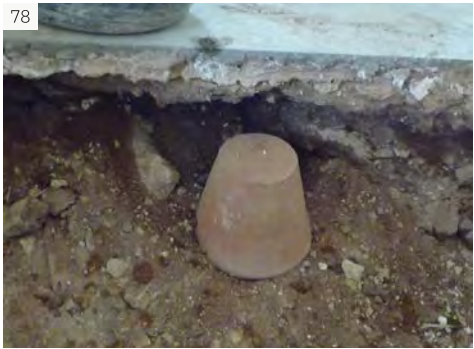
The *Beiruti* jack arch slabs feature steel beams aligned at 60-70 cm distance from each other. The intervals are filled with sandstone masonry or bricks with lime or limecrete. They follow a shallow arch or, more commonly, a flat soffit generally hidden by decorated lime and gypsum plasterwork. The beams are connected from the top by steel tie-rods spread evenly. These maintain the stability of masonry parts under compression and prevent movement between I-beams (76, 79). The slab is covered with a thick layer of fill (15 to 25 cm in thickness) and tiles. For acoustic and insulation purposes, and in order to reduce the dead load, hollow clay pots were sometimes displayed upside down on a regular pattern within the fill (77, 78).

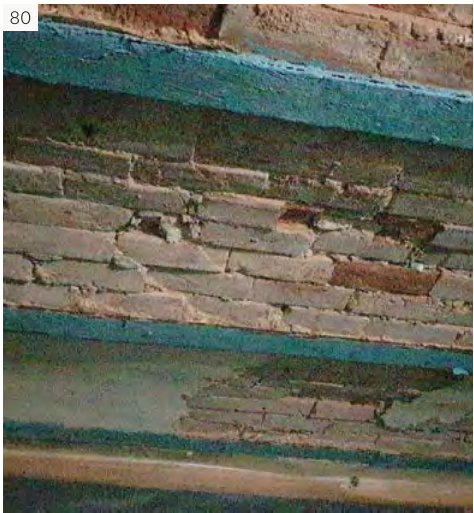
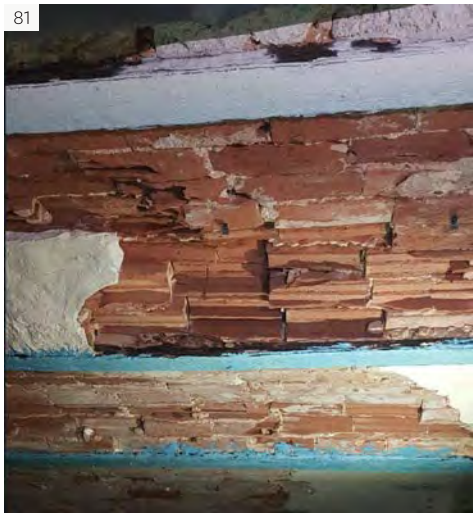
Having showed little decay over 150 years, the jack arch slab is markedly stable and resistant. However, the rusting on the surface of the ageing steel beams impacts the lime plaster’s adherence, creating cracks in the plaster all along both edges of the beams and resulting in the partial loss of the decorative plaster. Severe cases of highly corroded flanges are also identified where the beams’ lower flange is detached from the web.

Detachment of the beam's lower flange from the web: It is a delicate operation that must start by propping the steel beams. Then, the corroded flange and the lower part of the damaged web should be removed manually or using an electric saw, paying particular attention to not harm the plaster and the light brick masonry arches. A cementitious fluid grout should be then injected between the brick blocks. A T section with the same initial thickness of the web and the flange must replace the beam's missing part. To this end, an I-beam may be cut horizontally into two parts at the web mid-height level (82).

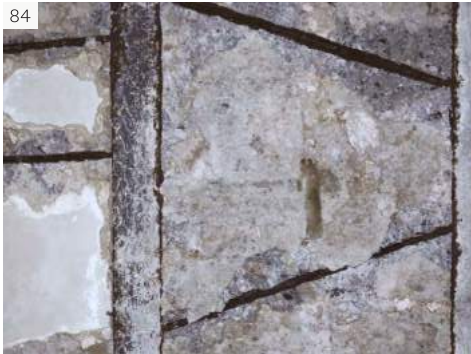
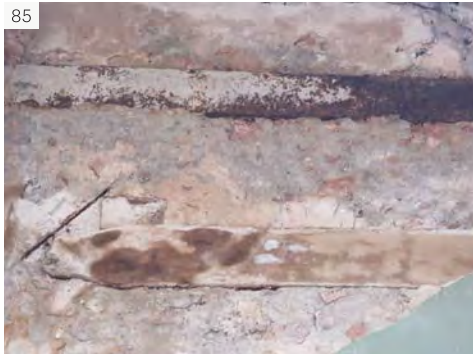
The limecrete slab is supported by I-beams that would span the floor and be placed every 60 cm. The 6 mm mild steel bars with their compressive strength of around 240 MPA are laid diagonally between the web of the I-beams, and the slab is then hidden from view with painted lime plaster (83, 86).

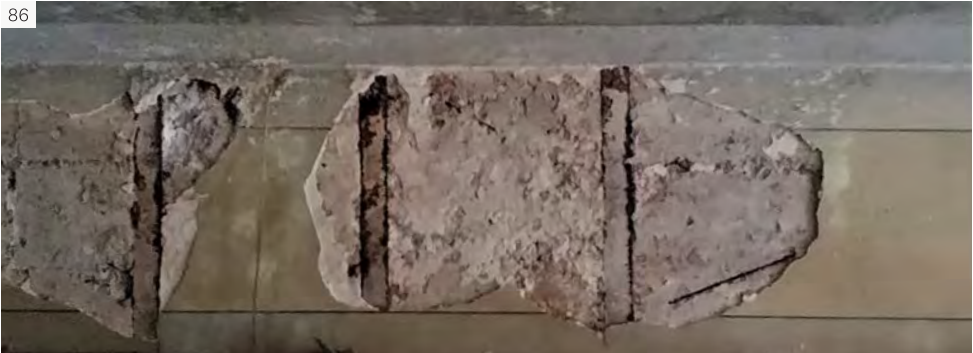
PATHOLOGICAL PROBLEMS (84,85,87)

Detachment of the protective plaster and the corrosion of the I-beam

Exposed to water infiltration and high humidity levels, the reinforced limecrete slabs show deterioration due to the corrosion of the embedded metal reinforcements. High humidity, combined with the naturally poor tensile strength of limecrete, means that a small steel section loss of the original embedded steel bars can initiate cracking in the surrounding limecrete.

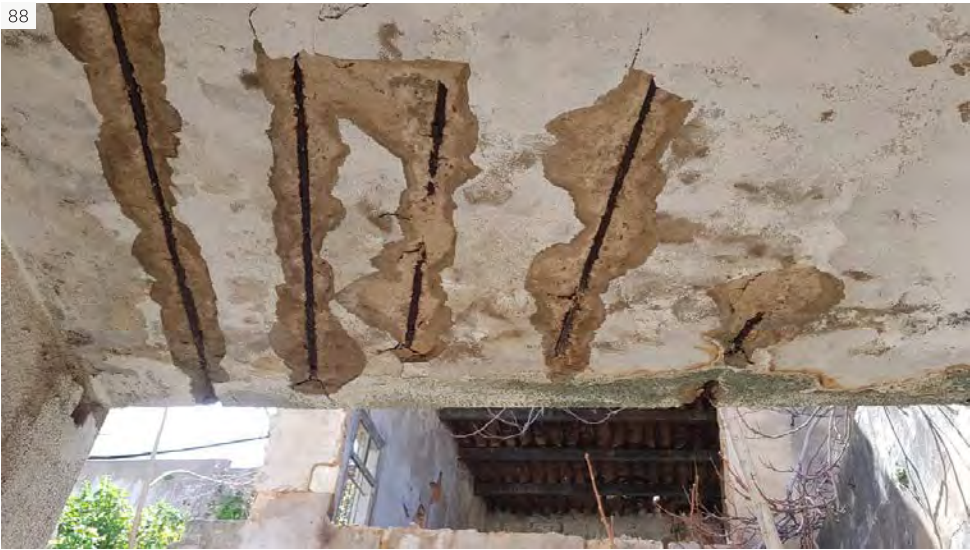
88: Concrete and steel rebars damage of a solid slab

Similar steps may be used to repair reinforced concrete beams or columns. Jacketing process consists of enlarging the initial cross-section. First, it is necessary to roughen the surface of the concrete elements and install L shaped steel connectors attached to the concrete elements using epoxy glue product. Then, longitudinal and transversal reinforcement should be added to the existing section. The newly added thickness around the existing section should not be less than 8 cm, and the concrete compressive strength of the poured concrete should exceed 25 MPa.

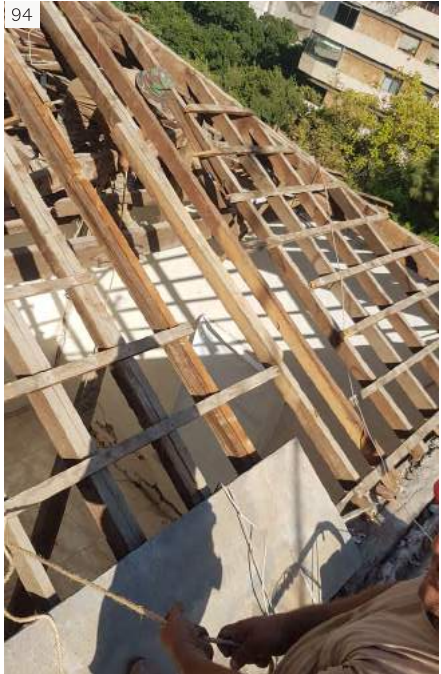
- Replacement with identical pieces preserving the traditional know-how.
- Improvement of sections with additional wooden planks.
- Metallic braces: riveted or bolted, to bind tear fibers.
- Joints: Wedges for nibbed key locked hooked scarf joints shall be well inserted (96).
- Metallic accessories: in case they are added, they should be perforated to avoid water confinement inside wooden sections.

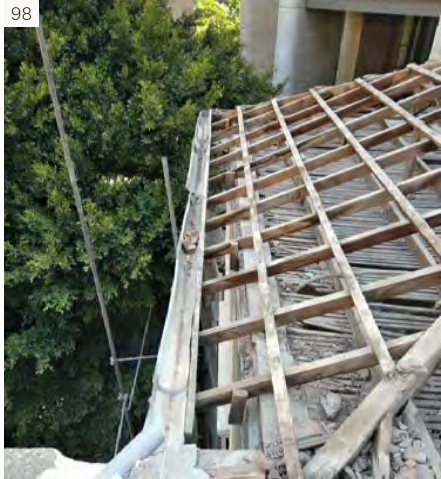
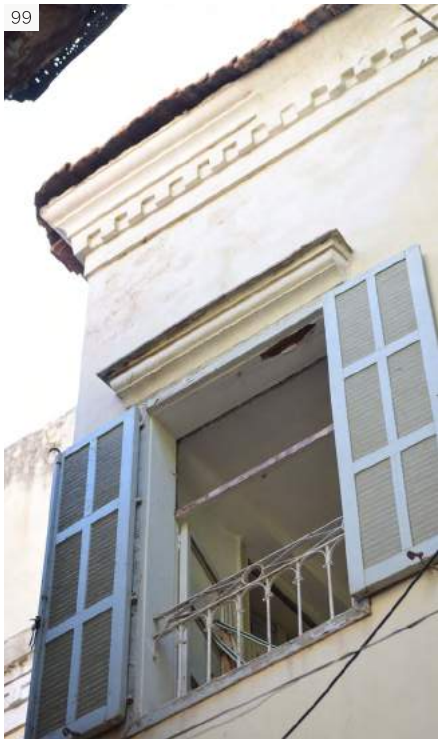
The eaves

- The eaves are the lowest part of a pitched roof, where it meets, or overhangs, the wall top (98). They have the main function of ensuring that rainwater is thrown clear of the top of the masonry walls.

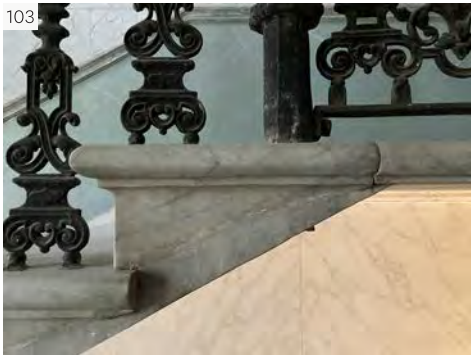
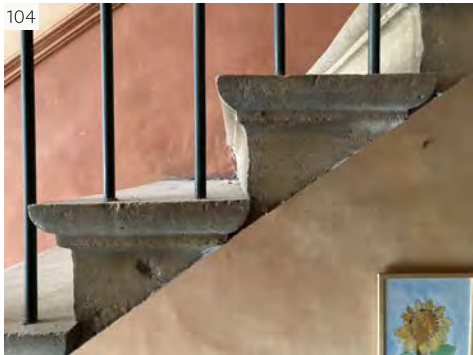
Cantilevered stairs: cantilevered stone treads are a traditional feature of local architecture in Lebanon. In the *Beirut* houses of the late 19th century, triangle-shaped treads are embedded 15 to 25 cm inside the wall and project 120 cm outwards. The steps are rebated, which means they are interlocked between each other to better resist torsion (103, 104, 106).

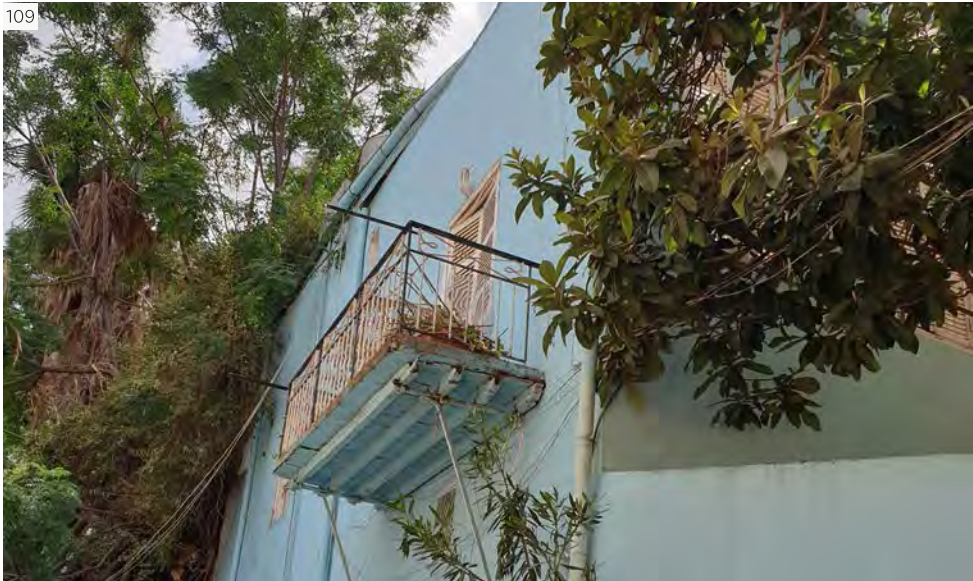
The few remaining examples show a lightweight structure consisting of either thin iron brackets, stone corbels, or I-beams supporting timber joists and wooden planks [1.5 cm thick and 20 cm wide]. The finishing varies between marble slabs, tiles, or an 8 cm concrete slab with cement finishing.

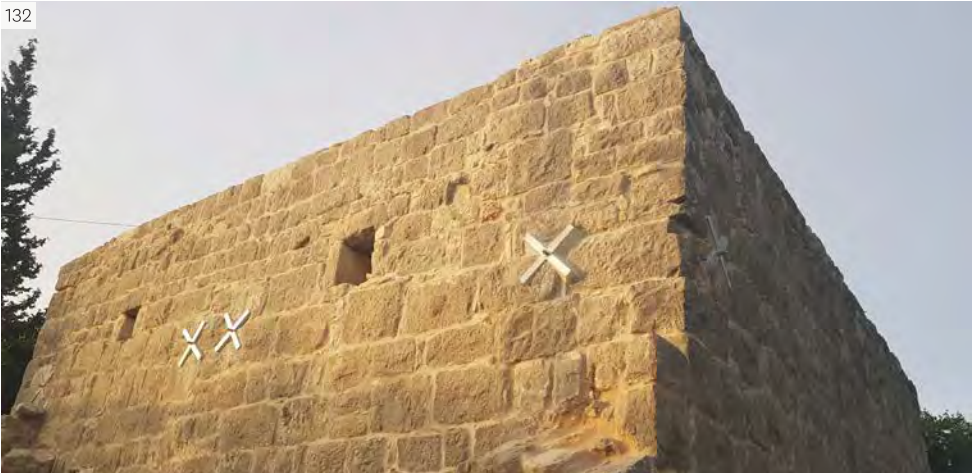
132: Système de tirants et appuis en forme de X en acier inoxydable installés sur les murs orthogonaux, Chamat Jbeil - Liban

Metallic tie-rods: They should be located at the floor level and anchored at their end using bearing plates, X’s, or straight metallic strips. The latter may be visible (132) or embedded in the mass of the wall (33, 34). Tie-rods may be executed with plain circular section or wire ropes; they should ensure a connection between two parallel peripheral walls. They also provide a valuable connection between orthogonal walls and consequently a restraint against OOP failure mechanisms. It is necessary to install the tie-rod system in such a way as to connect the different opposite walls of the building, mainly in two orthogonal directions 132). The IP behavior of a wall with openings is also improved by the addition of a tie-rods system. In fact, it develops a strut and tie mechanism in the spandrels below and above the opening.

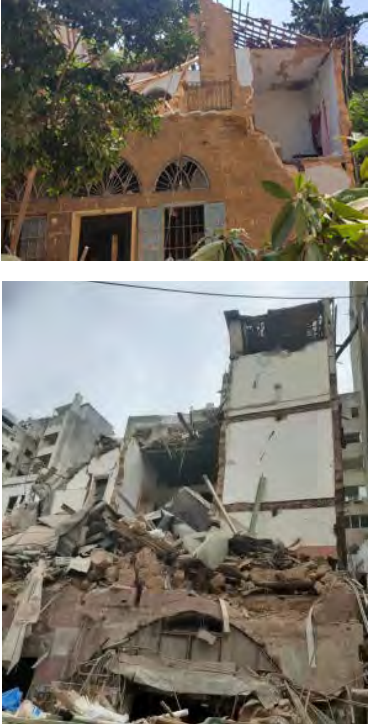
Typology of damage <i>Highly damaged and partially collapsed building</i>			
Description	Sketch	Proposal of immediate intervention	Illustration

Stabilize the remaining part of the building and dismantle the risky parts in order to reconstruct it.

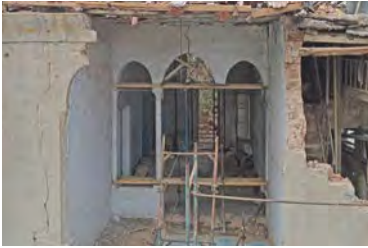
Columns are missing from the triple-arch elevation.

Add a propping system beneath the triple arcades.

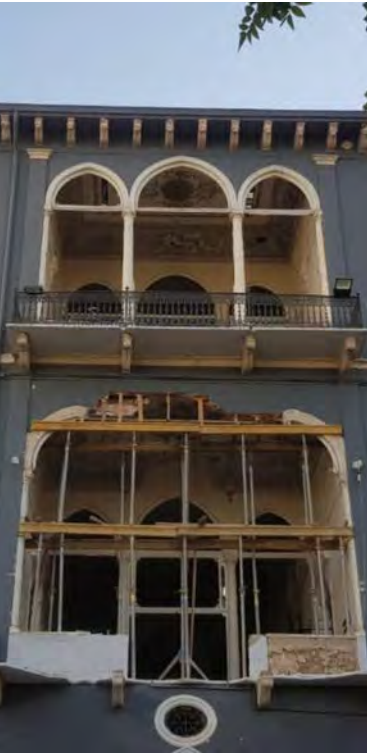
The whole triple arch's elevation is missing.

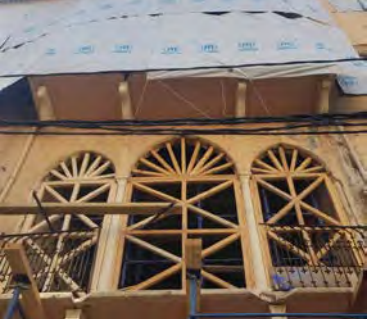
Typology of damage <i>Wall-to-wall and corner detachment</i>			
Description	Sketch	Proposal of immediate intervention	Illustration
Walls on the ground floor.

<p>Add a vertical lateral bracing system.</p>

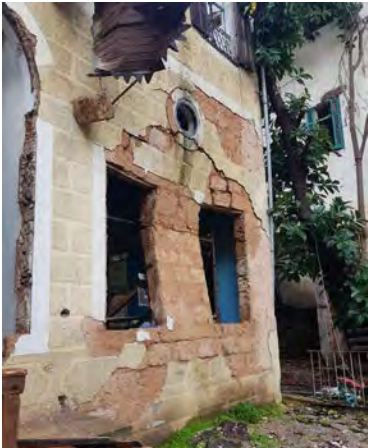
Typology of damage <i>Bowing of walls</i>			
Description	Sketch	Proposal of immediate intervention	Illustration

<p>Add a lateral, vertical bracing system connected to the damaged wall.</p> <p>Add a propping system in the lower floors.</p>	
Collapse of some peripheral end walls beneath the attic

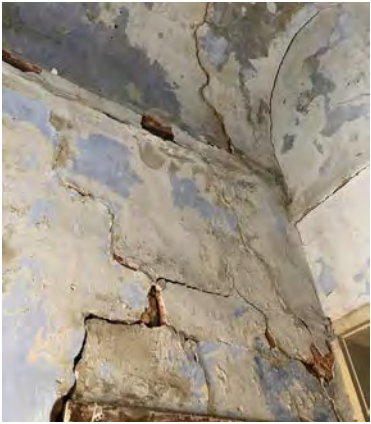
Typology of damage <i>In plane cracks with limited crack width < 2 cm</i>			
Description	Sketch	Proposal of immediate intervention	Illustration

Lime injection Add a propping system where needed.	
Broken beams or excessive deflection of the ceilings

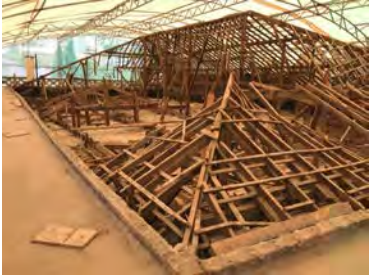
Typology of damage <i>Damage in attics</i>			
Description	Sketch	Proposal of immediate intervention	Illustration

<p>Partially or quasi-totally damaged.</p>		Repair the structure of the damaged truss. Add a temporary sheltering or tarpaulin system.

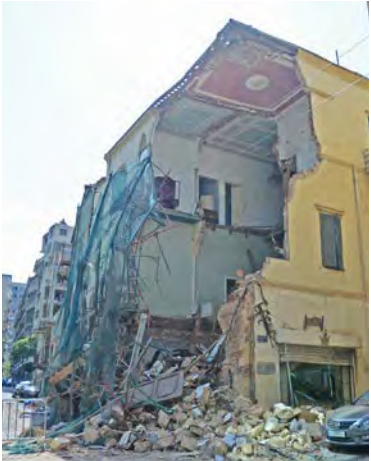
Out-of-plane failure - Local collapse with an unstable attic condition

<p>Hold the attic temporarily with a telescopic crane.</p> <p>Create a provisional structure (of steel or timber) where needed in order to retrieve the initial structural conditions of the building.</p> <p>Cover the attic and the collapsed elevation with tarpaulin or a sheltering system.</p>

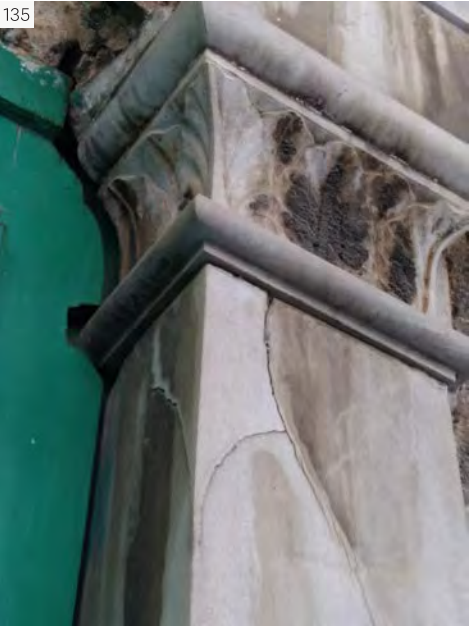
<p>Particle soiling and Black crust</p> <p>This can be caused by the airborne deposition of vehicle exhaust fumes, sea salts, and other contaminants.</p> <p>Acid rain causes carbonate dissolution, which leads to the degradation of the inside of the stone and triggers the formation of a black crust at the surface. In parallel, the residual concentration of calcite inside the stone could be heavily affected, causing stone alteration.</p> <p>Areas that are not exposed to the rain have a deposit of dust and show a darker color.</p> <p>Poor maintenance may promote the accumulation of soiling.</p>	<div>135</div>

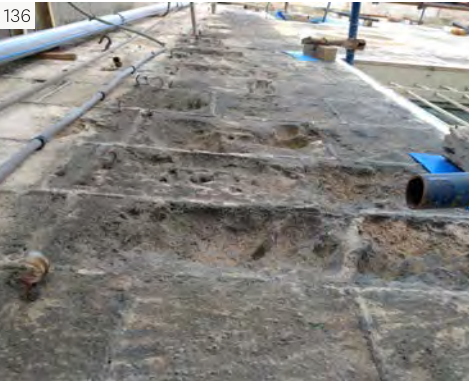
<p>Poor water management</p> <p>Water is the most destructive agent specially for lime or gypsum-based decorations.</p> <p>Humidity can be caused by several factors:</p> <ul style="list-style-type: none">– condensation caused by infiltration and penetrating and rising damp– capillary water transport (i.e. humidity by capillarity on the base of the walls)– backfilling behind the retaining walls in the ground floor areas– rainwater that generates changes in the porous sandstone	<div>136</div>

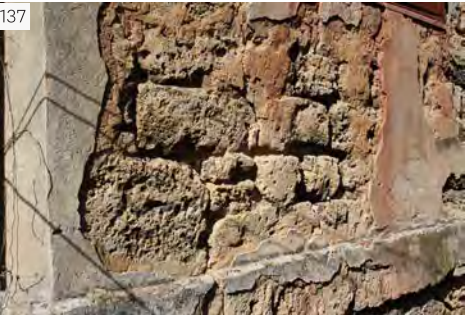
<p>Staining</p> <p>This is a natural process that can be dramatically accelerated by cleaning.</p> <p>It is caused by dark colored minerals such as iron or manganese that naturally occur in sandstones and gradually seep out over many years.</p>	<div>137</div>

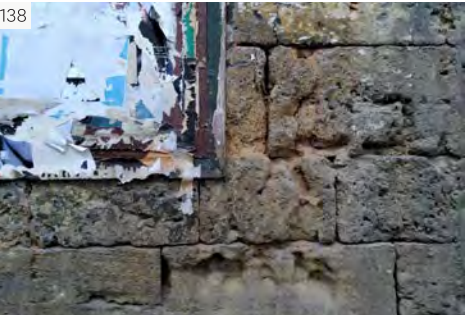
<p>Alveolisation</p> <p>This manifests in cavities of variable shapes and dimension—comparable to honeycombs.</p> <p>It is caused by high moisture levels.</p>	<div>138</div>

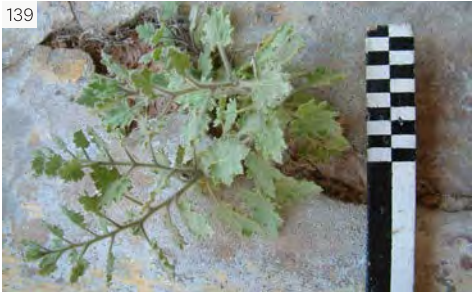
<p>Higher plants</p> <p>Presence of colonization of plants with sizable roots.</p>	<p>139</p>

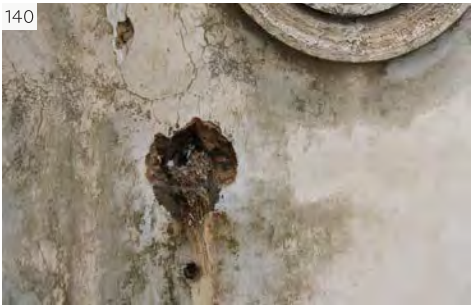
<p>Bird fouling</p> <p>The corrosive effects of the acids in birds' excrement have a prolonged impact that persists even if the fouling is removed.</p> <p>Fungi that live on pigeon excrement enter the stone, transporting naturally produced acids that are strong enough to dissolve stone and form soluble salts. This process increases the porosity of the stone's structure, allowing water to penetrate more readily.</p>	<p>140</p>
