HOUSES OF BEIRUT 1860-1925
Restoration manual

Restoration manual

under the direction of Nathalie Chahine and Fadlallah Dagher

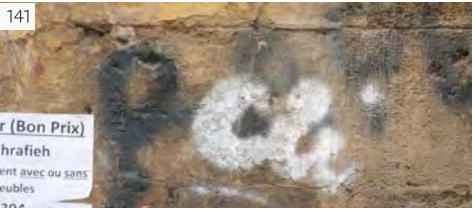
<p>Graffiti</p> <p>It is caused by highly penetrating aerosol paints that can permeate deeply into the stone's structure.</p>	<p>141</p>

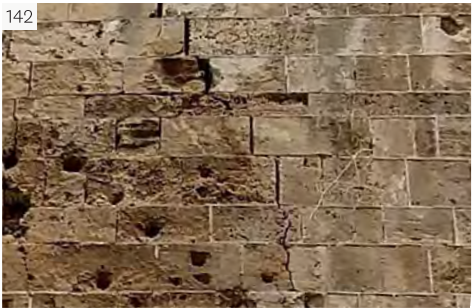
<p>War damages</p> <p>Missiles and shelling produce extreme temperatures that damage the stones and affect their resistance.</p> <p>Bullet impacts.</p>	<p>142</p>

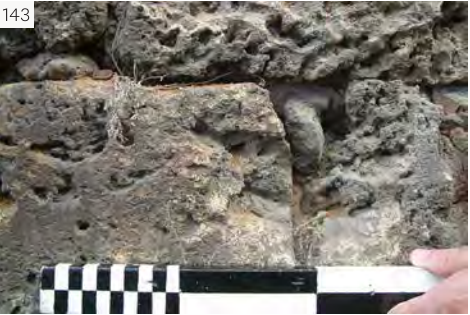
<p>Powdering</p> <p>This is visible in the spontaneous detachment of dust-shaped material.</p> <p>It is caused by high moisture levels.</p>	<p>143</p>

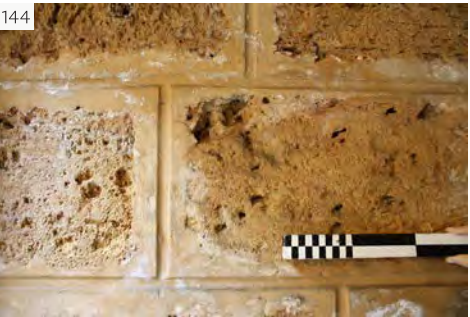
<p>Efflorescence</p> <p>The salts involved in the process are those dissolved in seawater (mainly chlorides and sulfates) which arrive at the house as aerosols transported by wind.</p> <p>Sandstone provides a porous surface for water to penetrate and stagnate. The soluble salts in the seawater dissolve and get absorbed by the masonry before re-crystallizing at the point of evaporation. This causes an efflorescent appearance at the surface of the stone.</p>	<p>144</p>

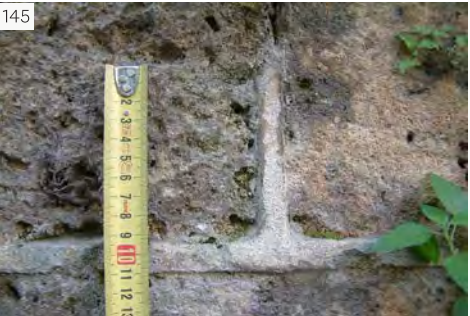
<p>Biological surface soiling - colonization by micro flora (fungi, algae, lichen, moss) and bacteria</p> <p>It is caused by atmospheric and micro-climatic conditions, fluid movement and concentrations, surface roughness, and physical changes.</p> <p>The umbra of trees located close to walls could also encourage the algal staining.</p> <p>In addition, water-holding and run-off surfaces are prone to biological surface soiling.</p>	<p>145</p>

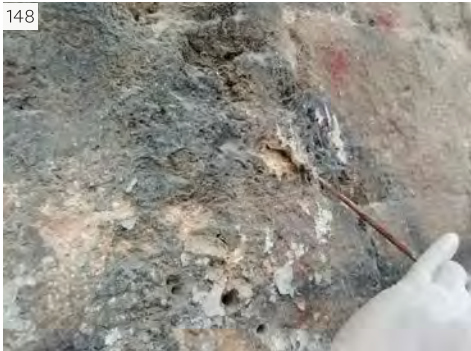
The pressurized water from the waterjet can infiltrate through the joints and the porous sandstone reaching the structure. It is recommended to schedule water-based cleaning work during dry season. This allows the infiltrated water to dry faster (150).

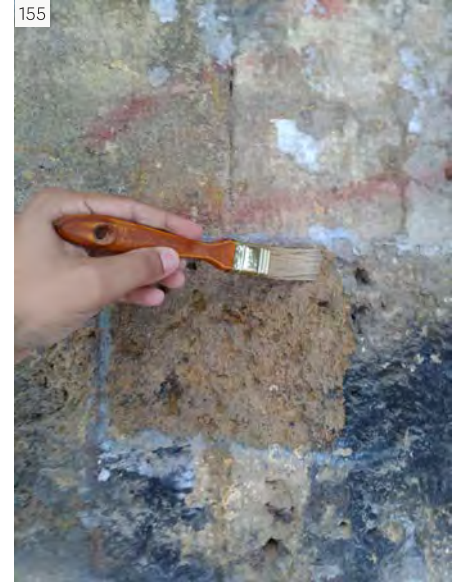
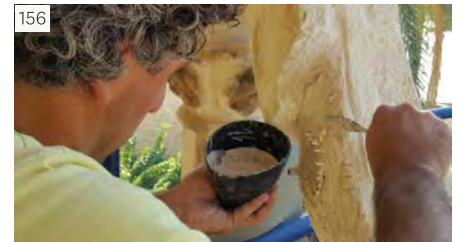
- Remove the disaggregated and powdered part. The area to be treated should be at least 6mm thick to avoid feathered edges for the patch.
- Remove loose particles, soil, debris, oil, and other contaminants from existing stone by cleaning with a stiff-fiber brush.
- Fix a mesh and/or stainless-steel screws if needed. Meshes should be cut at each joint in the stones (vertical or horizontal) in order to ensure the resistance of the patching mortar to expansion or withdrawal (156, 157).

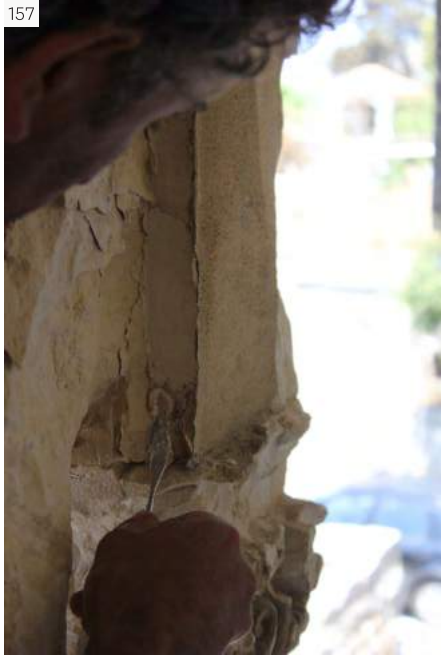
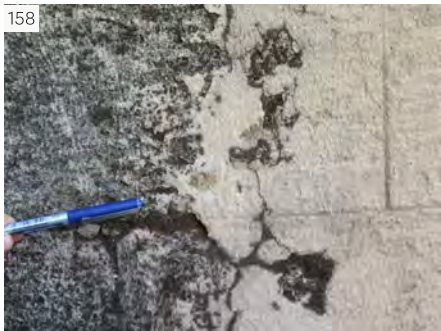
Unacceptable patches are those with hairline cracks or that show separation from stone at edges, in addition to those that do not match the adjoining stone in color or texture (158).

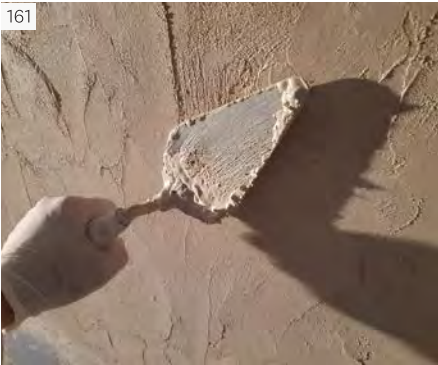
2-5 mm of a finishing coat.
This mix of lime and finer, sharp sand or stone powder can vary depending on the hardness and the type of finish required (165).

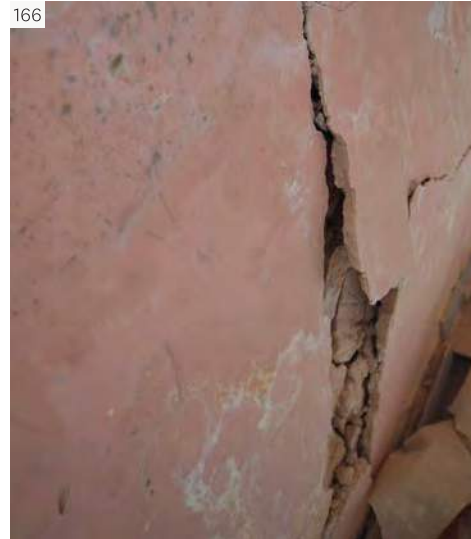
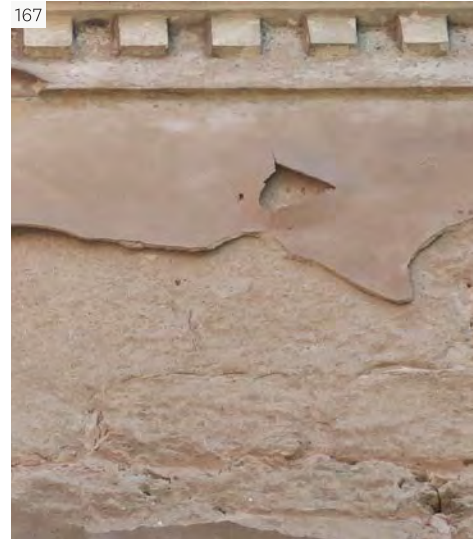
Surface related to the fatigue of the plaster and to water infiltration (167).

Chromatic decays: fading of original colors (167).

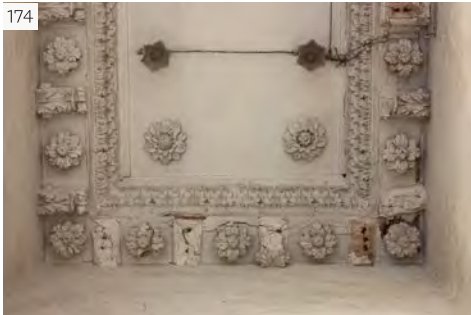
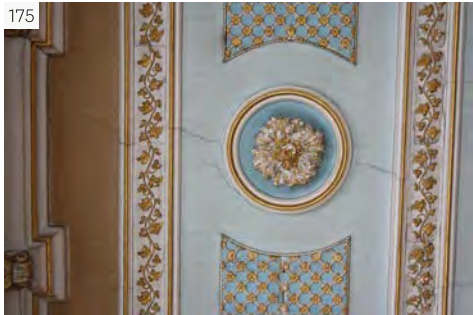
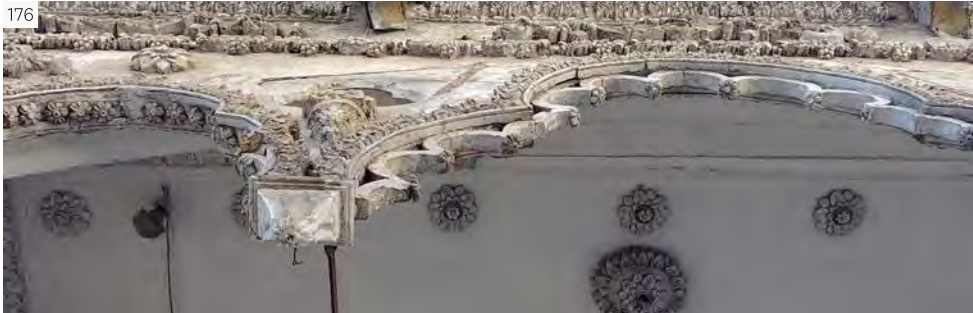
Mixed with water to a creamy consistency, gypsum was poured into low relief molds. Exploitation of these attributes in the late 19th century *Beirut houses*, together with the rise in popularity of the neoclassical style, enabled large quantities of repetitive low relief ornaments to be produced in situ. Flexible gelatins molding materials allowed a large number of ornaments, such as limbs, foliage, grapes, busts, etc., to be achieved in a single cast (174 – 177).

Molded elements required the use of an armature, usually metal bars, that attach them to the slab or the wood joists till adequately carbonated.

Whenever ceilings are affected by the humidity, the ferrous armatures attaching the molded decorations to the joists get rusted and become the major cause of the deterioration and, eventually, the loss of the modelling (174, 177).

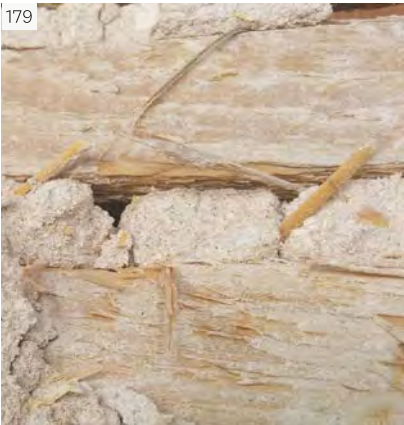
The *Baghdadi* partition is a system of a wood-frame structure consisting of studs, plates, and cripples, in addition to narrow wooden laths nailed horizontally across the studs and coated with lime plaster. The plasterer applies slight pressure to push the wet plaster through the spaces. The plaster slumps down on the inside of the wall, forming plaster keys that hold the plaster in place. The sleepers of the wooden frames are inserted into notches in the stone walls (178, 179).

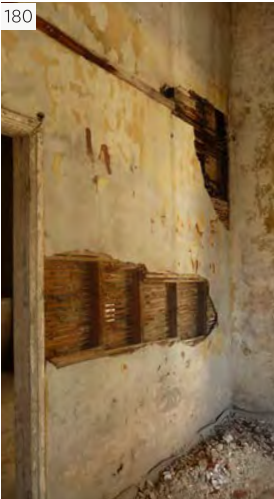
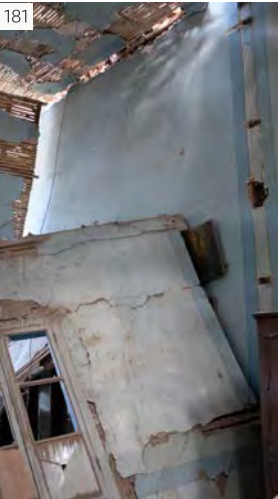
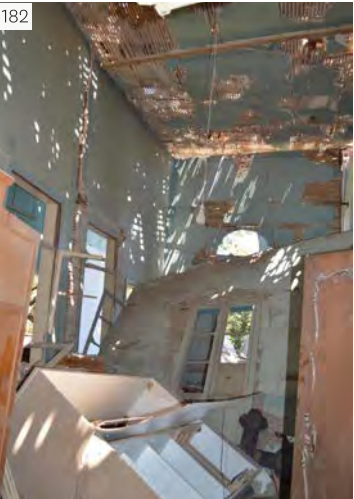
The blast of the August 4th explosion caused the detachment and dislocation of the *Baghdadis* walls and ceilings (181, 182).

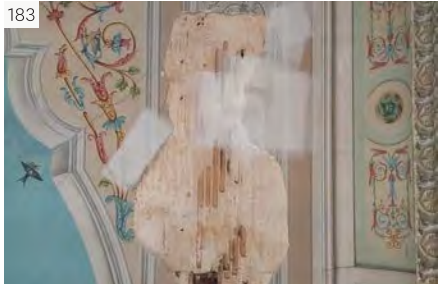
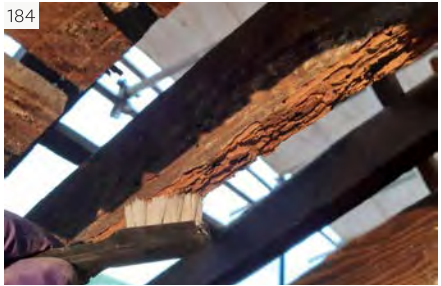
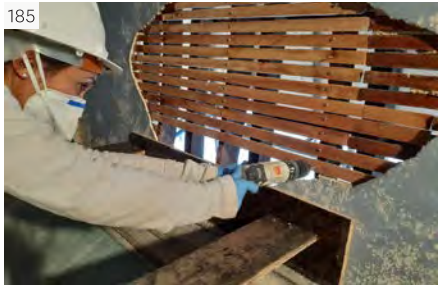
- Ensure that all water leaks and infiltration points are closed and proper lead-away of the water is done.
- To treat a deformed area, cover it generously with two overlapping layers of Japan paper and adhesive (183). If not sufficient, propping is needed. Make sure to use soft materials in contact with the plaster and paint and not to alter the deformation at this point.

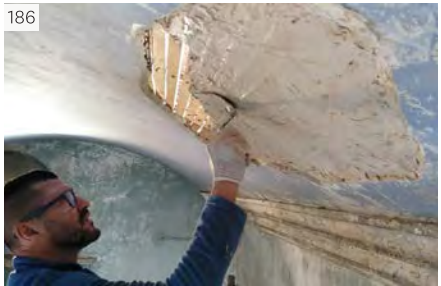
- Strengthen the attachments of the laths on the joists.
- Reconstruct the wooden supporting structure where needed.
- Inspect wooden laths for material flaws and degradation, apply strengthening and conservation measures as necessary, include substitution and biocide/fungicide treatments for the wood (184, 185).
- Reattach the plaster to the laths in sections by re-inserting the detached plaster keys
- The detached plaster keys will be reinserted in between the lath where possible. Otherwise, it will be reformed and consolidated with both the plaster and the wooden slats.
- Substitute areas of loss with similar material (186).
- Clean (dry, humid, chemical)
- Restore the paintings.

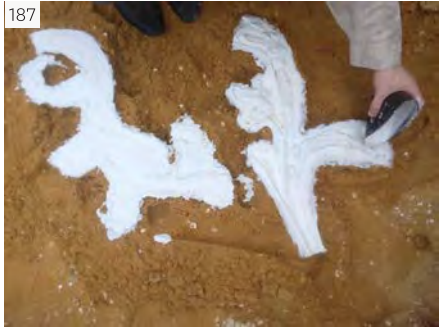
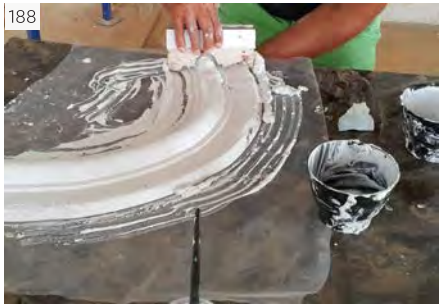
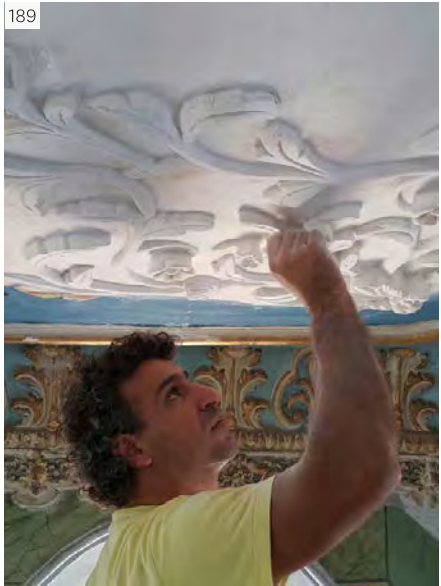
- Lightly push loose cornice plaster.
- Treat and close cracks by grouting and pointing.
- Reconstruct missing ornamental plaster moldings elements by casting existing molded plasterwork with silicone or similar (187, 188).
- Re-attach the ornamental plaster motifs with stainless-steel bars / screws.
- Perform final grouting and pointing of the plaster (189).
- Clean (dry, humid, chemical).
- Restore the paintings.

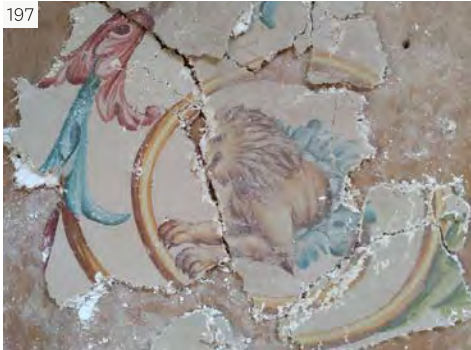
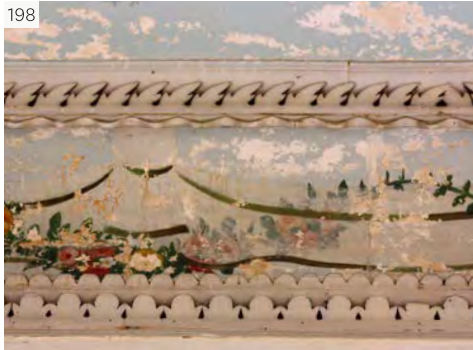
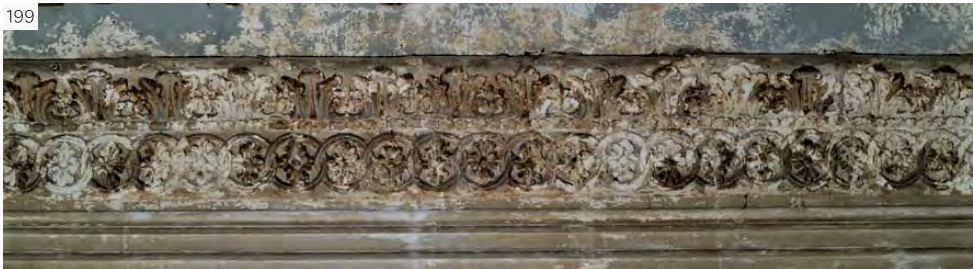
Surface disintegrations (197 - 199)

Paintings require constant maintenance and protection from weathering factors. Condensation caused by infiltration and penetrating and rising damp can lead to superficial pulverization and flaking of the painted surfaces. On the other hand, Lignin staining and leaching of the lime-based binder can disfigure the paintings over time. Moreover, aging signs—along with patinas, stains and discolorations—begin to appear on the painted surfaces over time and neglect. These effects are catalyzed in humid environments where poor water management causes the deterioration of the binder. Without proper treatment, such decays threaten the historic pigments and painted layers.

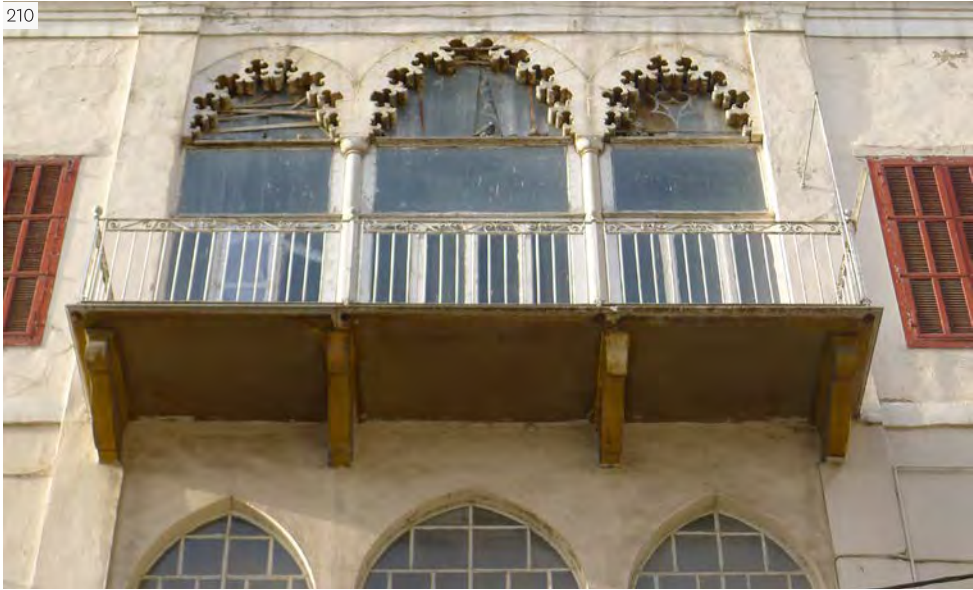
Cornices

The cornices are horizontal elements protruding from the façade, located over the windows (and sometimes over the doors), and on the periphery of the building at its top.

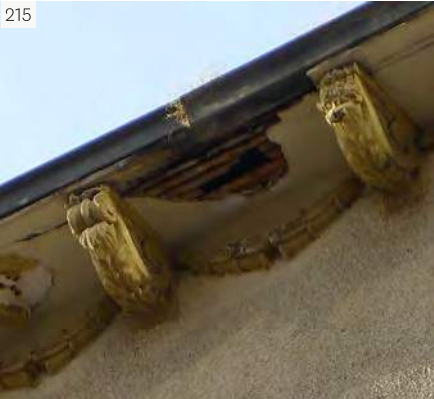
Composite deep roof cornices disorders

Of all molding’s elements, the deep roof cornices have been the most severely affected by the August 4 blast (215, 220), revealing latent disorders due to:

- movement in the structure, specifically at the base of the pitched roofs: These can be observed as systematic horizontal cracks at the intersection between the façade and the pitched roof timber frame. Subsequently, the top of walls and roof cornices were disturbed and left out of plumb.
- movement, breaking, and falling of corbels, marble slabs, and limestone edges. These are more visible at the corner.
- destruction of wood, *Baghdadi*, and plaster features
- partial or total loss of decorative molded motifs

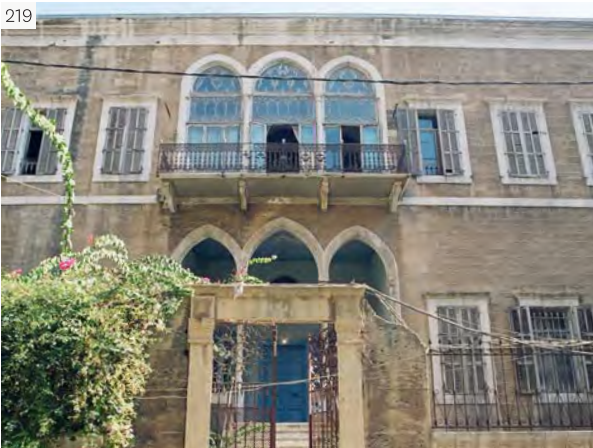
Composite cornices

In the case of various levels of damage, the assistance of a structural engineer is mandatory to assess the causes of distress and the structural remedies.

- Minor damage, displacement of pieces or cracks: pieces will be propped and put back in place.
- Minor to moderate damage, including broken pieces: broken pieces will be assessed and reassembled if deemed possible. Stainless-steel rods and anchors may be inserted for additional stability on the long term.
- Heavier damage:
 - General condition to be assessed with the assistance of a structural engineer, and a precise method statement for reconstruction should be established.
 - Displaced elements will be propped, reinforced, and put back in place.
 - Stainless-steel rods and anchors may be inserted for additional stability on the long term.
 - Lost pieces will be reproduced in similar material and reinstalled in place.

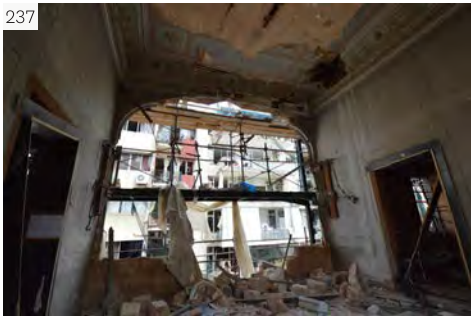
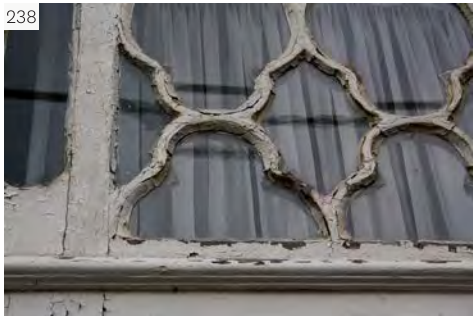
The triple-arched bay was one of the most damaged elements by the August 4 explosion. Located at the center of the façade, it forms a light diaphragm nestled amongst rigid elements. As a result, it could not withstand the deformations the structure was subjected to by the blast.

- Several columns, and subsequently their arches, collapsed—shattering not only the shafts and keystones, but also the slabs and corbels of the balconies.
- **Out of Plumb Structures:** This refers to the masonry walls or columns that are found in a leaning, bowing, or buckling position. It is either a direct effect of the explosion or a result of accumulated load, movement, or structural problems.
- **Cracks in masonry:** Cracks can be found in the masonry walls surrounding and forming the arches especially in the middle of the arch or keystone and in the stone columns of the triple bay.
- **Cracks in marble:** These are found in the marble columns, capitals, doors, and windows' sills.
- Systematic loss of the wood, glass frames and transoms.

- Keystones and lintels should be consolidated. In case of loss or damage, they must be replaced with a new, similar stone that bonds to the wall's structure by means of a lime mortar mixture.
- If elements of the bay are broken and irrecoverable, their debris should be gathered and documented, and the missing elements (spandrels, columns, and arches) must be reproduced and reassembled in an identical manner. This must be made with the compatible material and by specialized masons
- In masonry displacement and out of plumb cases, it is necessary to observe the assembly in detail to identify and, if possible, return the parts to their places by means of shoring and clamping. The process must be done without negatively impacting the future stability of the system. In general, it is recommended to dismantle the structures and rebuild them to ensure plumb and structural stability.

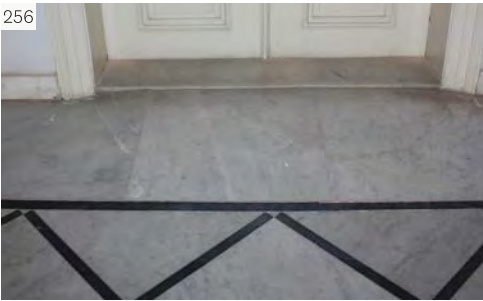
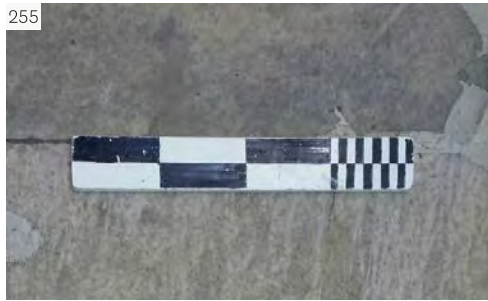
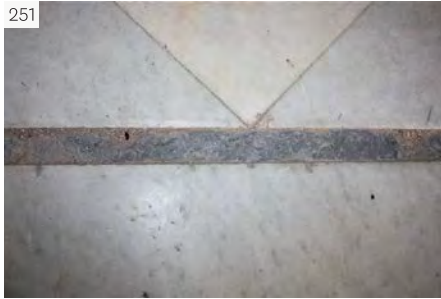
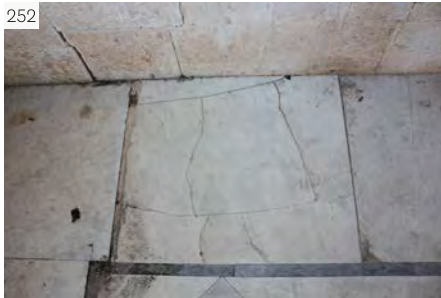
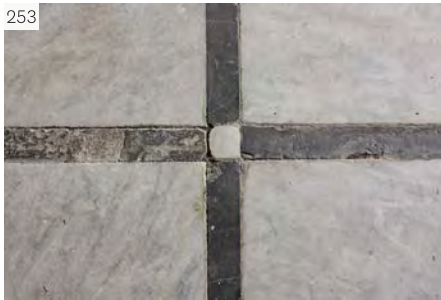
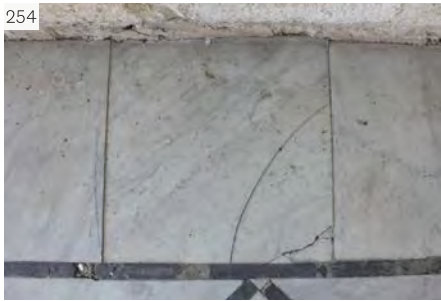
Even within the walls of the house, marble tiles are subject to a range of processes that can cause deterioration. Moisture is usually the key agent of decay, with condensation or penetrating and rising damp leading to direct surface erosion. Clear effects of the August 4th explosion were seen in cracking, spalling, and settlements (256).

Erosion (251, 253): This problem is mainly caused by the aging of the marble and its weathering. For example, marble exposed to direct rain (as in the balcony) will generate a surface layer that is hard to remove without a thorough cleaning. Marble can also be damaged if it is exposed to acids and strong alkalis. Lemon juice, vinegar, and wine can etch the surface and remove the polish. Repeated exposure may erode the surface even further.

Abrasion and Degradation (254): Most marble has a low abrasion-resistance rating: i.e., it is likely to scratch.

Cracks (252): Water leakage can weaken the mortar beneath the tiles, which, in turn, causes crack formation. Cracks can also be an indicator of a structural settlement. Additionally, while veining gives a decorative effect, note that it can also be a source of weakness in the stone.

Surface soiling and staining (255): it can be attributed primarily to airborne dust and pollutants, degraded coatings, staining through condensation or water ingress, corrosion of metallic elements and fixings, such as radiators elements, and human activity (such as previous maintenance and restoration, handling, and graffiti).

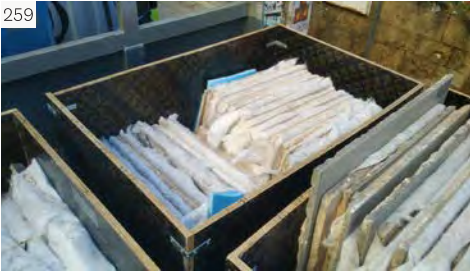
- Clean the marble with a soft tissue and removing all residue.
- Give a code for each tile on the survey papers [e.g.: rows are marked with numbers, columns with letters] (260).
- Mark each tile with duct tape according to the above coding system. Make sure that the tape's label specifies that it is safe to use on marble (257).
- Find a cracked stone to be the first tile to be gently removed. Carefully remove the grout around the tile without damaging the neighboring tiles using a chisel or a flathead screwdriver and a hammer (258).
- Clean the back of the marble by using a hammer and a trowel and soaking the tiles in water for about 30 minutes to soften the mortar if needed. Scrape off the mortar with a trowel and brush off remaining particles of mortar with a medium brush.

- Store the marble in plastic boxes. Insert geotextile 150 g/m2 between every 2 tiles and give a code to every box (259).
- Consolidate the new soil to receive the tiling. Lay down a new layer of sand and lime mortar, and reinstall the tiles in their original location.
- For jointing, humidify the floor, then spread a grout with a well-dosed binder [1 volume of lime to 1 volume of water] on the surface.
- Scrape the surplus and clean.

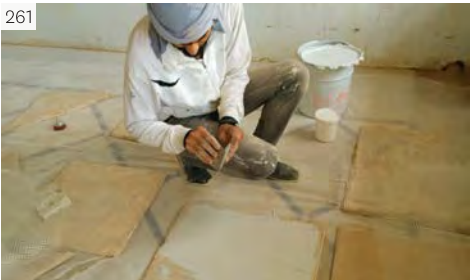
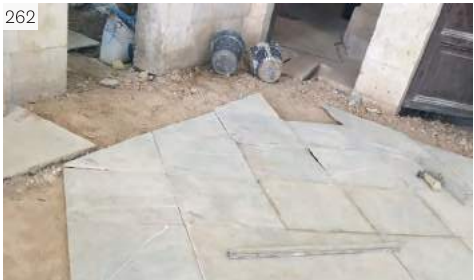
- Pieces of marble that exhibit cracks could be salvageable using glues, dowels, or special mortar and a reinforced net from behind (261).

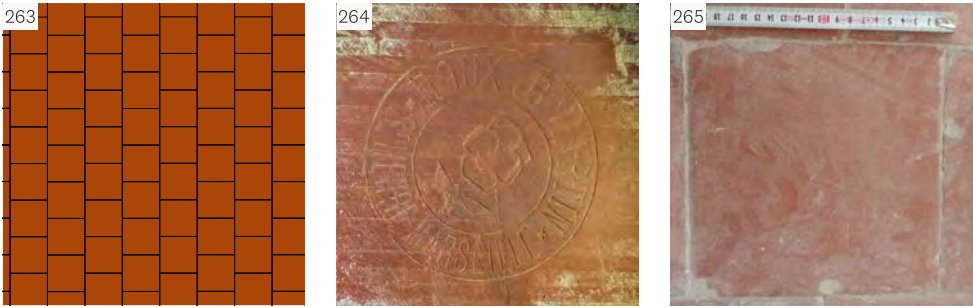
Clay floor tiles of 20*20 cm were generally imported from Marseille to Beirut. Their colors can range from dark reds to browns. In rich houses, the surface of the clay floor tiles is glazed for extended longevity. The tiles are 20 mm thick and are bedded in lime mortar—often in a staggered pattern. Clay floor tiles usually cover multipurpose family rooms like the sleeping rooms, the sitting rooms, and the dining rooms.

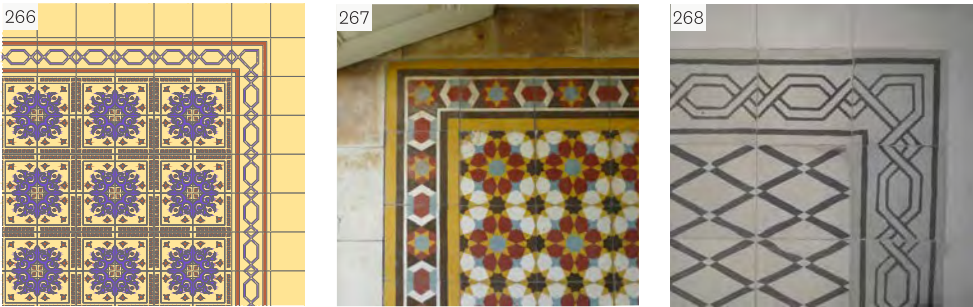
The 20 x 20 cm tile has an overall thickness of 20 mm and was locally produced starting 1920s.

It consists of base, frame, model or forma imported from Europe and a cover. The pattern is carved into the forma and set in the metal frame.

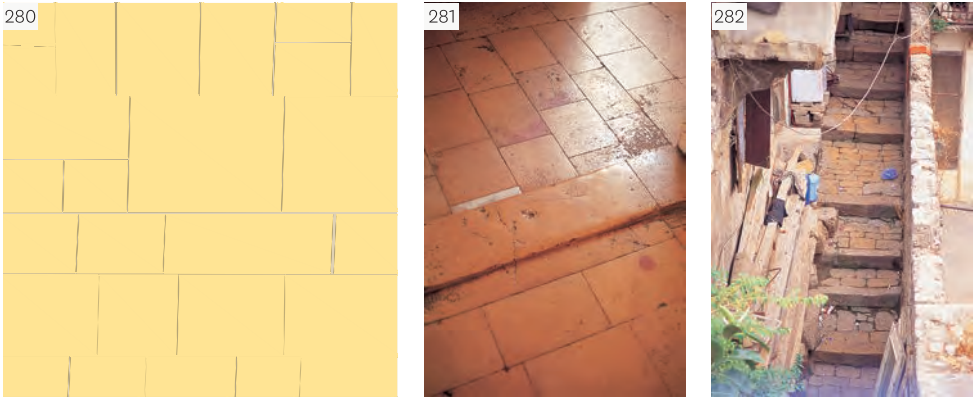
The “Furni” is a limestone, ranging from light yellow to white and mostly composed of calcite. It is used on floors, stairs, corbels or even columns because of its hardness and durability. The kitchen and outdoor floors of most Beiruti houses comprised solid floors of Mansourieh quarry tiles laid directly on a well rammed earth or sand. The tiles, with their irregular lower face and variable dimensions, were butt-jointed. Their thickness varies between 10 and 20 cm.

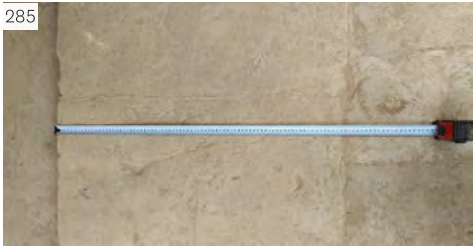
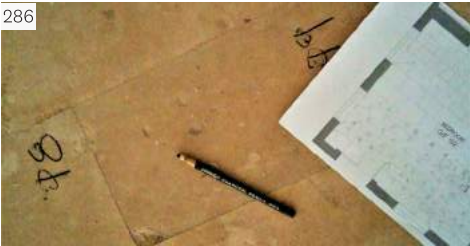
The same method of dismantling and reinstalling of marble floors applies (285-289).

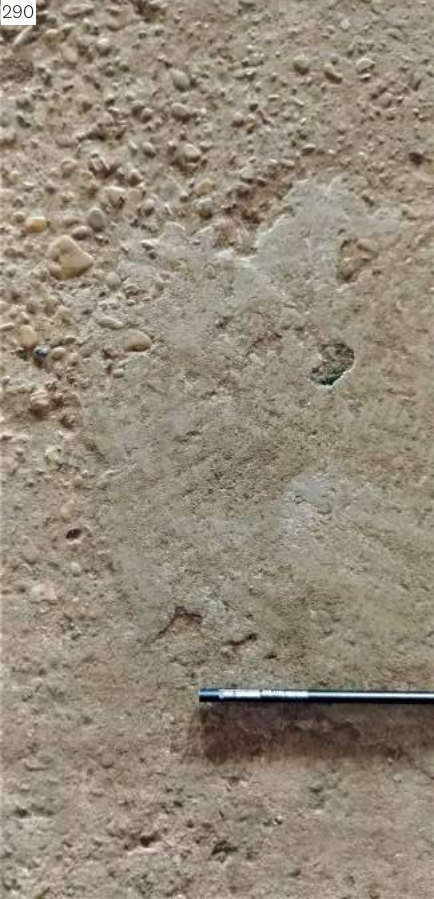
Where a new screed is to be created, one option is to use a lime screed that is breathable rather than one based on cement, which is less permeable. A lime screed floor can be designed to meet modern insulation requirements and can even incorporate under-floor heating.

Preparation method

- The surface can then be worked over, using either a trowel to achieve a fine closed finish or a combination of wooden and sponge floats to create an open-textured finish. Some water is likely to be required in this process. Splash it on with a brush.

- Leave it for around three weeks to dry while spraying with a light water mist 3 times a day.
- Apply several coats of a drying oil such as linseed to consolidate the surface.

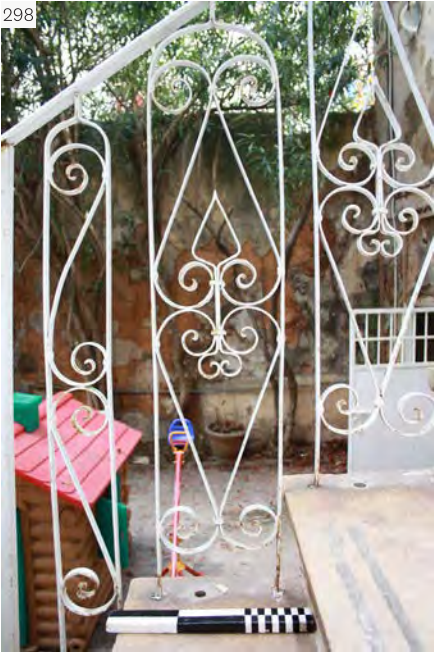
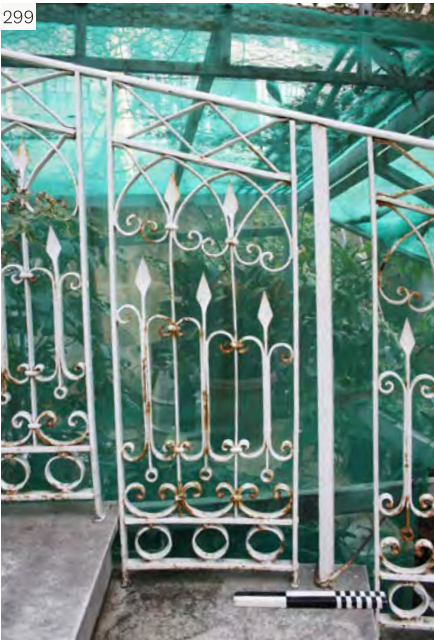
In examples prior to the arrival of cement, the structure of the wrought iron railing rests on vertical posts with a cross section of 4 cm. These posts are bolted to the lower part of the slab by means of a flat iron support. They are sealed with molten lead within holes cut in the stone to the dimensions of the vertical element (300). Horizontal bars, bent up or down in an "L" shape, are riveted to both sides of the vertical posts (300). The slender rods, flat bars and scrolls are first fabricated separately, and then connected to each other by riveting (301, 302, 303). Fastening collars connect lighter cold-bent elements such as volutes and the supporting bars of the staircase, while balcony handrails are connected by means of "L" shaped notches (304). Towards the end of the 1920s, the execution and assembly techniques of wrought iron structures experienced a turning point with the introduction of electric welding. Initially, this new technique coexisted with traditional fixation techniques; the production of a solid panel, rather than a series of separate elements, reduced the process of mechanical assembly to merely fixing the product onto vertical posts anchored in the concrete slab. The exclusive use of welding eventually appeared in high standing projects around the mid-1930s and spread quickly due to its easier production.

In corbelled balconies, the stability of the guardrails is intrinsically linked to that of the structure they are attached to. The breaking of the marble slab or the shattering of the concrete systematically weakens the wrought iron structure (305). This endangerment can also be triggered by external hostile factors that cause oxidation, corrosion of the material, and degradation of the original riveting system. Such issues are apparent in most of the buildings that have been deprived of maintenance.

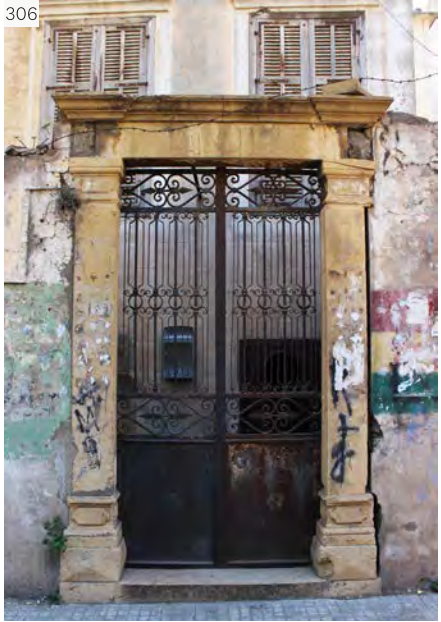
At the turn of the century, grand portals giving access to a terrace or a private garden were mostly present in bourgeois residences. They can also be found in some of the Mandate period's buildings, located on plots that were not saturated by the built environment. Up until 1920, and before the widespread use of reinforced concrete, these two-leaf portals were framed by a decorated “Furni” stone structure (306). Other examples with larger dimensions appear in the grand, honorary entrances of buildings from the late Ottoman period. Composed of two or four leaves, the latter can be surmounted by an articulated motif based on volutes. The upper part gradually leaves its crown in favor of a straight or rounded shape with simple protruding elements. A look at the transformative practices initiated by residents reveals a tendency towards a closed and secured entrance area. This is developed from the moment of the portals’ installation. Driven by necessity, the inhabitants added perforated or flat iron sheets to block small and large openings in the structure and avert access to the portal's lock from the street (307). In addition, this measure protected the entrance area of the building or the ground floor from the gazes of passers-by and prevented littering. In concurrence with this closing-up phase, safety locks, that did not exist in the original structure, were added. Growing insecurity will eventually prompt the installation of new steel lever clasps with padlock holders.

After guardrails, buildings' entrance doors with one, two, or more leaves were one of the most common wrought iron structures in town. In examples prior to the mid-1930s, entrance doors rarely exceeded 1.40–1.60 m and can sometimes be limited to one meter or less. The delimitation of the access door is mainly marked by the projected ornamentation made of stone or molded concrete. The opening can be further marked by a geometric articulation ranging from the simple semicircular arch to the more elaborate stepped opening in constructions inspired by the Art Deco movement. The absence of glass in the entrance doors underlines the permeability between the exterior and the interior of the building. The addition of the transparent material will not be generalized effectively until the mid-1940s. With a few exceptions, the production of building entrance doors before that date, was largely limited to wrought iron that guaranteed security and privacy at the entrance. The dimensions of entrance gates underwent considerable change during the 1930s as we witness the widening of access doors and openings, while ceiling heights gradually decreased.

In addition to oxidation and corrosion problems of wrought iron works, further types of deterioration include the loss of ornamental objects, like rosettes integrated into the doors' bases or other utilitarian elements like handles.

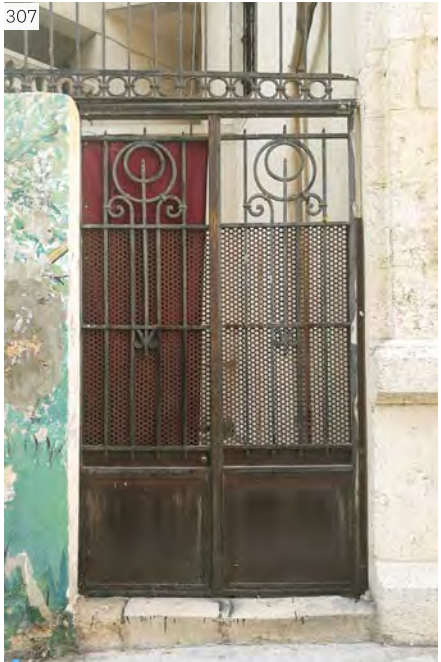
In Beirut, wrought iron fences are visible in several public and religious buildings as well as bourgeois residences. Generally, they consist of a stone parapet, or concrete blocks of varying height, surmounted by a series of pilasters and wrought iron grids with a straight or convex top. Their function can vary from protective structures of private gardens to separation elements marking boundaries between certain passages and adjacent properties. In terms of form, the metal structures of the fences, in most cases, resemble the entrance gate, and until 1920-1925, they were characterized by simple, vertically rhythmic configurations. However, some of the more elaborate examples reveal certain inspirations carried out from steel exporting countries to Beirut's port, such as France or Belgium. A few publications, like Henri Grave's *La Ferronnerie* published in 1881, Paris, included several surveys and represented important indicators of such transmissions in the late 19th century. Wrought iron fencing works, similarly to gates and entrance doors, were subject to continuous renewal due to waves of Art Deco inspiration that nourished the architectural scene of the mandate period. Fences from 1860-1925 reveal some dating clues that can be summed up by the coupling method of modules and the geometric definition of each module's upper part. In addition to both those indicators, the assembling techniques used, such as welding or riveting, are key dating elements for works from the turn of the century. The oldest works are sequenced by stone pillars and embedded at the base of stone parapets. They consist of repetitive round or square bars surmounted by spears that formed a straight, convex, or concave top. The lower parts of the first examples are ornamented with circles or volutes introduced at the square intersections of vertical and horizontal axes. As of the 1930s, bourgeois buildings with security walls witnessed a reduction, and even elimination, of masonry or reinforced concrete pillars. Subsequently, to ensure a similar stability, the structure in these late examples is reinforced by introducing wrought iron fence pillars.

The main problems with fences are similar to those encountered in other wrought iron works, like corrosion. The latter causes some ornaments or other horizontal elements to become loose and fall down. While this degradation is common to all wrought iron works, problems such as tilting are particularly evident in fence grids. Typically caused by a push exerted on the fence's upper part, the deformation can weaken the embedment of the metallic body in the wall, thus requiring the rehabilitation of the entire assembly.

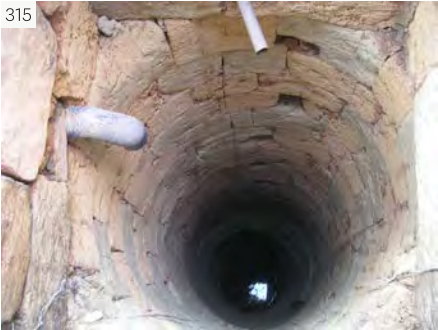
The well is a vertical circular shaft with a diameter of 80 to 100 cm approximately, dug from top to bottom. The perimeter is clad out of sandstone with holes left to climb down and up the shaft during digging, as well as for further cleaning and maintenance. The depth of the well is relevant to the depth of the running stream. The average depth to reach the water table is 12 to 15 meters. However, evidence of depths reaching 30 meters have been observed on the edge of the hills and cliffs. The top of the shaft is framed in Mansourieh limestone.
