URGENT ROOF COVERING FOR 10 OR MORE HERITAGE BUILDINGS

EMERGENCY RELIEF GRANT

مبادرة بيروت للتراث
BEIRUT HERITAGE INITIATIVE

EMERGENCY RESPONSE PLAN

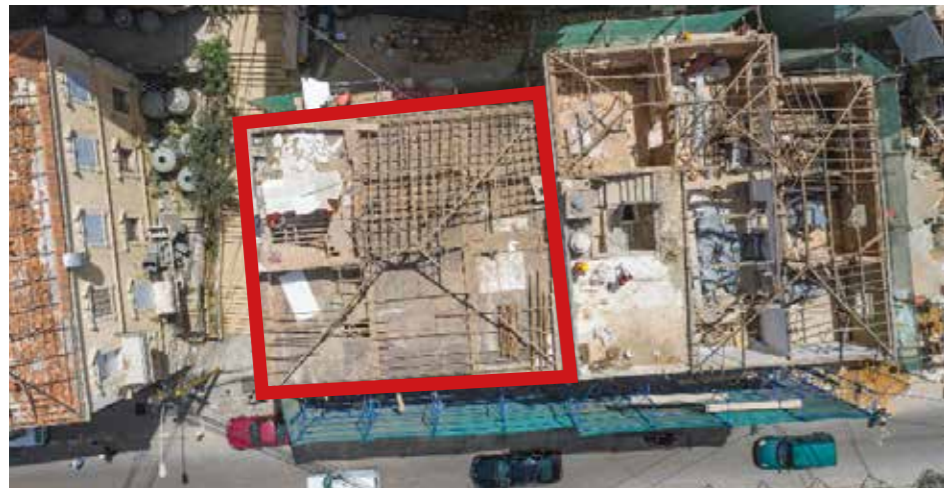
Rmeil 722, roof condition after the blast, J. Kallas

Rmeil 722 was left with structural damages and an exposed roof.

BHI intervened in late October 2020 on the sheltering of the pitched roof with a tarpaulin cover to protect the building from the rainy season.

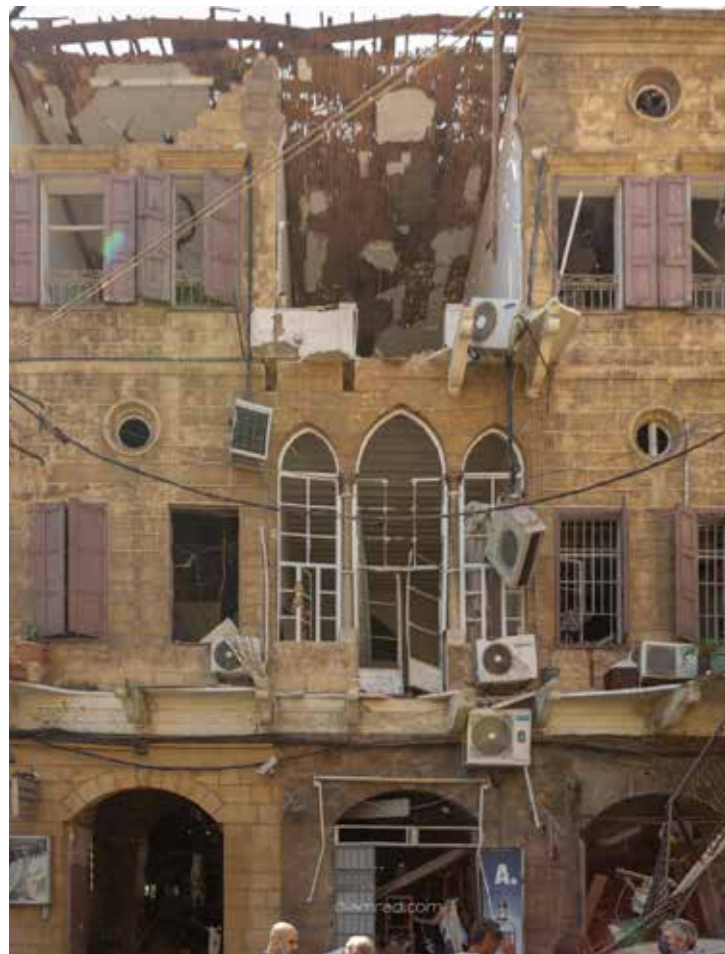
Rmeil 722, on Aug. 5 2020, D. Mrad

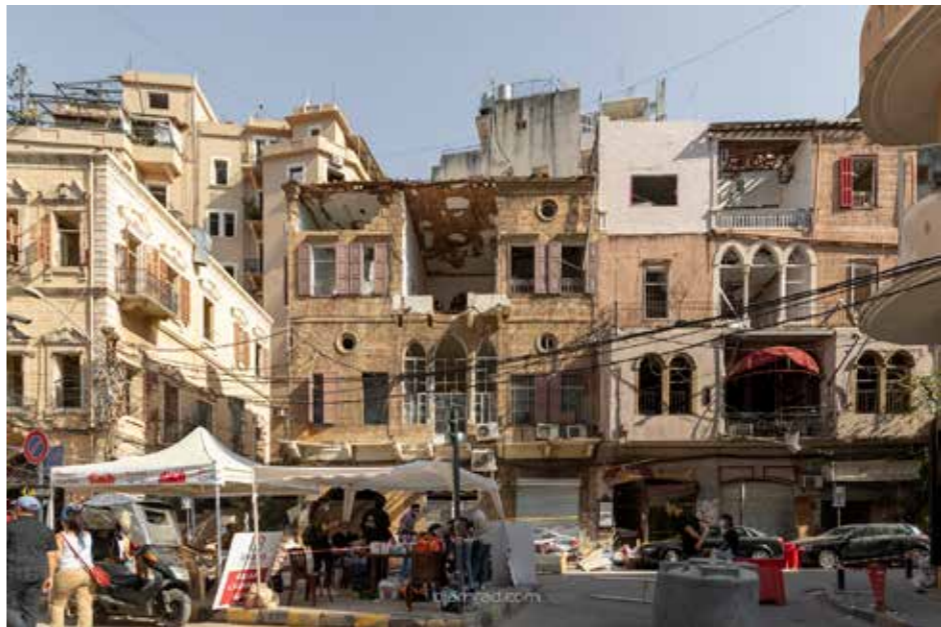
Rmeil 723 was deeply affected by the explosion, and was left with an exposed roof. A tarpaulin cover was installed to protect the building, and the windows were closed off in mid October 2020.

Rmeil 723 (right), next to Rmeil 722, D. Mrad

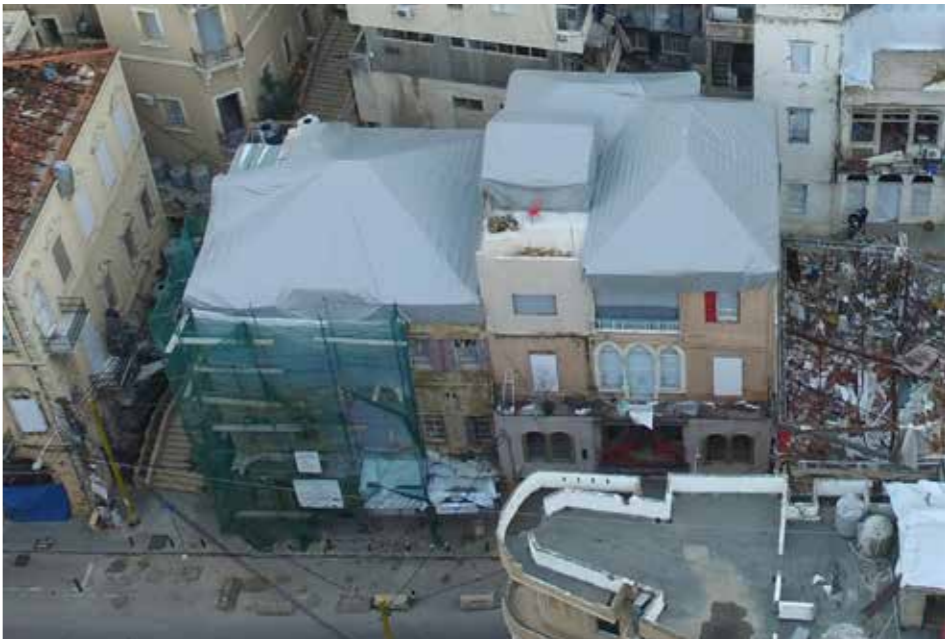
After the intervention, Rmeil 722 (left) & Rmeil 723 (right), ACE

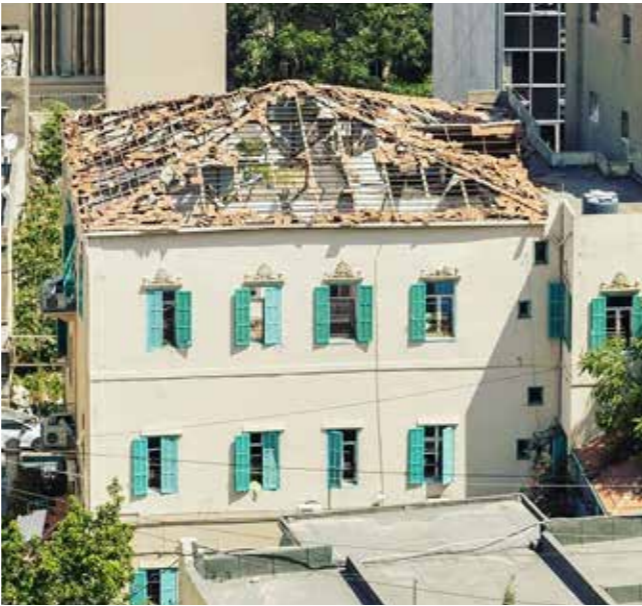
Rmeil 292, built in the late 19th century, is composed of three floors (GF +2). The ground floor is used for commercial purposes, and the upper floors, composed of a ‘central hall type’, had an educational function. The roof structure, which is the subject of our report, is made of a steel frame, and was severely damaged by the impact of the blast. The steel was distorted, and the red roof tiles were all broken and dismantled.

Rmeil 292, after the blast, *D. Mrad*

Due to the level of damage done to the roof structure, a tarpaulin cover was installed on the roof and the openings for protection. Even though Rmeil 292 is currently uninhabited, its shelter and protection was necessary to preserve it from further damage.

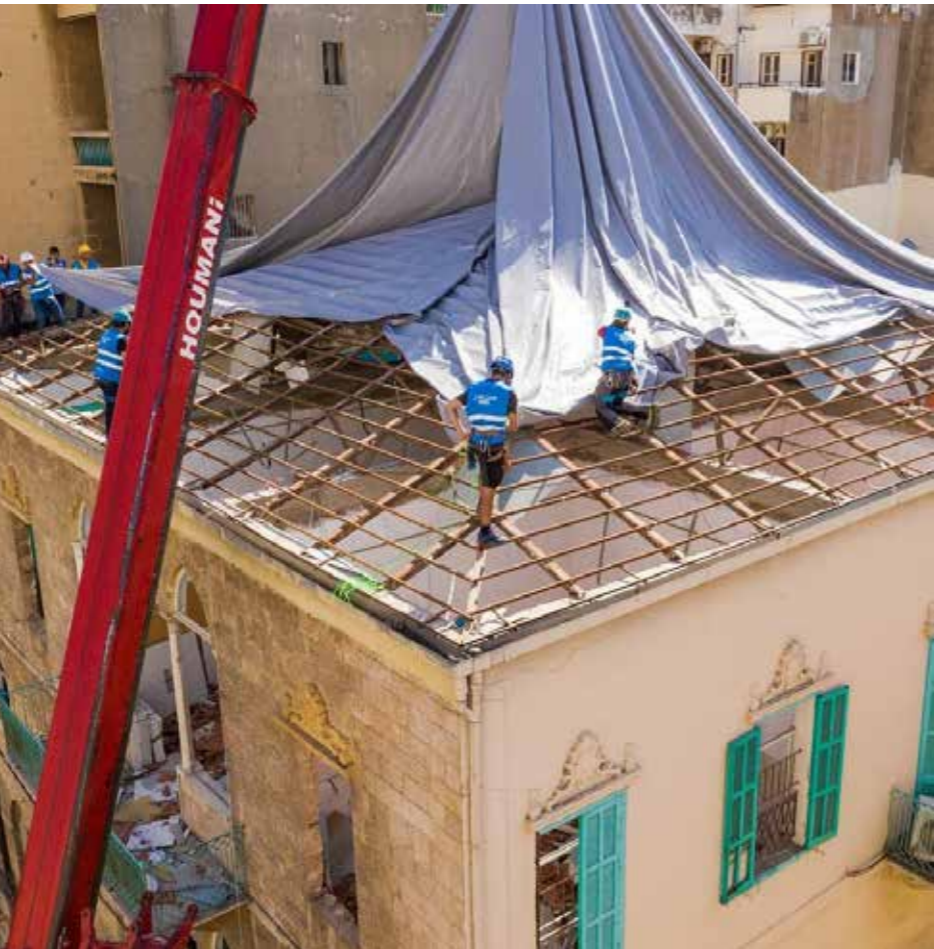
During the intervention, *LiveLoveBeirut*

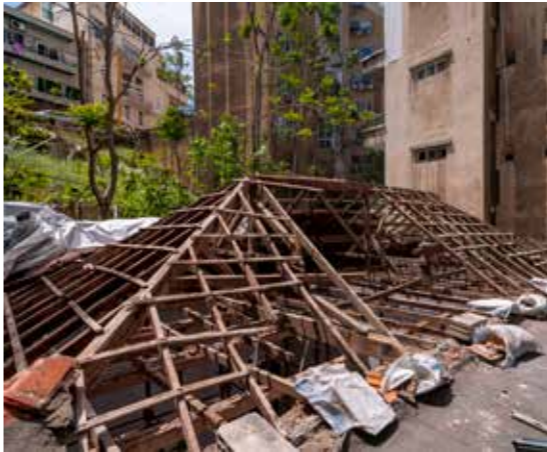
The building is located in the heart of Mar-Mikhael and took a hard hit from the explosion. The building had some structural damage to the concrete slabs, and the pitched roof was completely destroyed. Structural consolidation for the entire building was an urgent priority. In order to rapidly consolidate the first and second floors, and since the *Baghdadi* roof structure was heavily damaged, a tarpaulin cover was installed on the pitched roof and openings, to allow for consolidation work on the lower floors.

Roof damage, *D. Mrad*

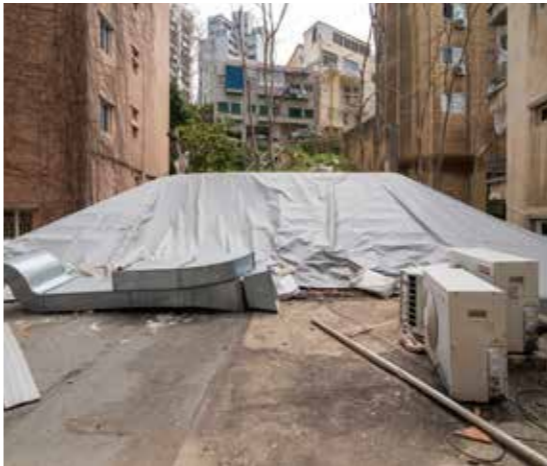
Roof covering with Tarpaulin, *D. Mrad*

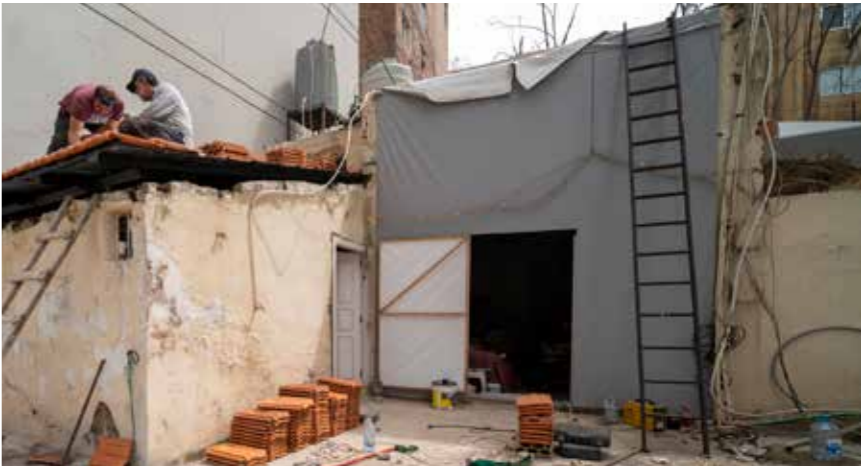
Façade covering with Tarpaulin, *D. Mrad*

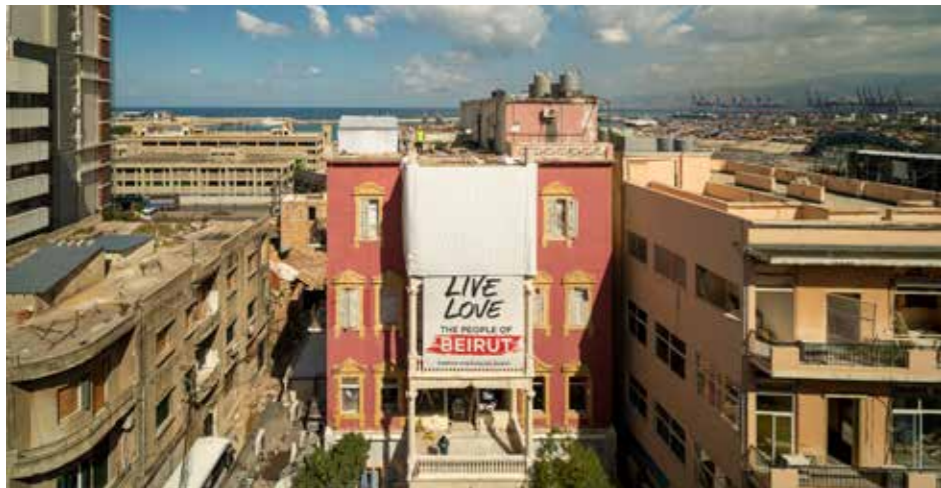
Medawar 119's south sheltered, *D. Mrad*

Facing the port, Medawar 119 was deeply affected by the explosion, and suffered severe structural damage. The carpentry were totally destroyed, the concrete slabs were shaken and present large cracks, and the staircase's walls collapsed. Urgent intervention was needed to protect the building before the rainfall, so a tarpaulin cover was added on the windows and the staircase.

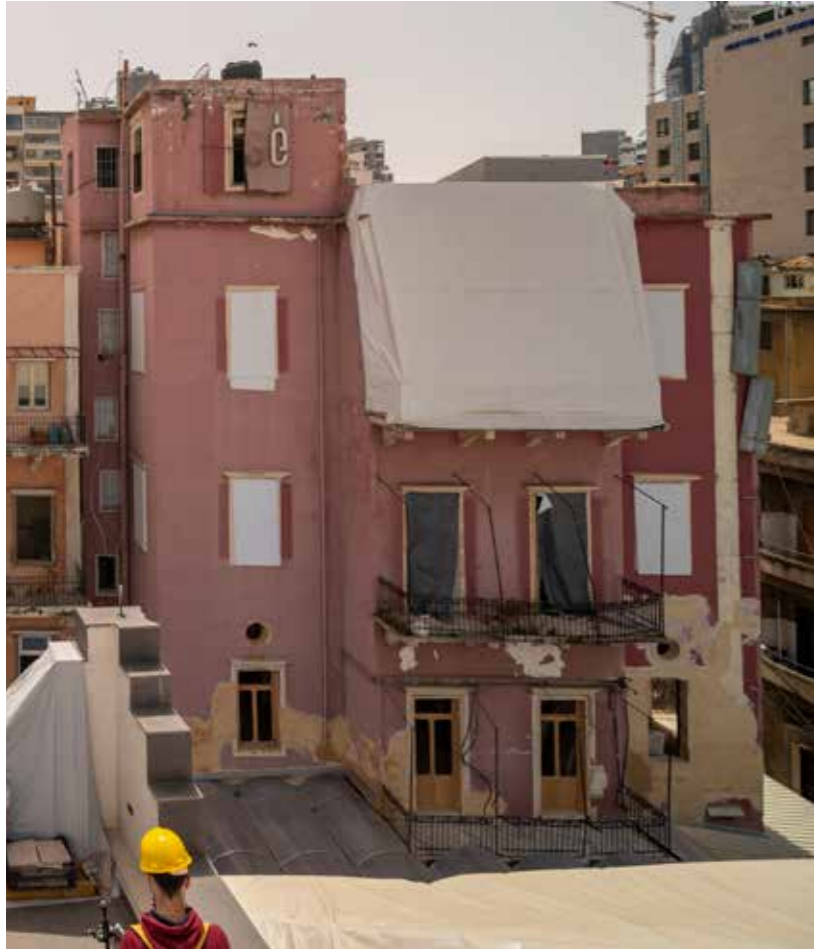
Sheltering of the North façade, *D. Mrad*

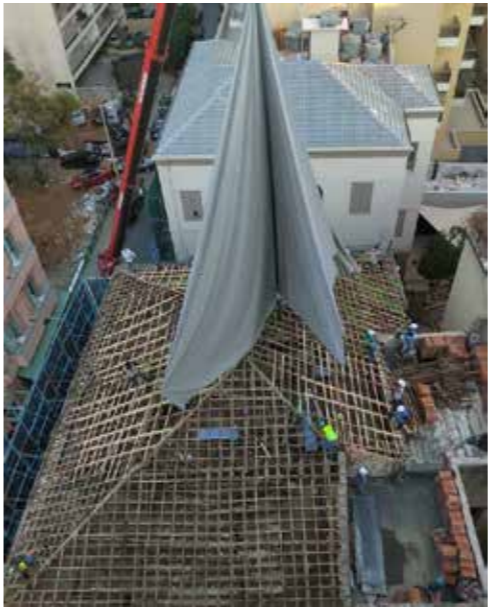
During the intervention, *LiveLoveBeirut*

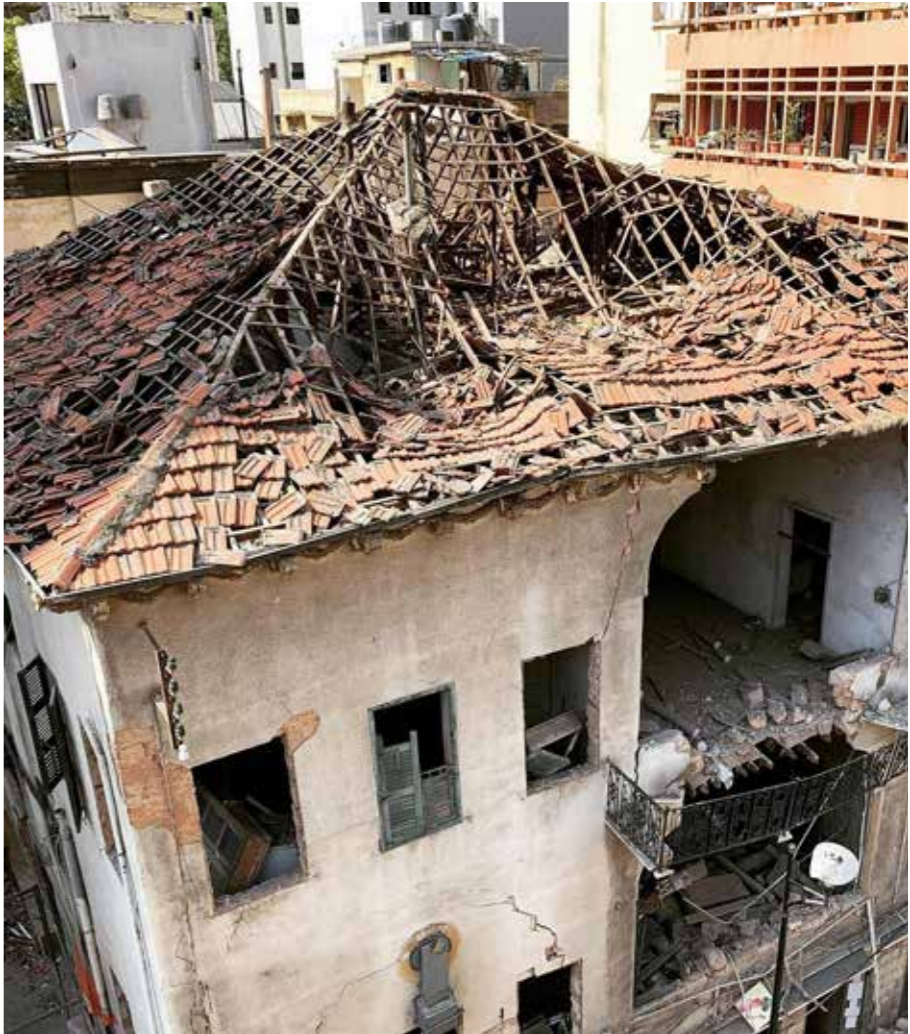
This Heritage Building was severely affected by the Aug. 4 2020 blast, and suffered structural damage, such as north façade displacement and collapse and pitched roof destruction.

Rmeil 300, after the blast, *Instagram*

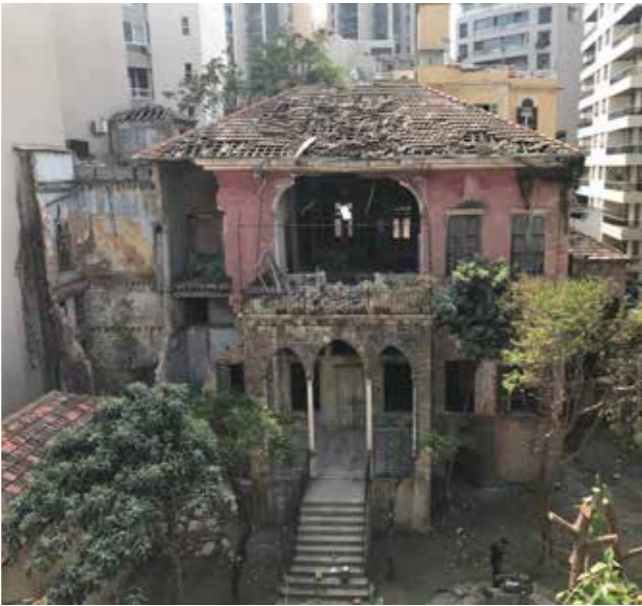
Ashrafieh 569 is one of the few heritage houses left in the Furn El Hayek area that has a garden and small pavilions. Compared to its neighbours, Ashrafieh 569 suffered more damages than the rest of the cluster. The three arches on the upper floor were destroyed by the impact of the blast, and the partial destruction of the roof damaged the Baghdadi ceiling on the upper floor.

Ashrafieh 569, after the blast, M. Gharzouzi

Both floors needed propping in order to consolidate the building structure. The villa's pitched roof was also heavily damaged, and was covered by a Tarpaulin cover. Existing tiles found in good condition on the main roof, were reused on the roofs of the two small pavilions that weren't as heavily damaged.

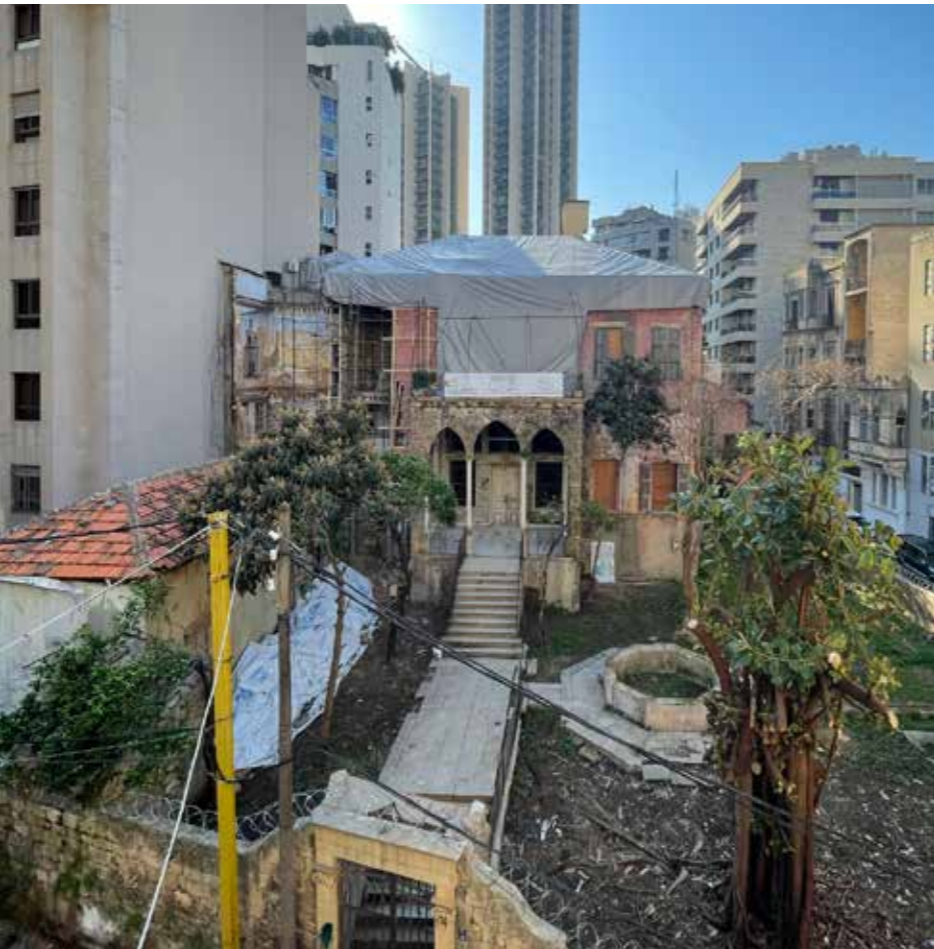
After the intervention, Y. Dagher

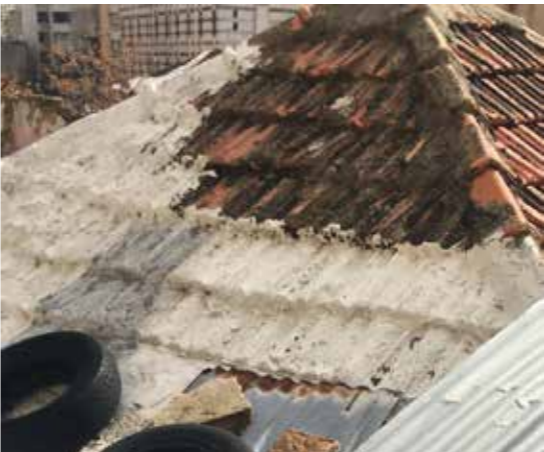
Prior to the explosion, the wooden structure of the roof was in bad condition, and did not sustain to the blast's impact. Due to the explosion, the tiles on the small pitched roof were dislocated and an urgent cover with tarpaulin was installed in order to protect the three low-income families that inhabit the building.

Roof damage, Y. Kassir

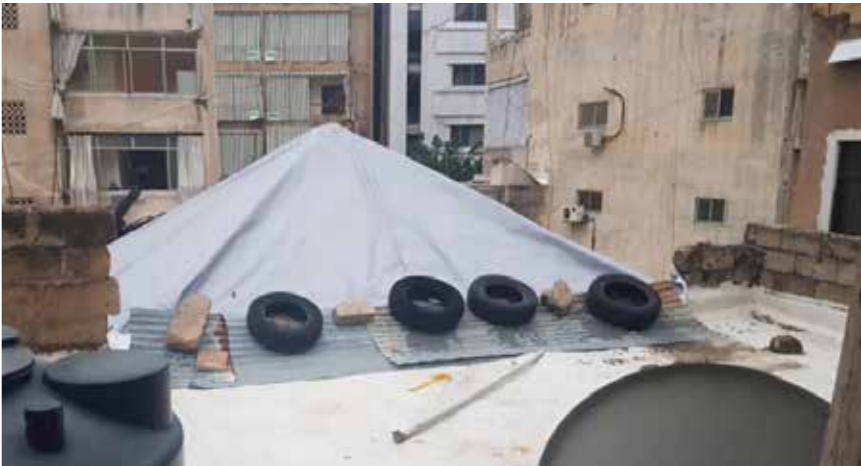
Roof covering with Tarpaulin, Y. Kassir

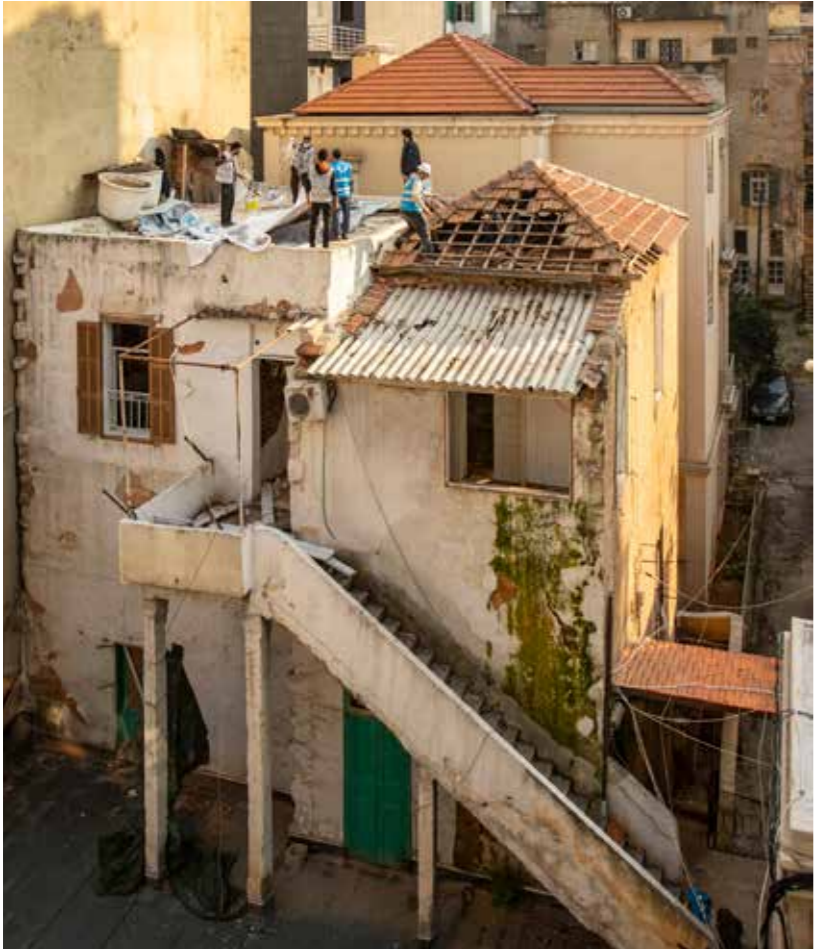
Before the intervention, D. Mrad

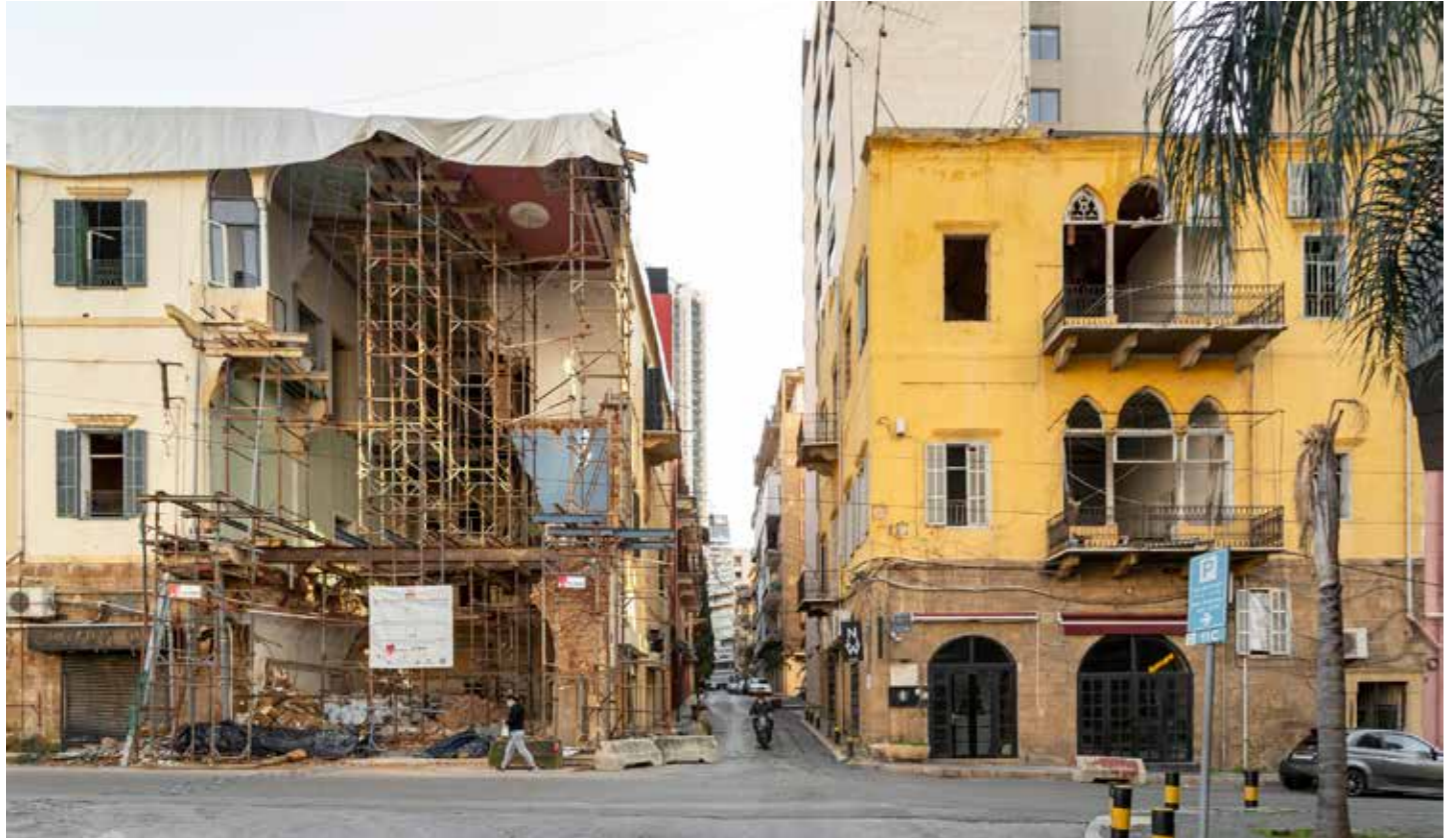
Located approximately a kilometre away from the blast, the roof's building, which is subject to our report, sustained minor damages, and needed tiles replacement. *BHI* intervened in October 2020 to repair the minor damages in the structure, and replace the broken red tiles.

Ashrafieh 1139 (right), *D. Mrad*

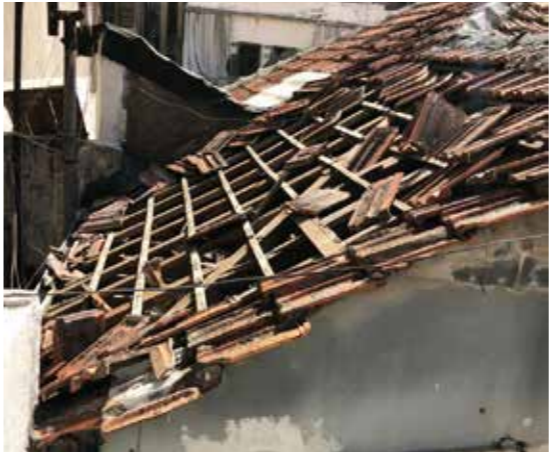
Both roofs sustained minor damage to their wooden structure, and needed tile replacement to protect them from the rainy season.

Roof damage, *C. Acra*

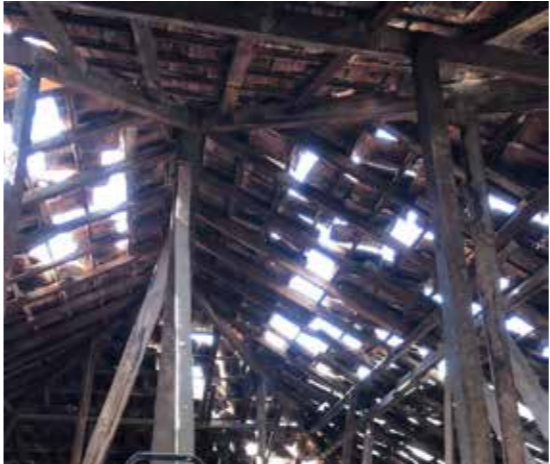
Roof damage, *C. Acra*

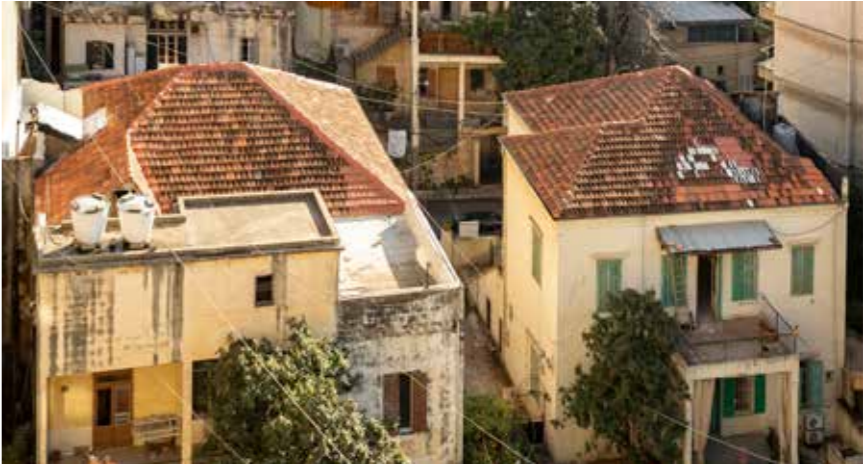
After the intervention, *D. Mrad*

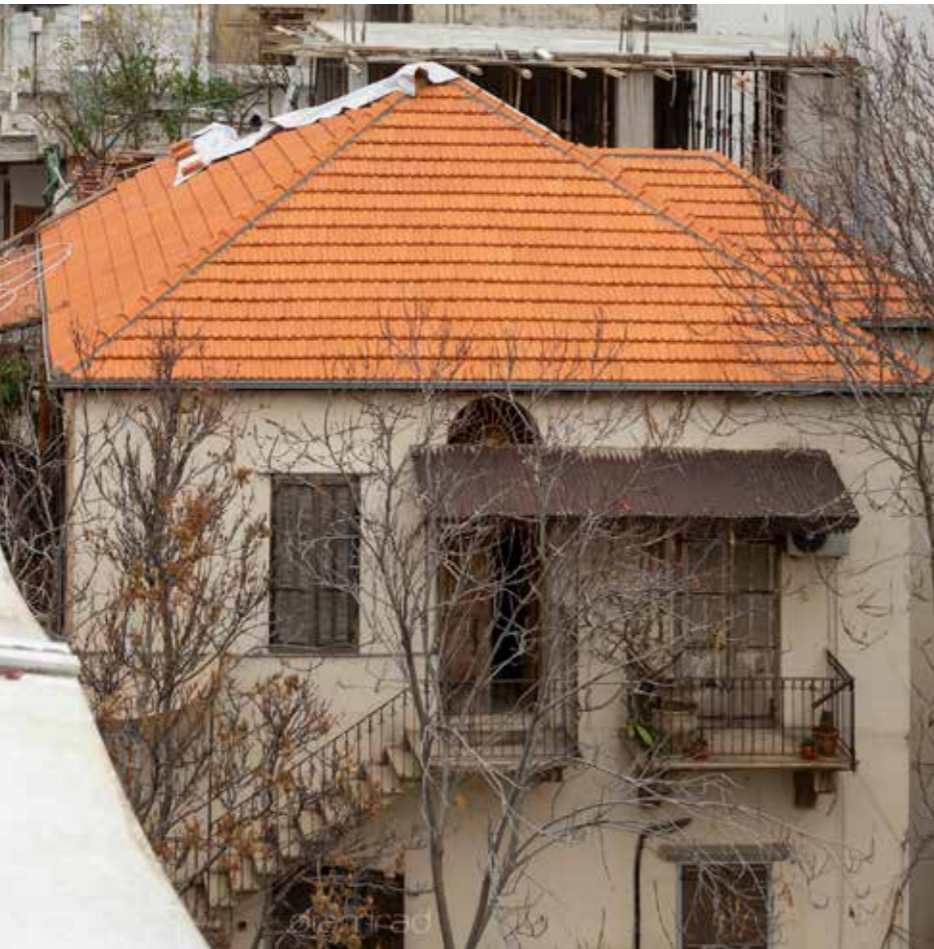
After the intervention, D. Mrad

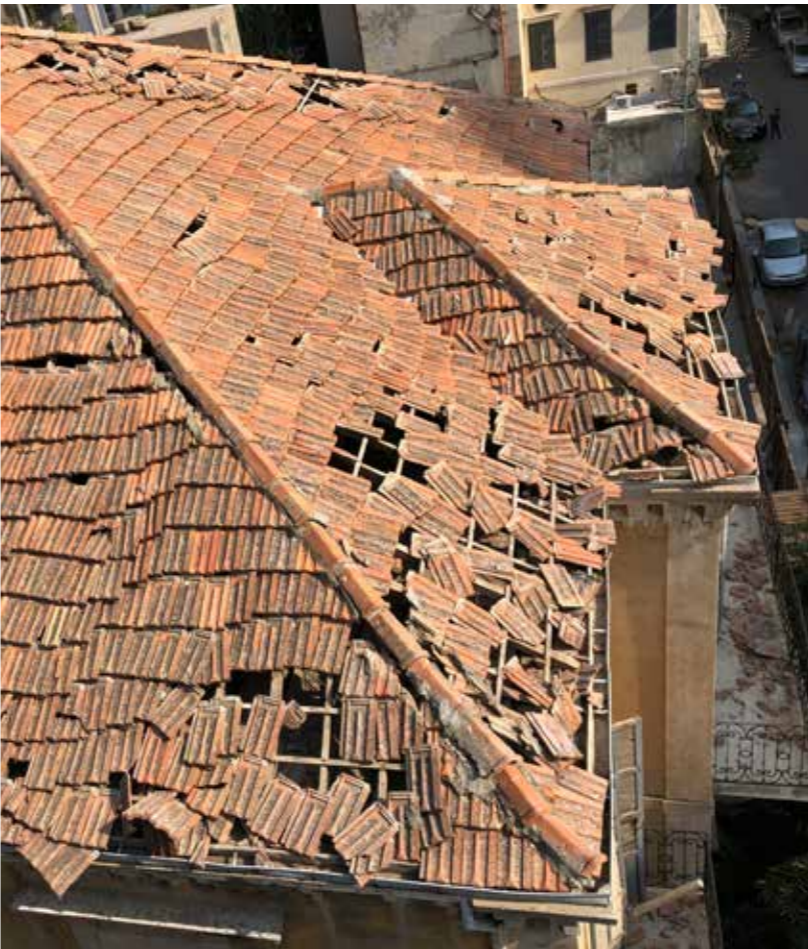
Before the intervention, Y. Dagher

The floors are composed of a 'central hall type' with the three arches and a loggia on the main façade. It was built with sandstone walls, Qotrani wooden carpentry, and has Baghdadi ceilings on the upper floor. The Qotrani wooden pitched roof endured minor damage from the blast. BHI intervened in late november to secure the roof by replacing the broken tiles.

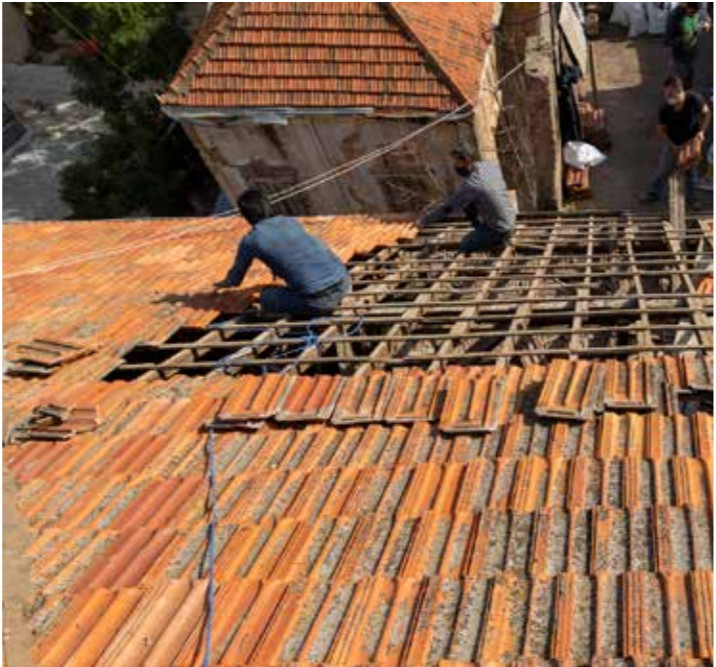
During the intervention, D. Mrad

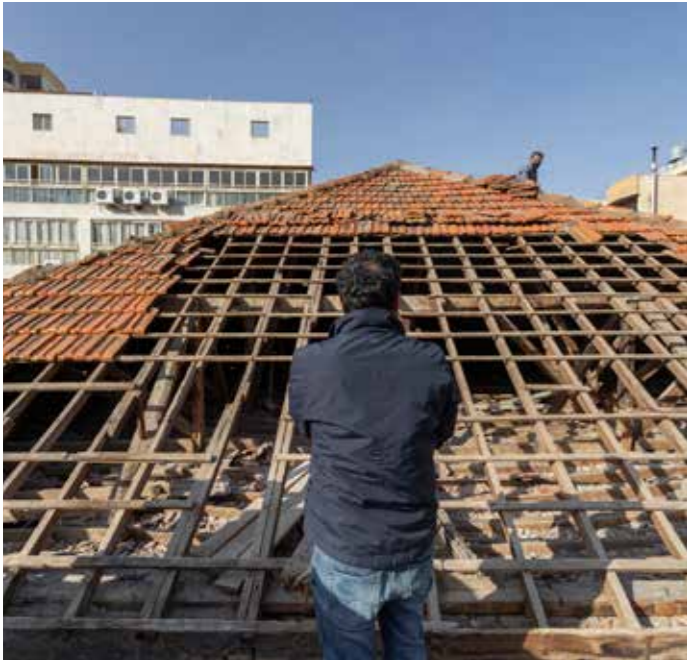
After the August 4 2020 blast, some roof tiles were broken and displaced, and needed to be replaced before the rainy weather. *BHI*'s mission consisted of replacing the tiles on the damaged roof to ensure the safety of the buildings and its tenants.

After the blast, D. Mrad

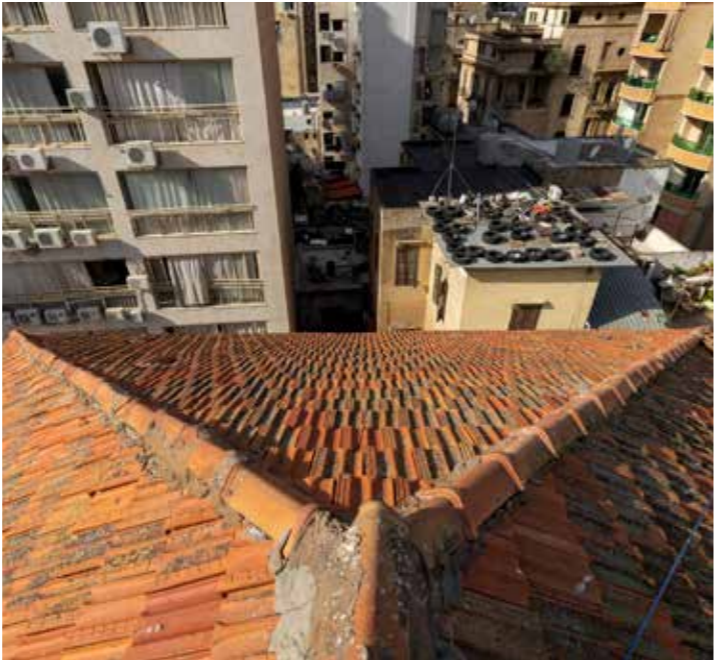
Bachoura 1503, after the intervention, D. Mrad

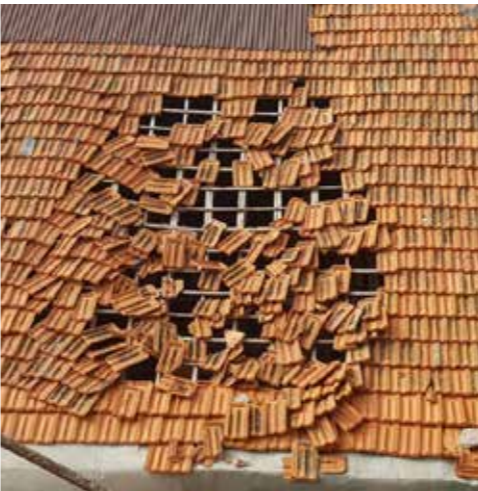
After the blast, Y. Kassir

To secure the building and safeguard it from further damages, *BHI* intervened to recover the roof by mending the shattered wooden structure and replacing the broken tiles that were displaced by the blast.

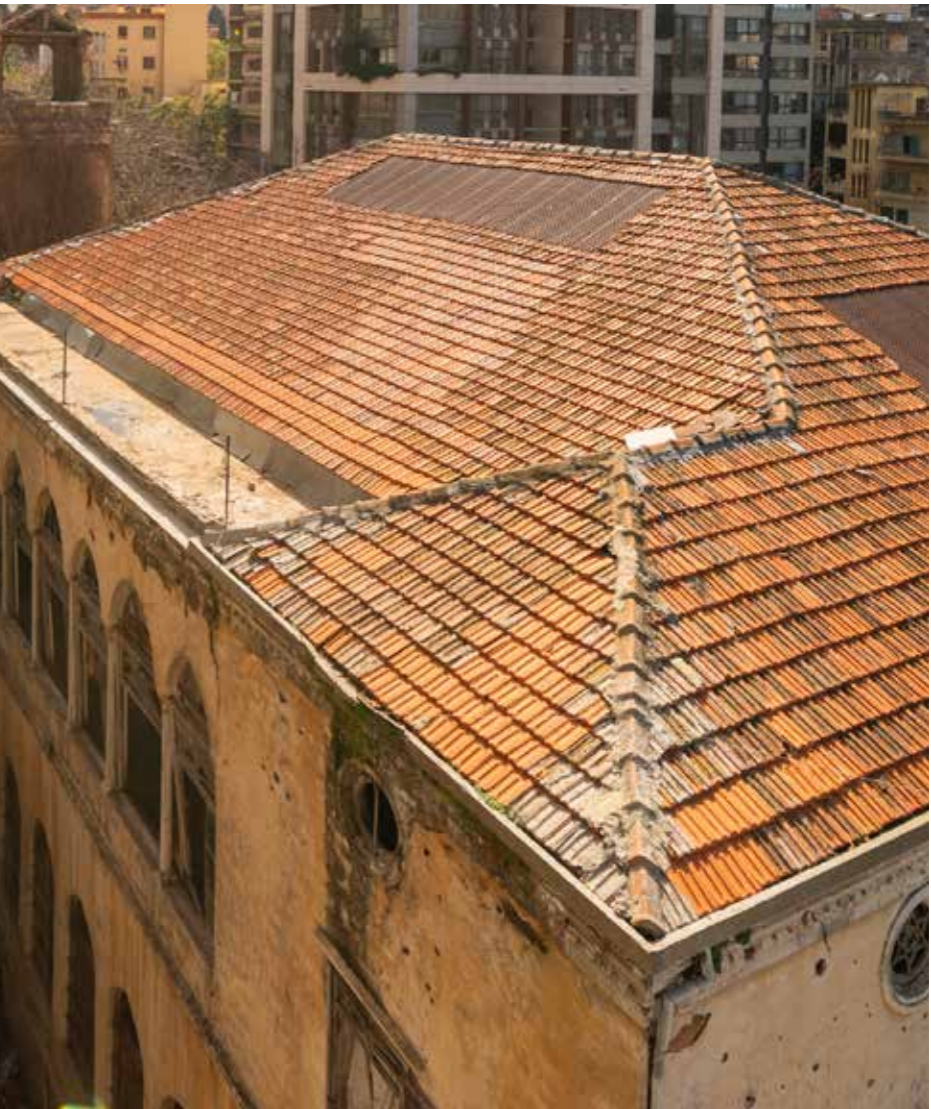
After the intervention, D. Mrad

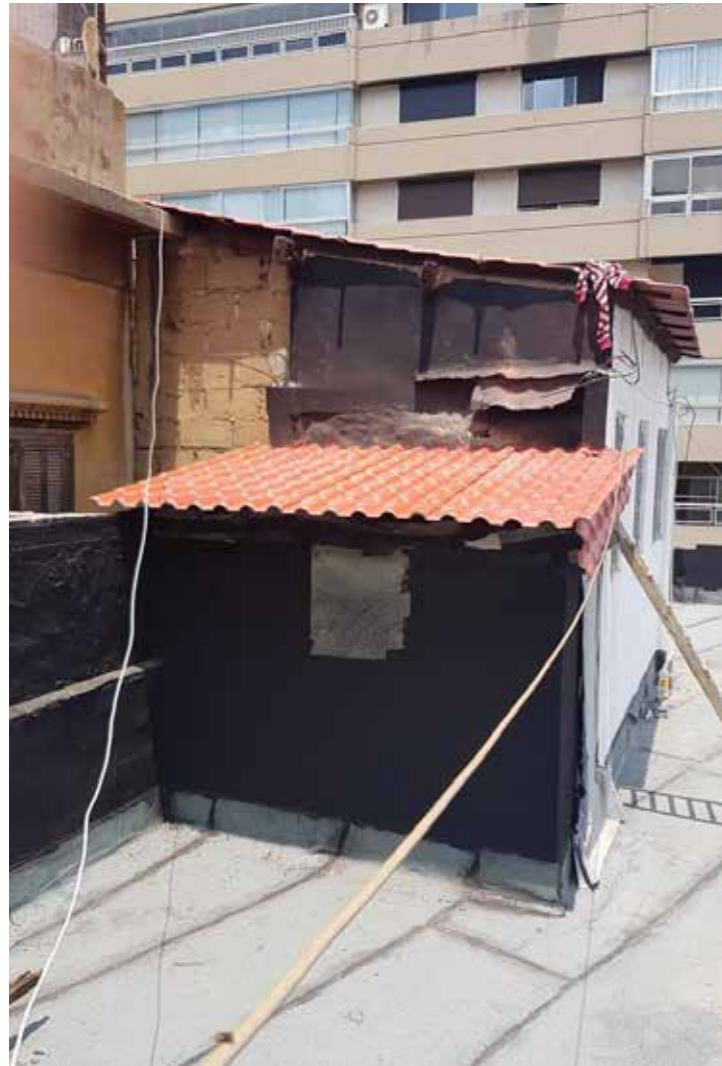
Rmeil 155, built in the first half of the 20th century, is composed of four floors, with two central hall apartments per floor. It belongs to the early modern period, and was built with sandstone walls, concrete slabs and roof. Located less than a kilometre away from the blast, roof's existing membrane was heavily damaged by the earthquake caused by the blast, and urgent action was taken, in October 2020, by *BHI* to prevent any water leakage and infiltrations to the apartments. Furthermore, resin panels were placed on the roof's staircase, to replace the existing *Asbestos*.

Rmeil 155, covering of the staircase with resin panels, Y. Kassab

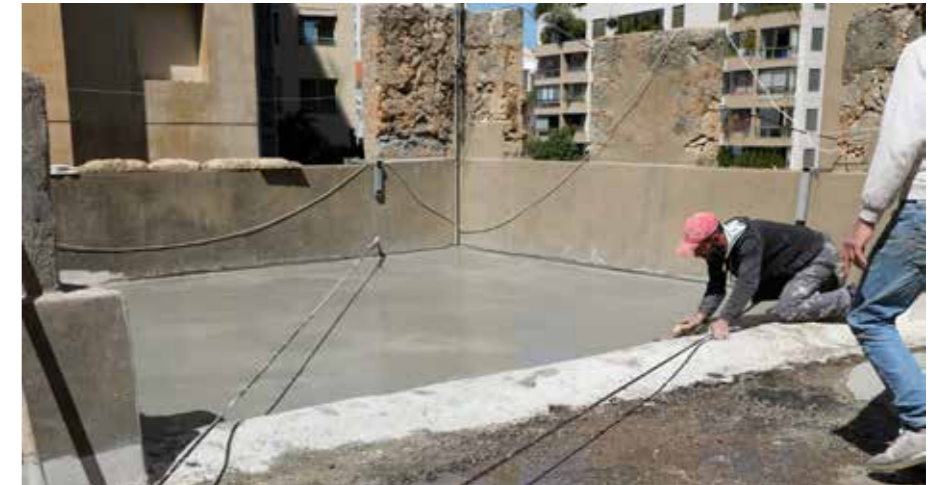
Waterproofing application, D. Mrad

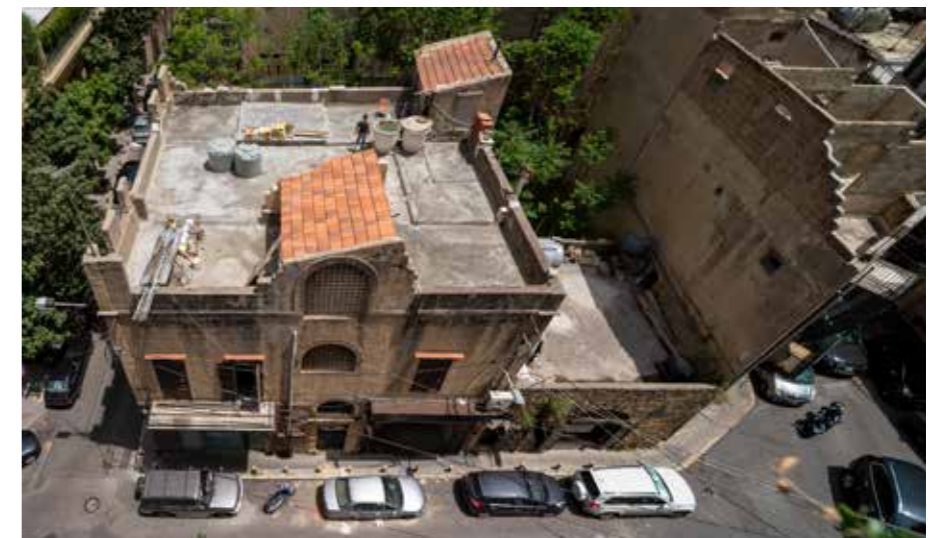
Ashrafieh 1161, after the intervention, D. Mrad

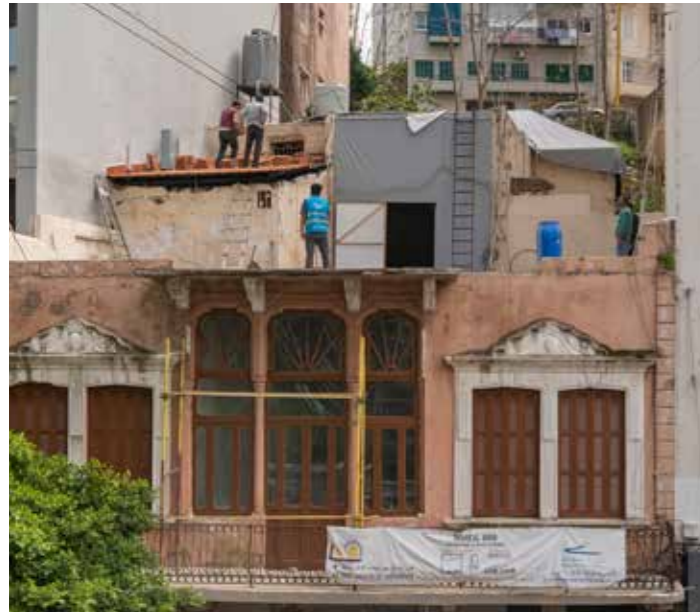
Kitchen roof reconstruction, *D. Mrad*

BHI previously worked on the roof sheltering of Rmeil 688, located in Mar-Mikhael (November 2020). In April 2021, *BHI* came back on site to work on the full reconstruction of the *Qotrani* wooden roof, as well as the reconstruction of the kitchen roof, and the waterproofing of the flat surface. With this operation complete, the building is now 90% completed and rehabilitated after the blast.

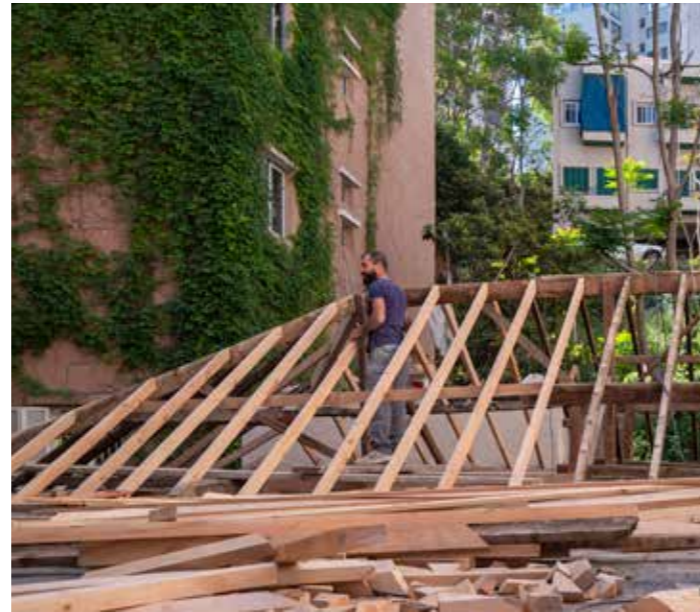
Reconstruction of the wooden structure, *D. Mrad*

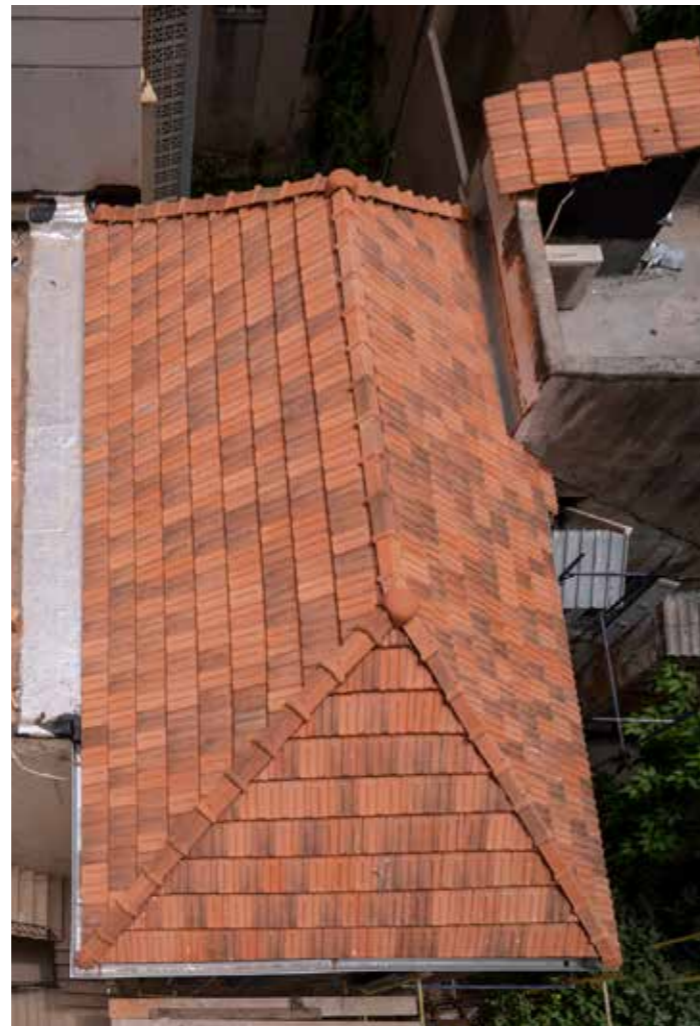
After the intervention, *D. Mrad*

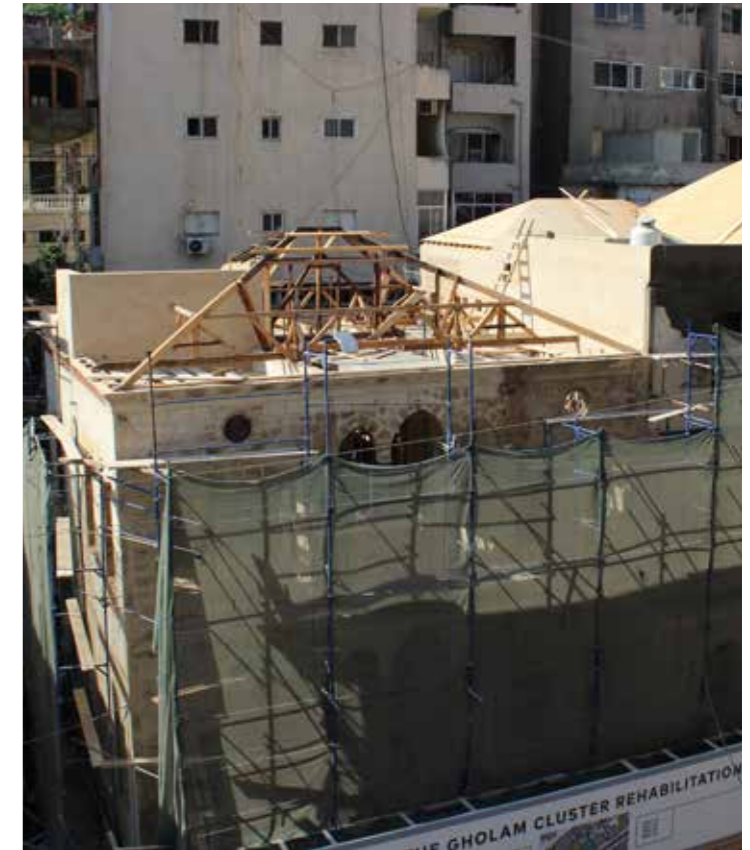
The material used in the construction of the new roof are the original ones, with *Qotrani* wooden beams, and red tiles from Marseille. Further waterproofing works were done on the small concrete surface adjacent to the pitched roof.

Reconstruction of the structure, July 2021, *J. Chalfoun*

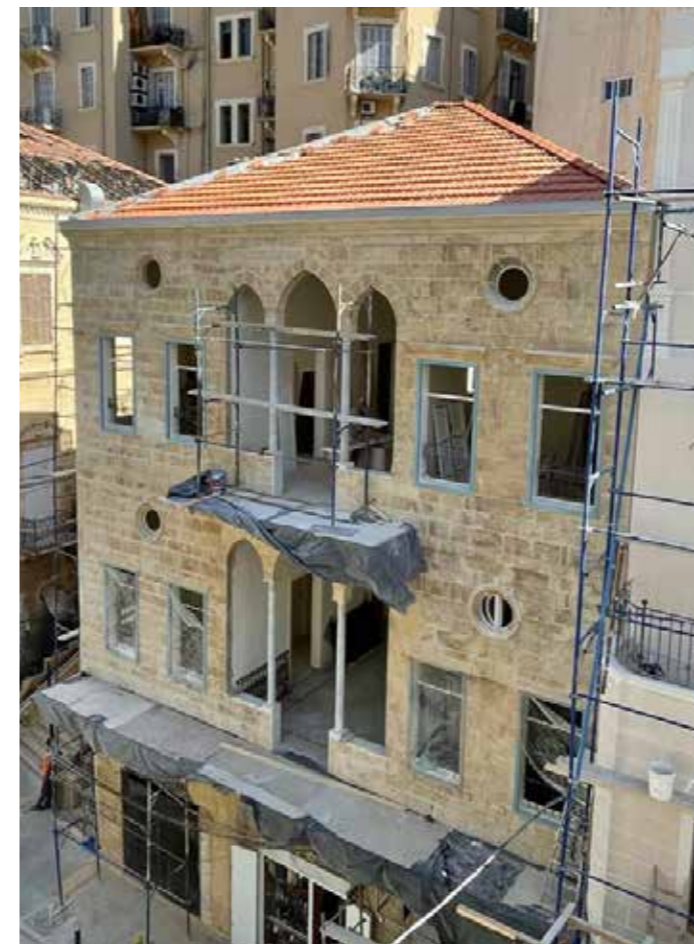
September 2021, *D. Mrad*

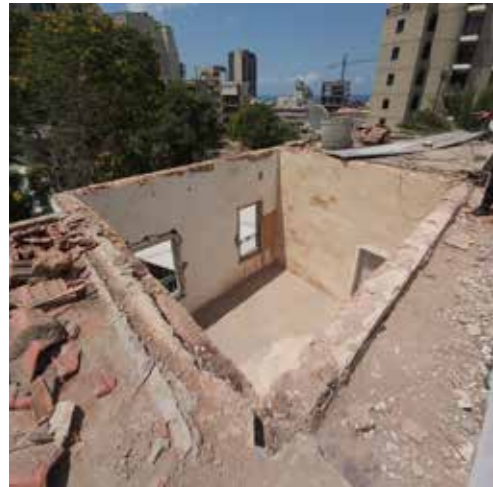
Rmeil 812, built between at the end of the 19th century, is a heritage building located in the “Hekmeh” area. It is composed of a ground floor & an upper floor. The roof, which is subject to our report, is composed of a pitched roof and a concrete slab. Both elements were severely damaged by the blast. *BHI* intervened in august 2021 to rebuild the Qotrani wooden roof, and waterproof the concrete surface, allowing the residents of this heritage building to come back, a year after the blast.

Before the intervention, Y. El-Majzoub
