URGENT ROOF COVERING FOR 10 OR MORE HERITAGE BUILDINGS

EMERGENCY RELIEF GRANT

مبادرة بيروت للتراث
BEIRUT HERITAGE INITIATIVE

EMERGENCY RESPONSE PLAN

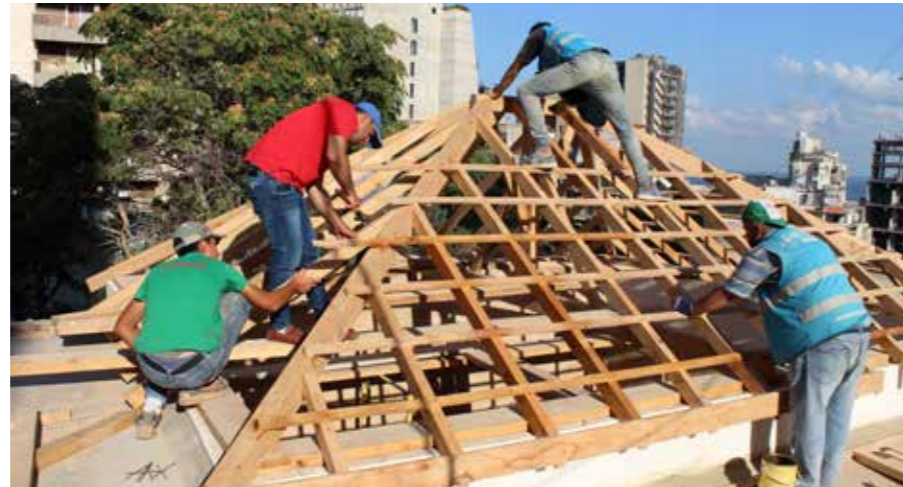
Roof reconstruction, J. Chalfoun

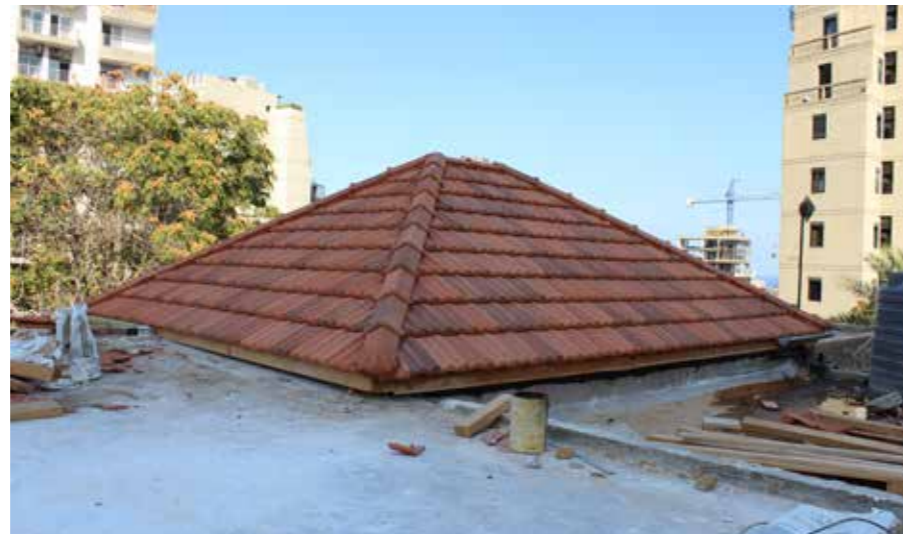
Rmeil 812, after the intervention, J. Chalfoun

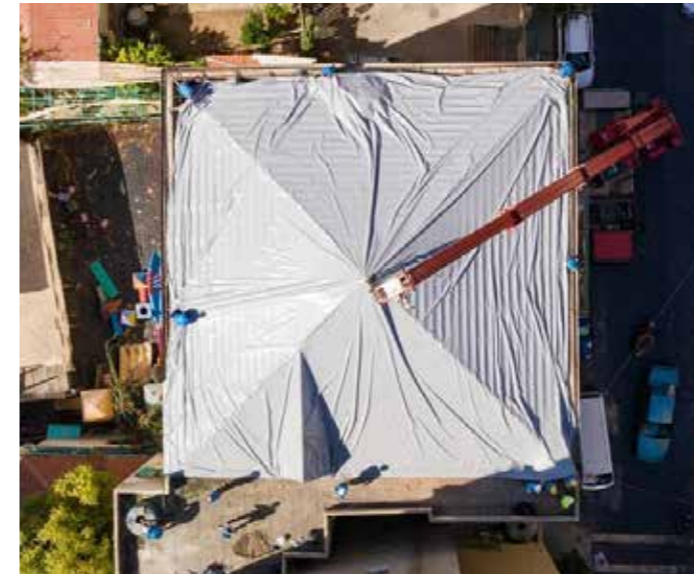
After the sheltering operation, Live Love Beirut

Rmeil 292, previously sheltered by a tarpaulin cover by *BHI*, has been granted a full roof reconstruction by *ALIPH* in September 2021. The roof's structure is made out of metal, and bent on the day of the blast. The contractor's team started working in October 2021 to fix the structure, replace the damaged steel beams, and place new red tiles ensuring the protection of this heritage building before the rainy season. With this operation complete, the building is now 30% renovated and works on other parts are able to start.

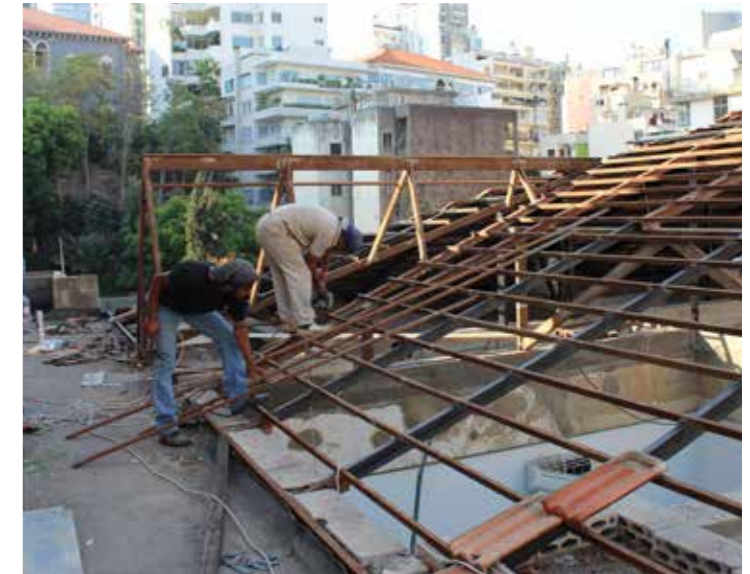
Before the intervention, J. Chalfoun

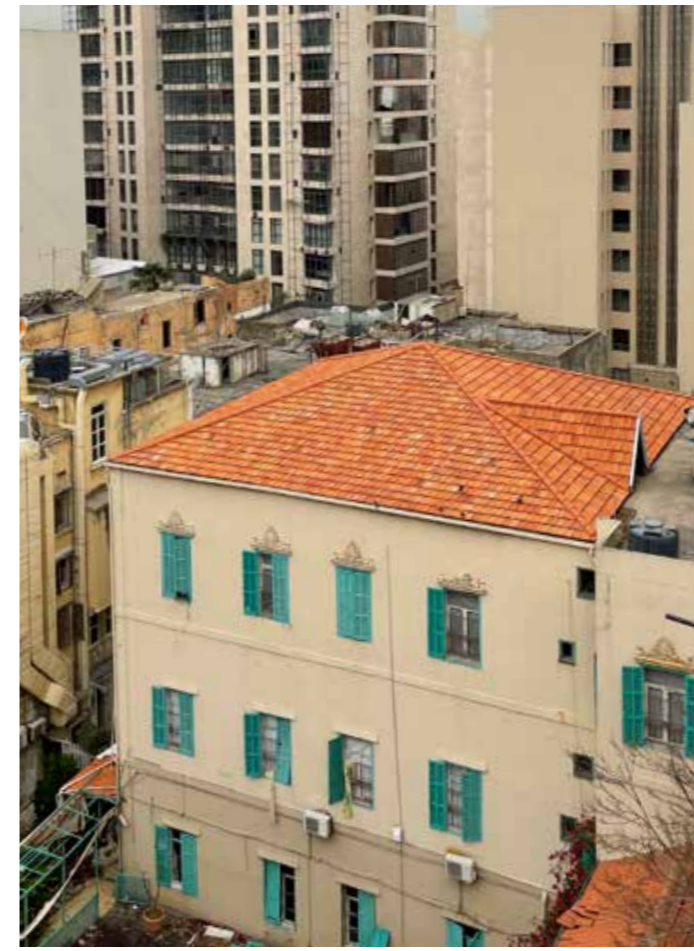
After the intervention, Y. Dagher
