# THE GHOLAM CLUSTER REHABILITATION: RMEIL 722

Restoration of a heritage building affected by the August 4, 2020 Beirut Blast.

April 2021 - December 2021

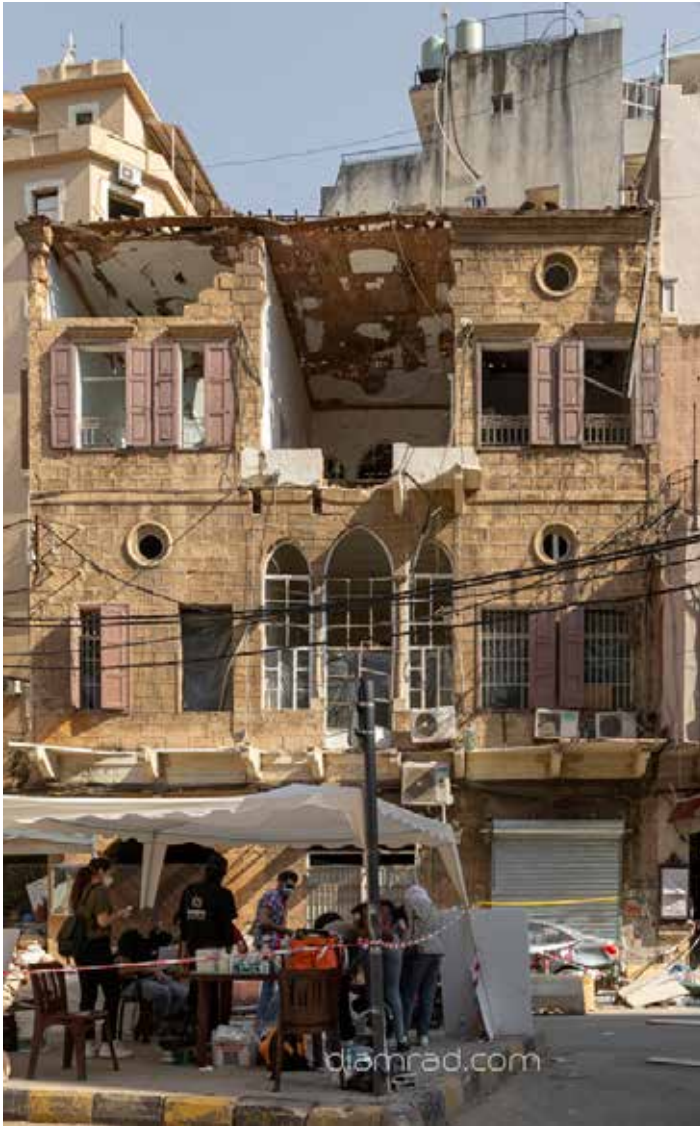
After the blast, *D. Mrad*

The building sustained heavy damage following the blast, with partial loss of the sandstone on the North Façade and three arches of the upper floor, wall bulging, roof destruction, loss of the *Qotrani* wooden windows, arches, doors, and shutters, interior damage, including the *Baghdadi* light structure.

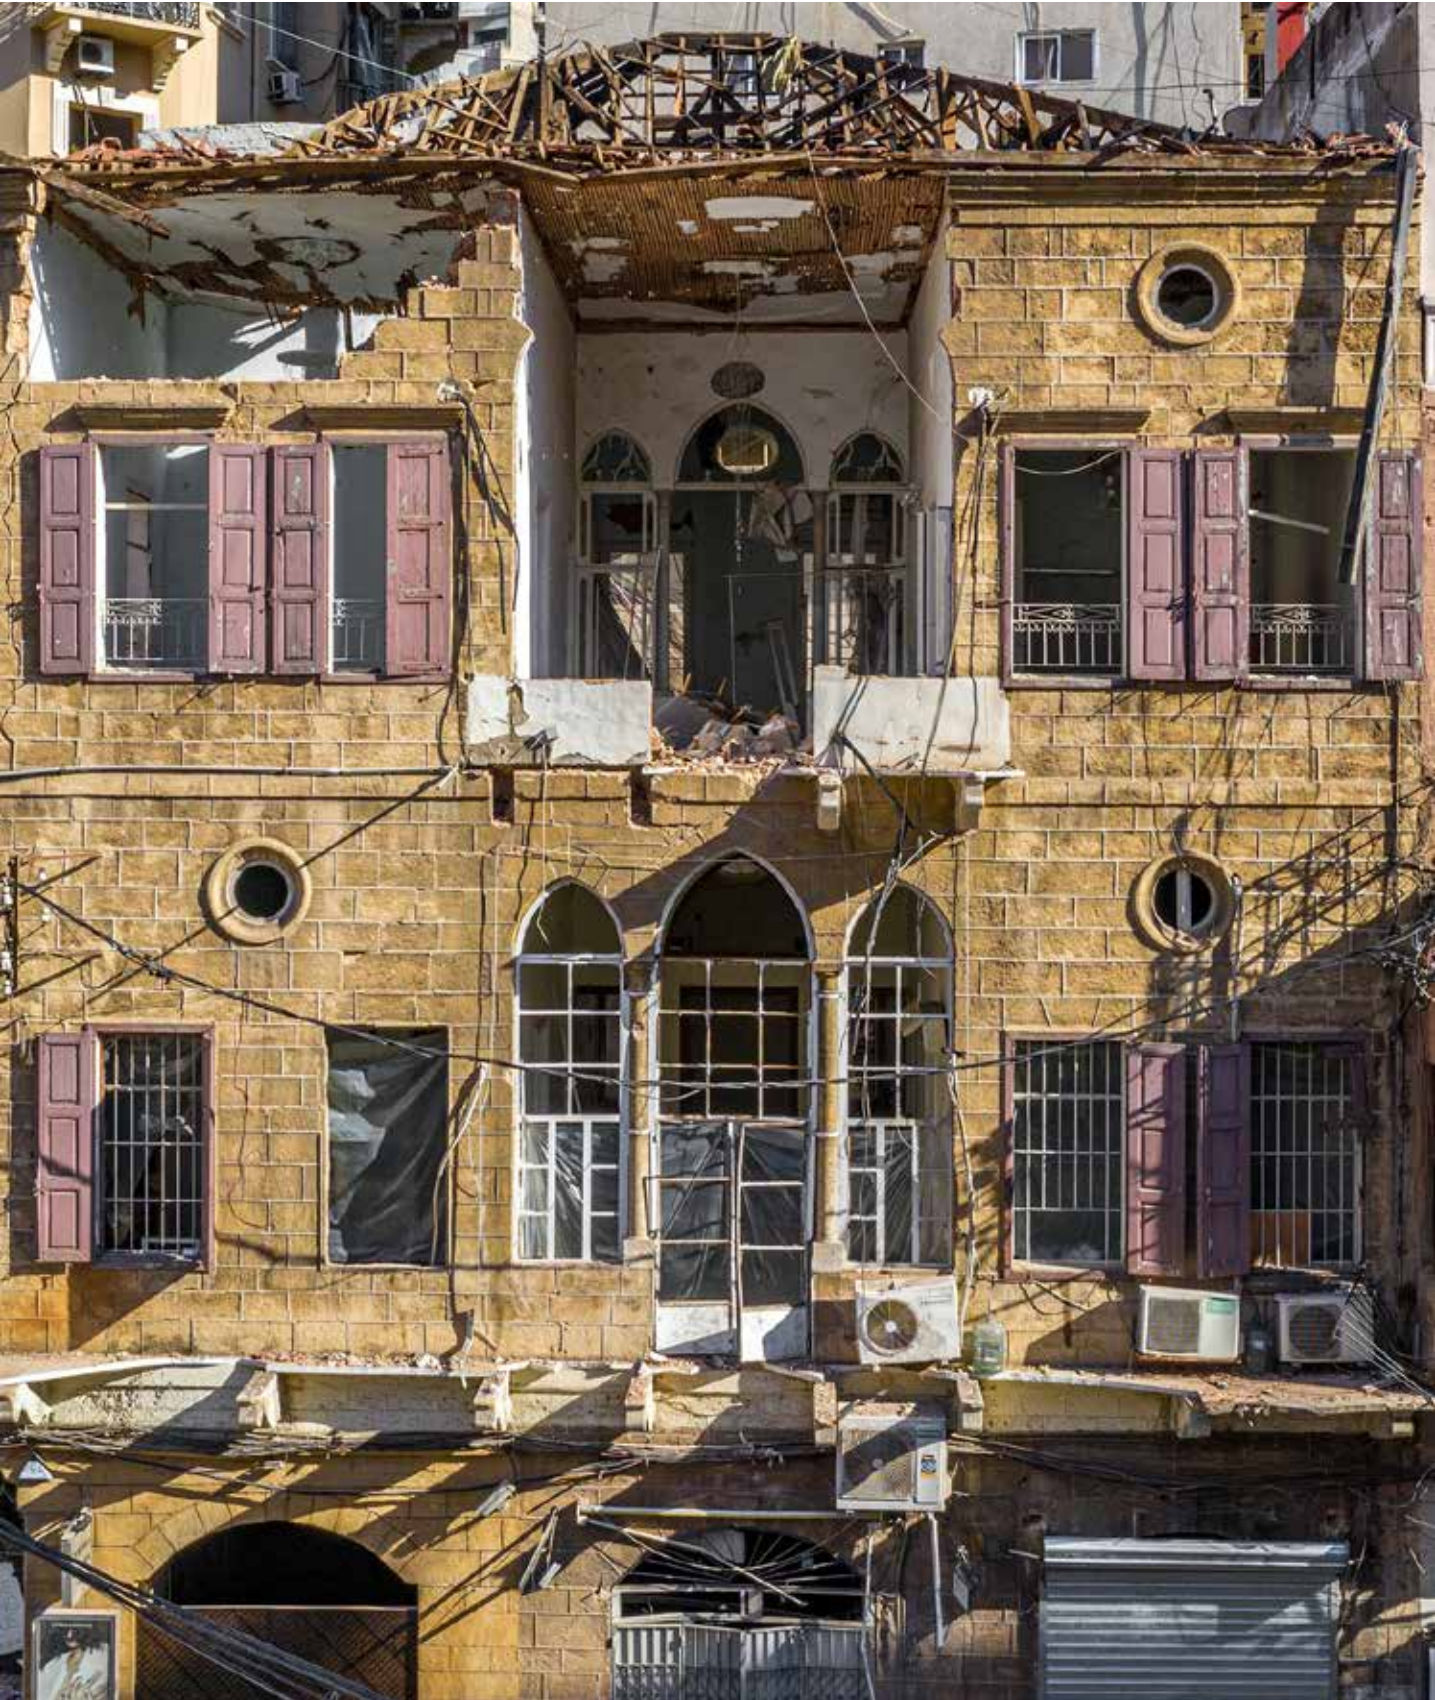
After the blast, *R. Rizk*

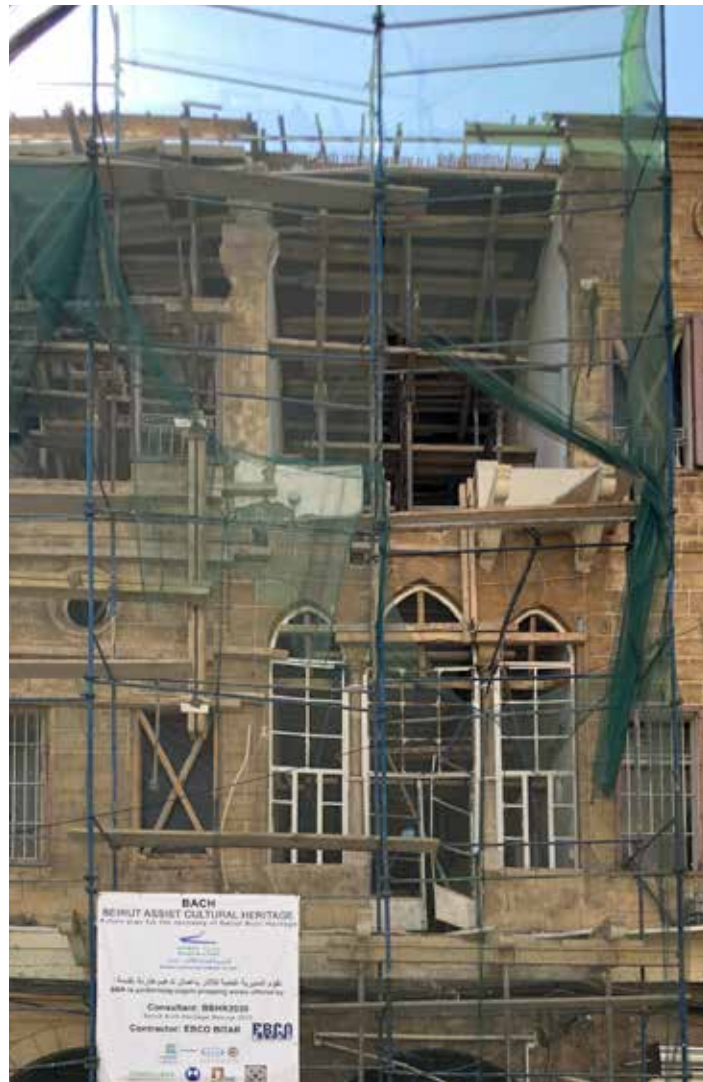
Propping of the north façade, September 2020, Y. Dagher

In September 2020, Rmeil 722 was propped by the *Directorate General of Antiquities (DGA)*. In October 2020, *Beirut Heritage Initiative* sheltered Rmeil 722, as well as Rmeil 723, with a Tarpaulin cover, thanks to the support of *ALIPH Foundation*.

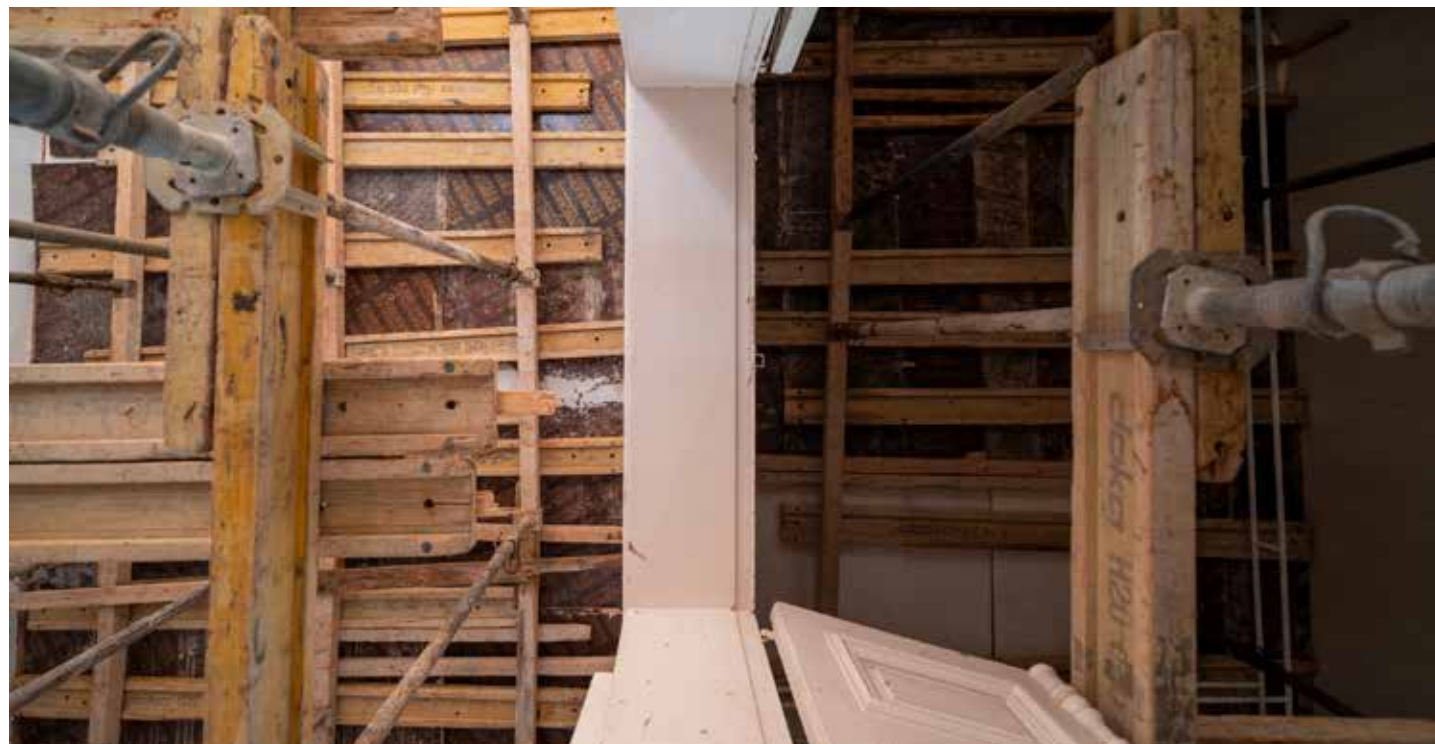
Propping of the Baghdad ceiling, D. Mrad

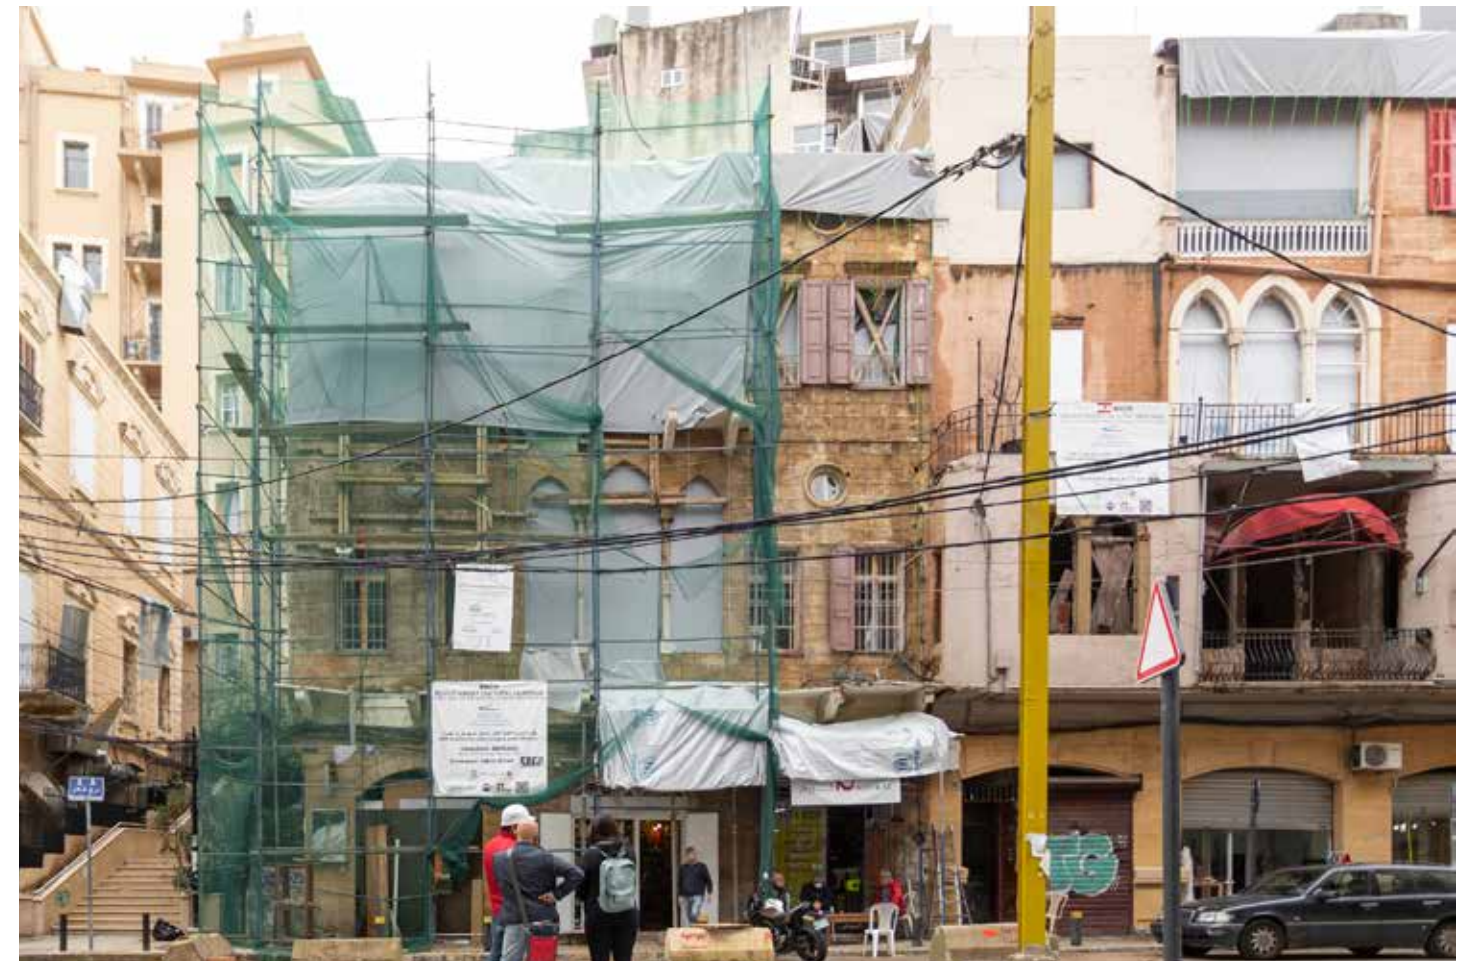
North façade propped and sheltered, Rmeil 722 (left) and Rmeil 723 (right), D. Mrad

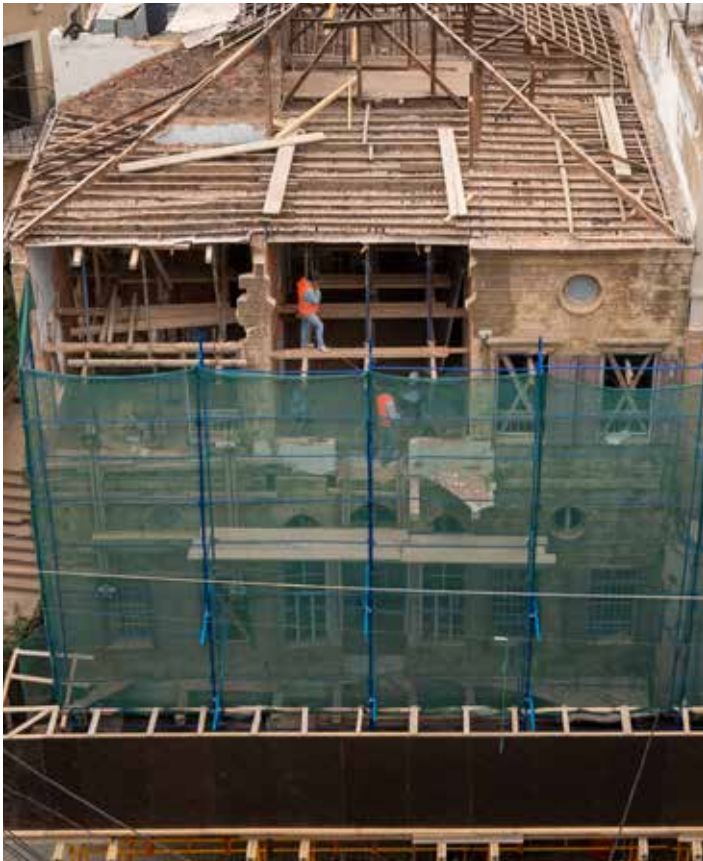
Start of the dismantling operation on North Façade, D. Mrad

The North façade's restoration process started with the numbering of the salvaged and out of plane walls' stones. Then, **the out of plane walls were manually dismantled starting with the second floor and down to the first**. All the sandstones were later sorted and stored in a safe place until the reconstruction process started.

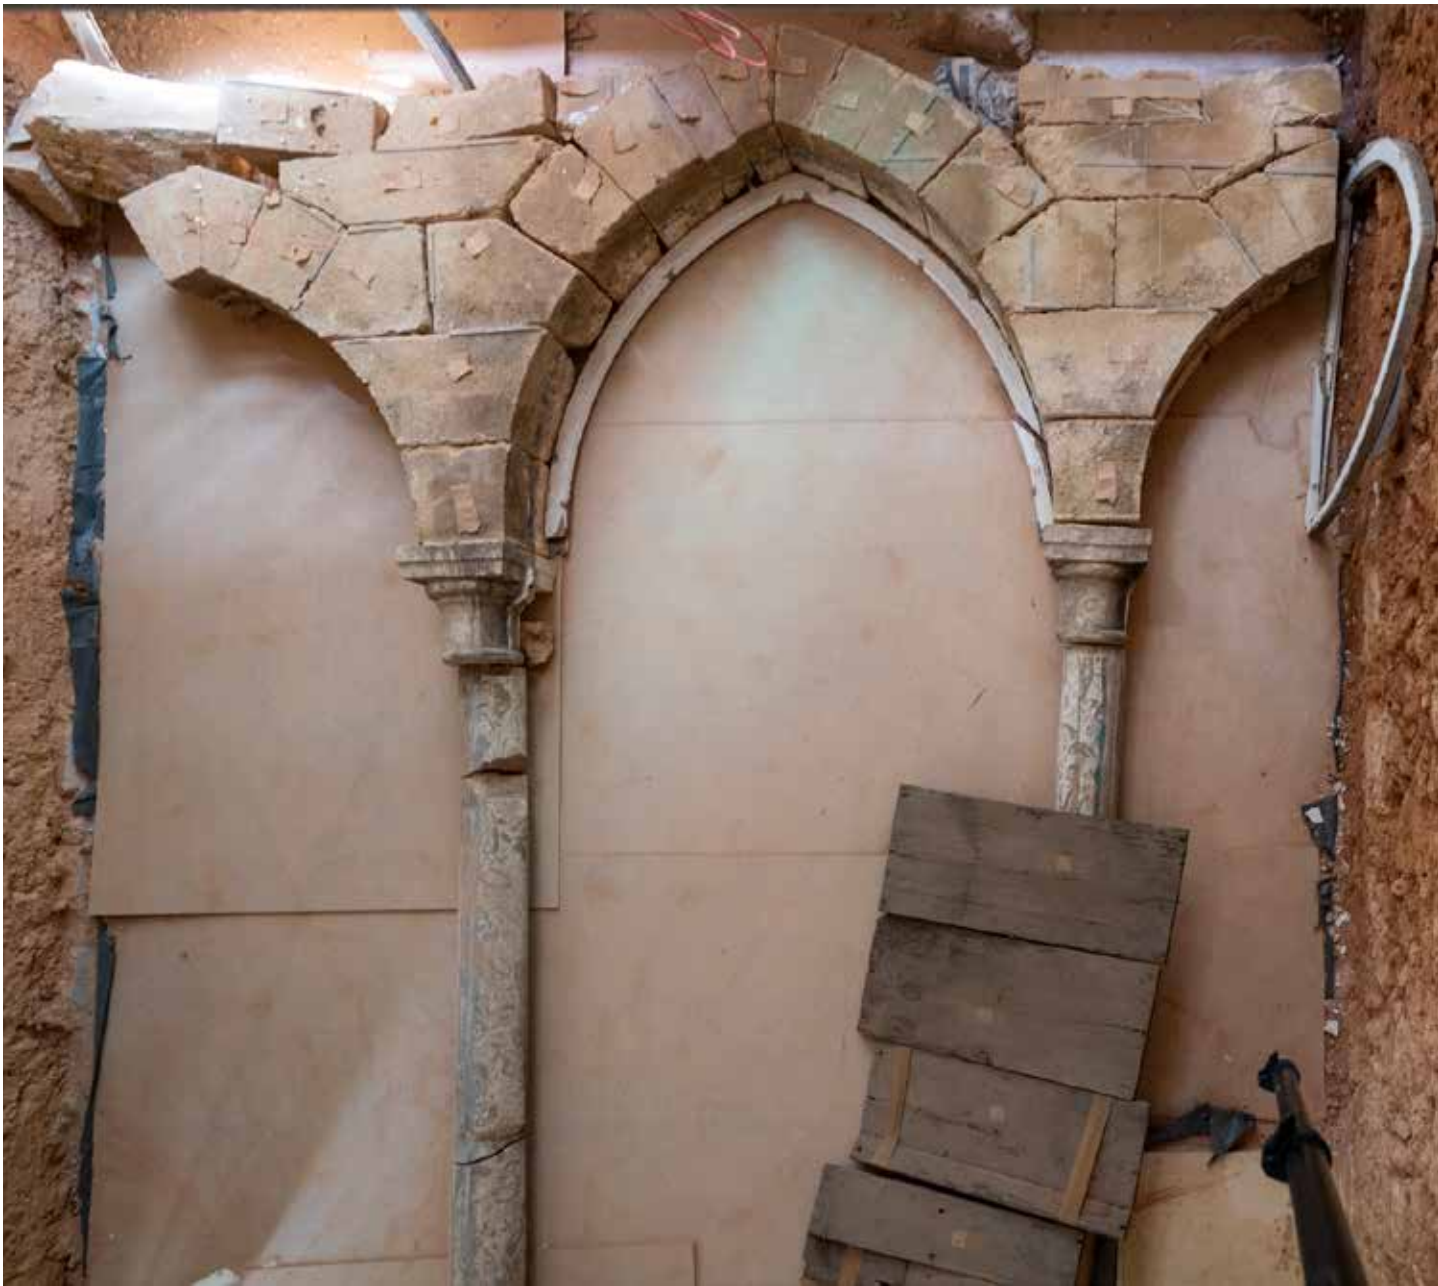
Laying of the triple arches of the first level, D. Mrad

The reconstruction of the North façade started with the reinforcement of the first floor's limestone corbels that held the *Carrara* marble balcony slabs. Then, the dismantled triple arches and wall were rebuild using the previously sorted material. A similar process was followed on the second floor and the final step in the North façade's reconstruction was the rebuilding of the roof's stone cornice. The North façade took 3.5 months to be rebuilt.

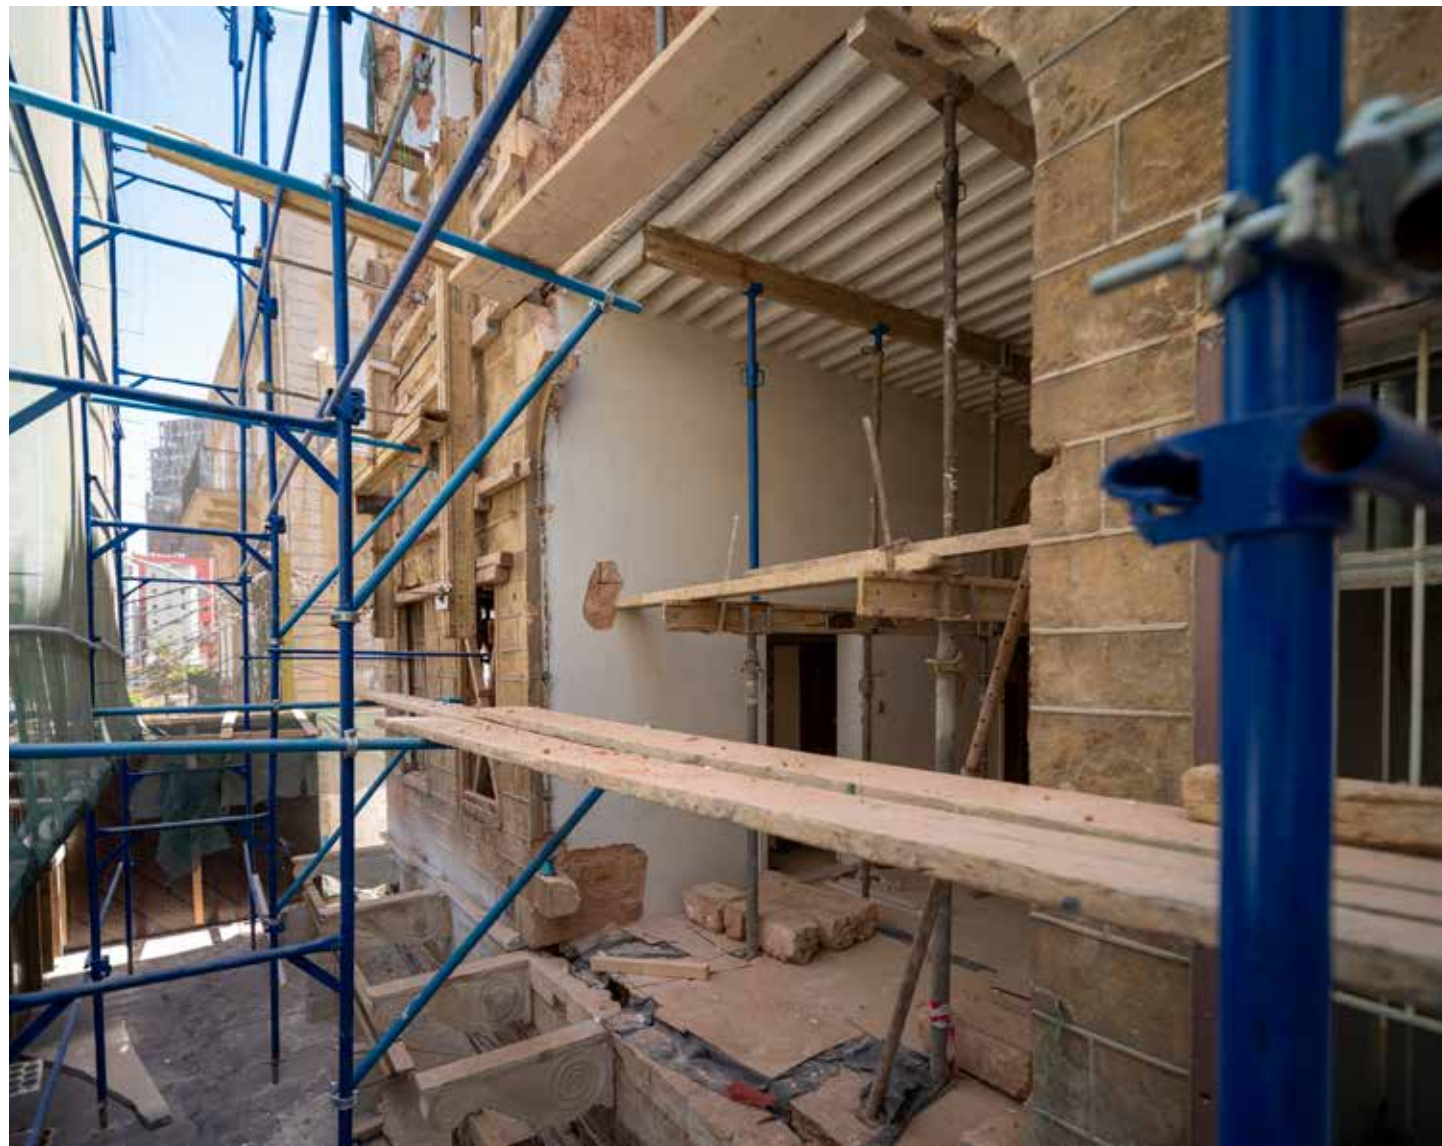
First floor triple arches dismantled, *D. Mrad*

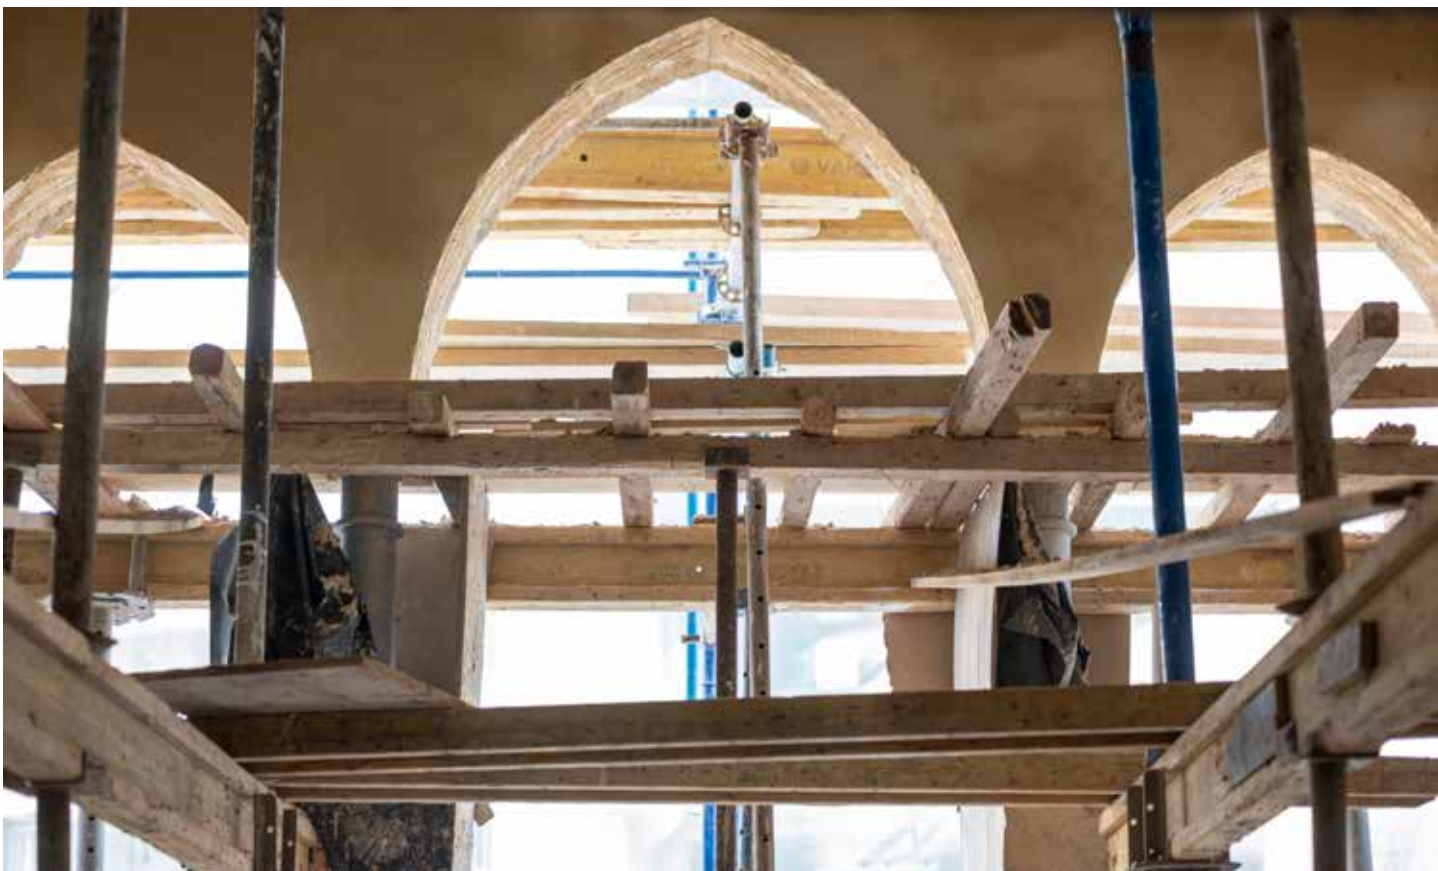
First floor triple arches, *D. Mrad*

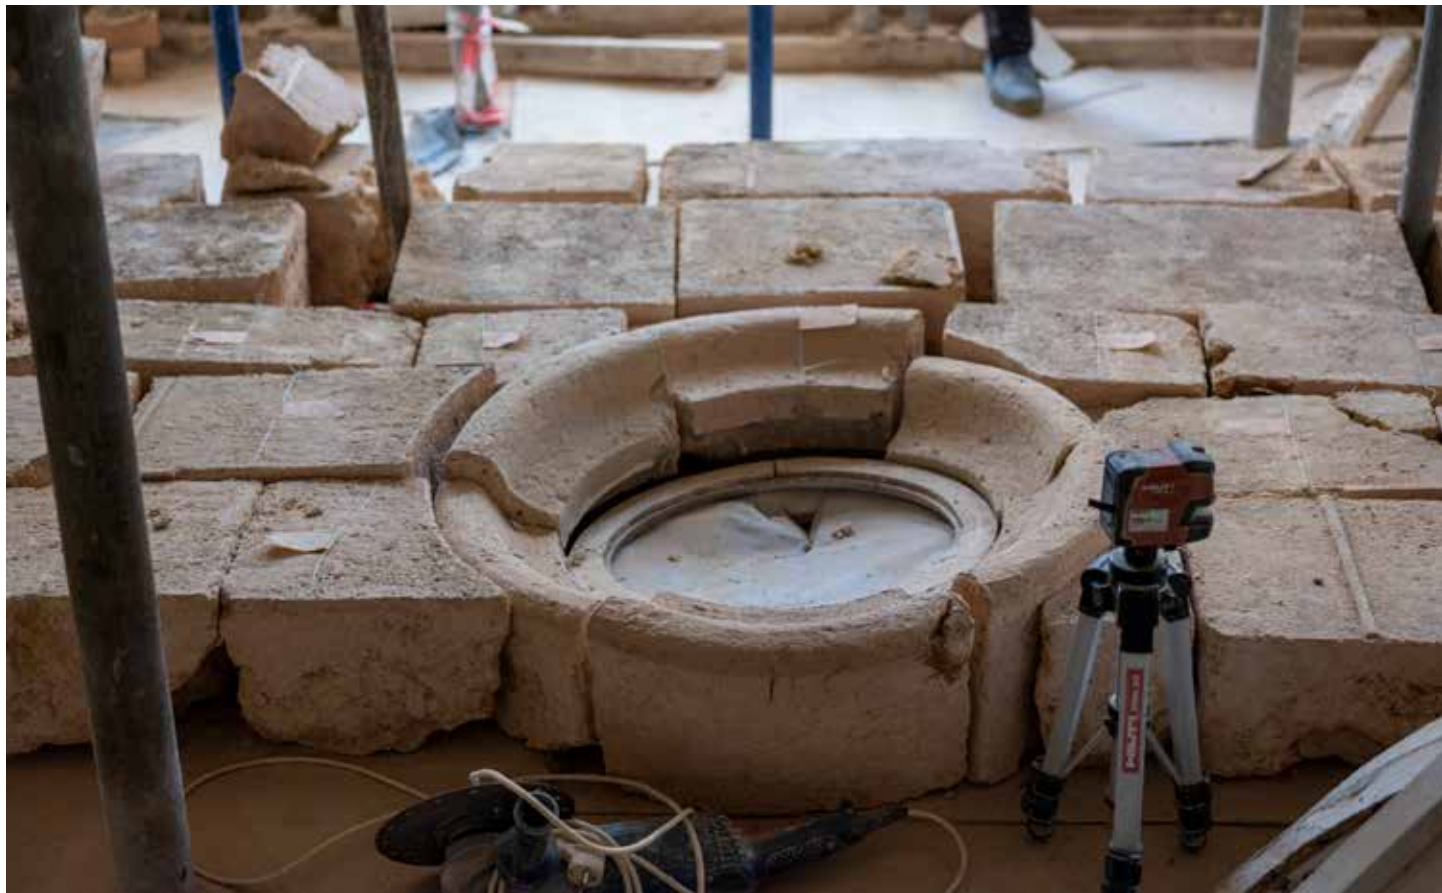
Sandstones awaiting for their placement, Second floor, *D. Mrad*

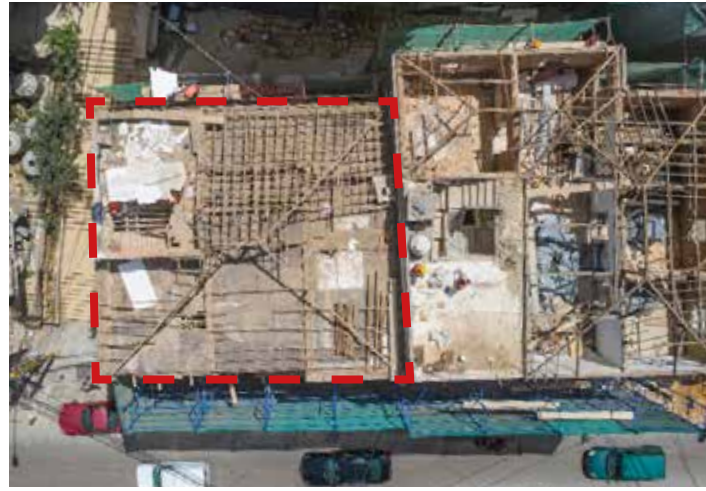
Rmeil 722, roof condition after the blast, J. Kallas

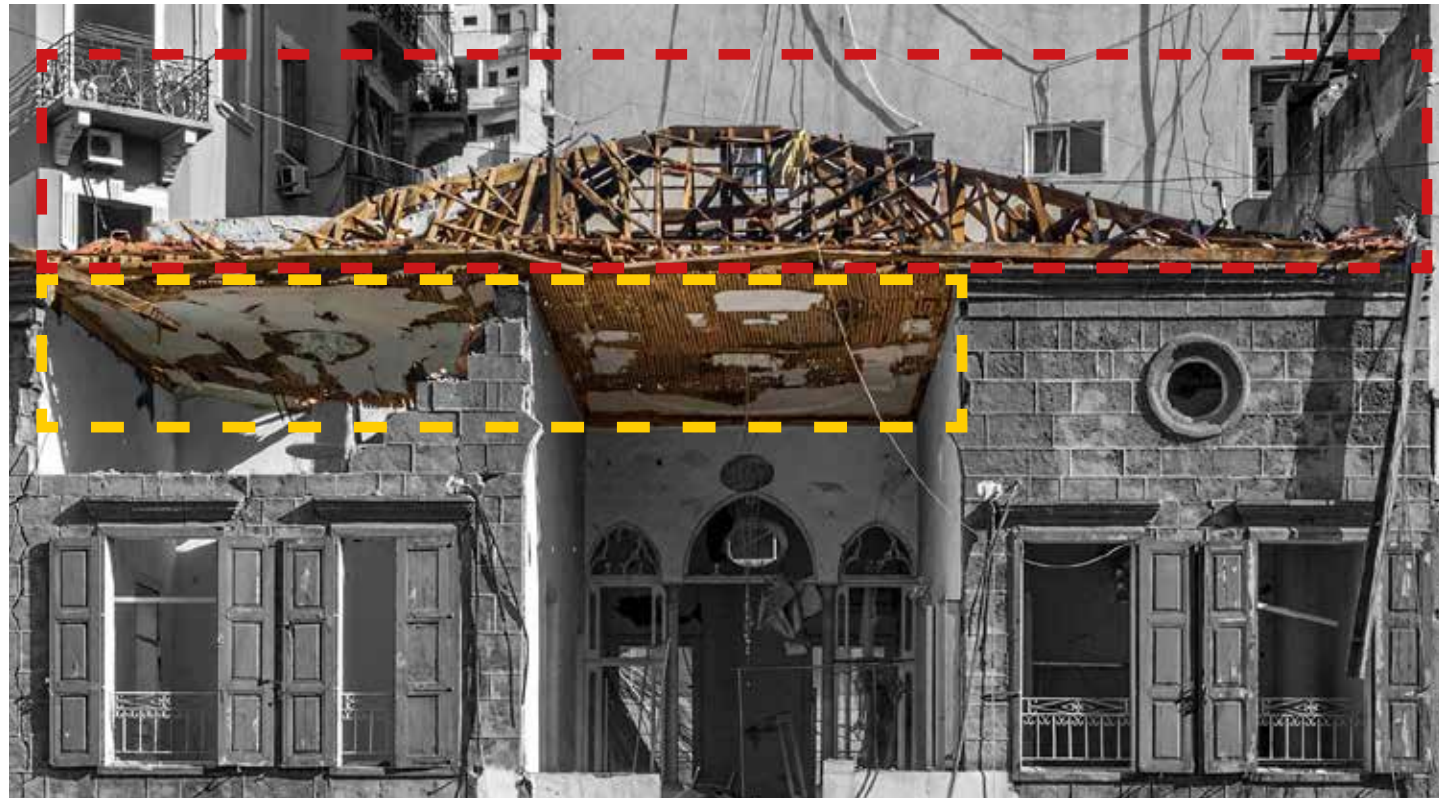
Roof condition after the blast, R. Rizk

— — — — — Damaged roof — — — — — Damaged Baghdadi

During the first month, the existing damaged wooden structure was dismantled, and a recently added concrete room that led to the pitched roof was removed. The second floor's damaged *Baghdadi* ceiling, located under the roof's structure was also dismantled.

The pitched roof's wooden structure was rebuilt using *Qotrani* wood, which was traditionally used in the construction of these heritage houses following the conventional building techniques of the time. For additional protection, a vapour permeable underlay was installed on the wooden structure prior to the installation of the red tiles and caps.

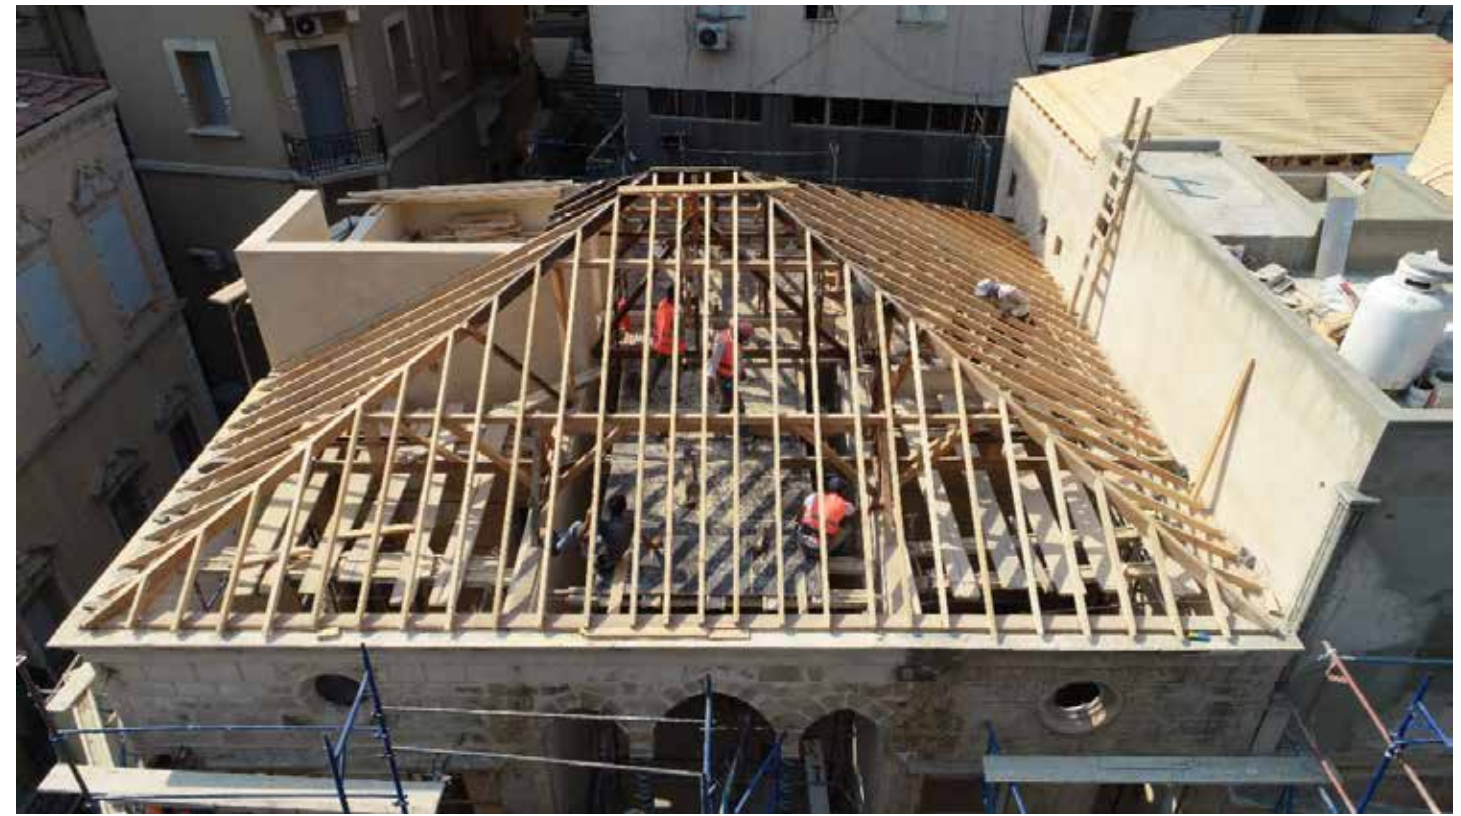
Reconstruction of the wooden rafters, July 2021, M. Khadra

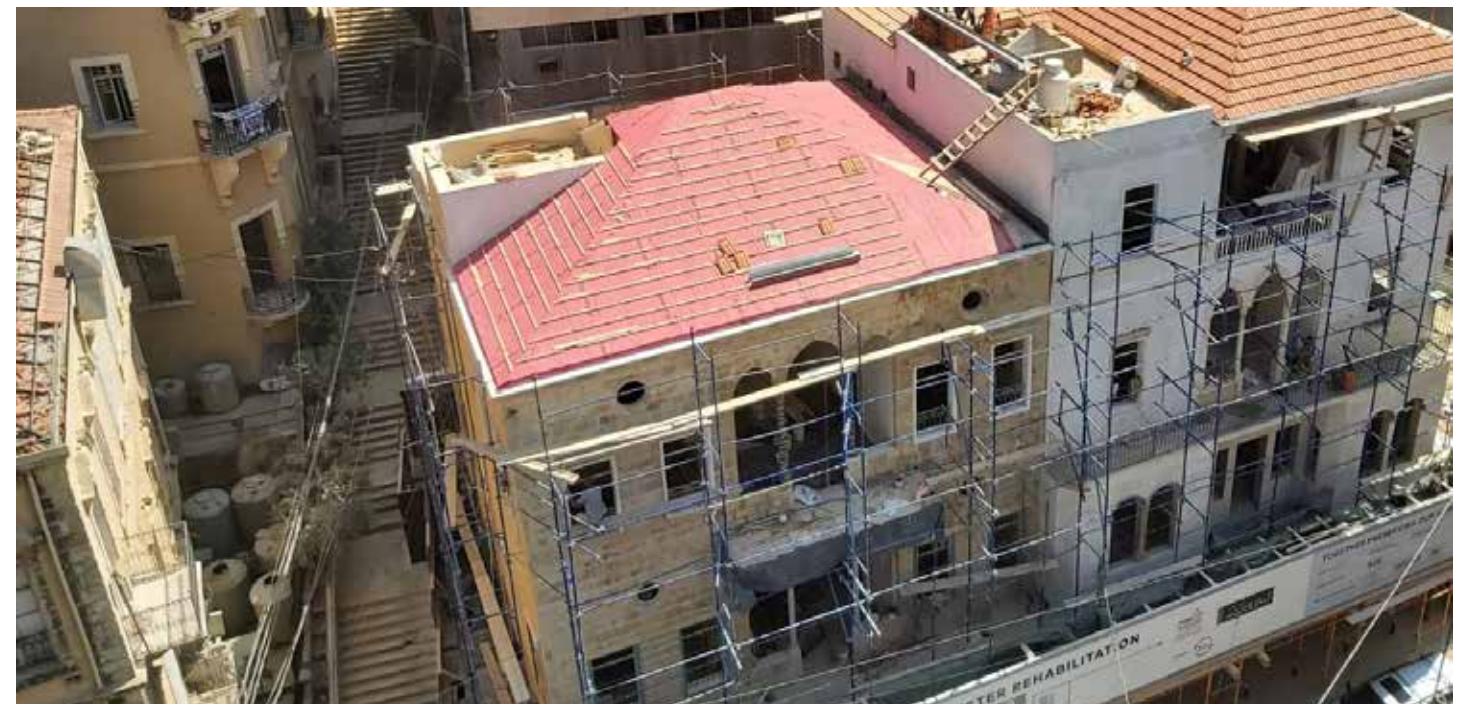
Installation of vapour mesh, Y. Majzoub

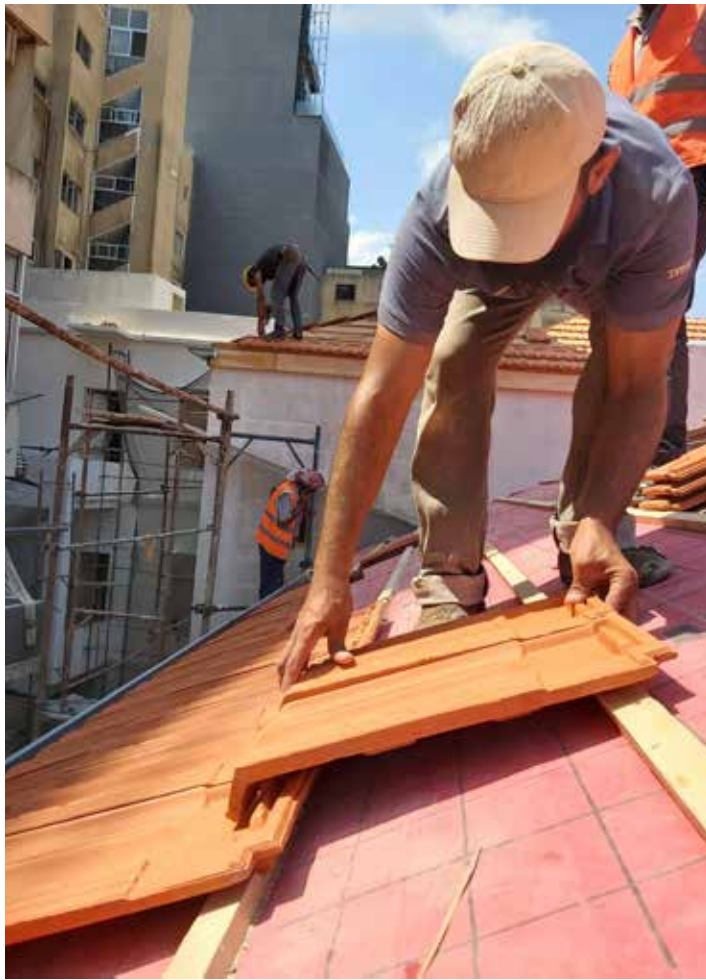
Installation of red tiles, *Y. Majzoub*

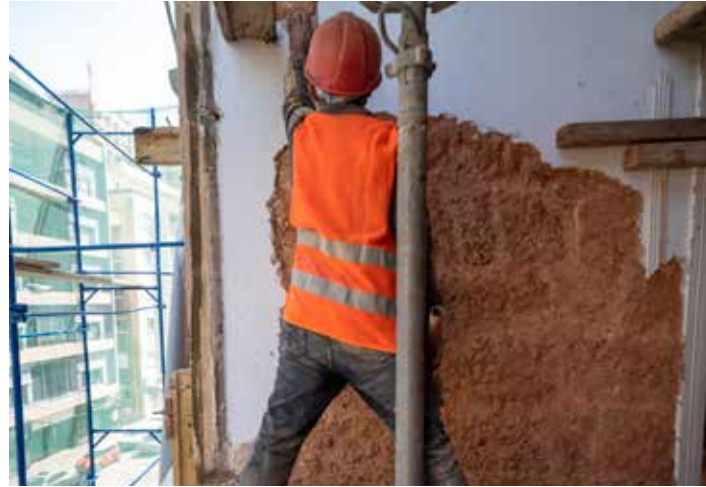
Manual removal of the lime plaster, D. Mrad

- Assessment of the damaged and cracked plaster
- Removal of the decayed plaster without alteration of the masonry - manual removal
- Cleaning of the sandstone surface
- Structural consolidation with stitching and injection of cracks in the sandstone wall, using grout and stainless steel plates
- Application of a setting coat for the preparation of the lime plaster
- First rough application of lime plaster - scratched coat
- Second and final layer of lime plaster - smooth surface

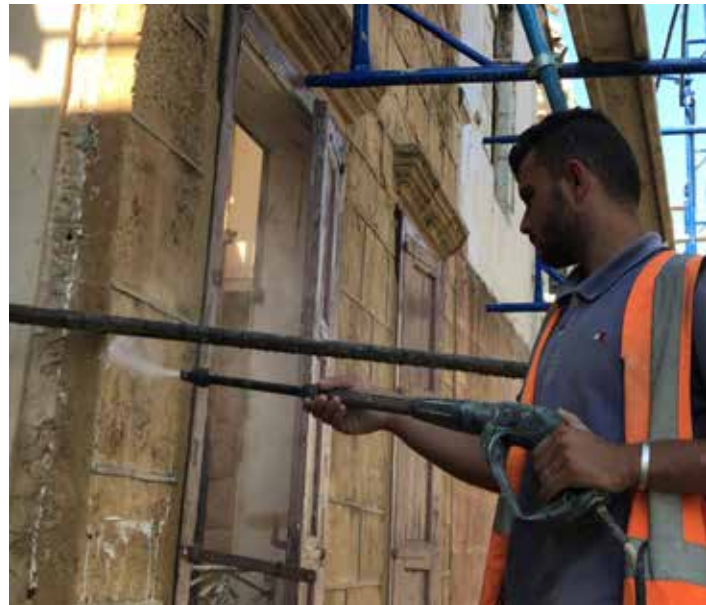
Cleaning of the north façade, M. Khadra

The decorative stone jointing of Rmeil 722's North façade was also made of plaster. After the reconstruction of the north façade, the stones were cleaned manually, and in small areas using a low-pressure water jet. Then the decorative jointing was repaired where needed and a light tea-stain was applied on some parts of the stone surfaces to balance out the overall colour of the façade.

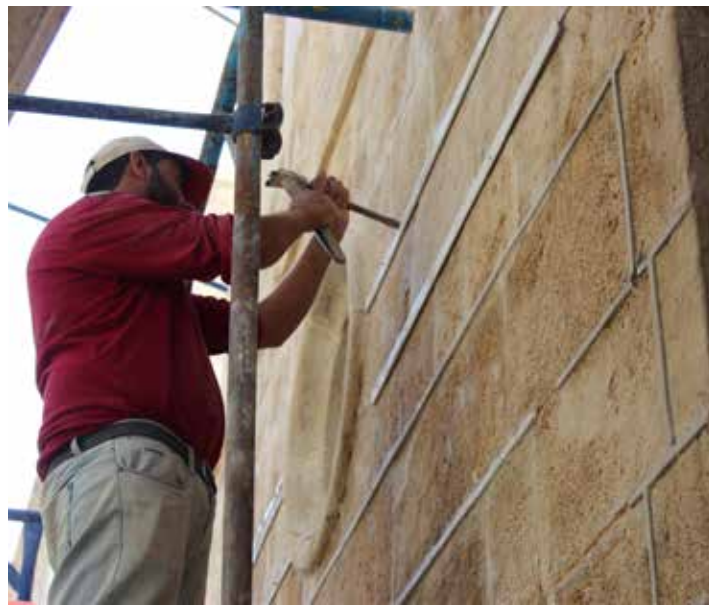
Rejointing north façade, J. Chalfoun

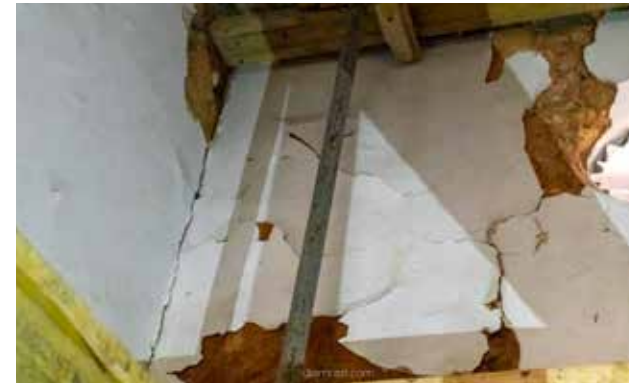
1- Assessment of the damaged lime plaster

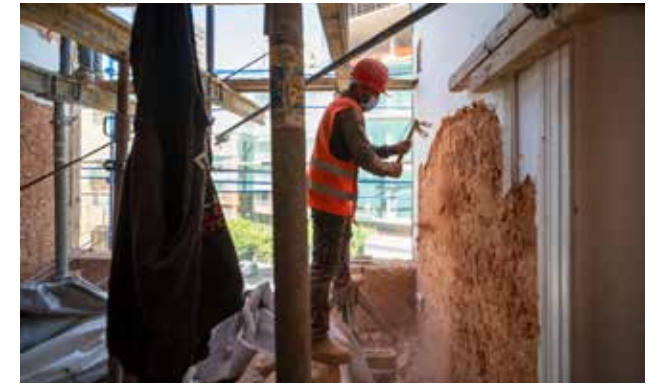
2- Manual removal of the damaged lime plaster

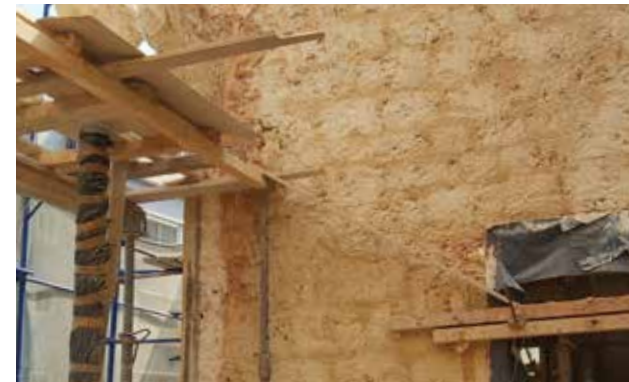
4- Sandstone preparation for lime plaster application

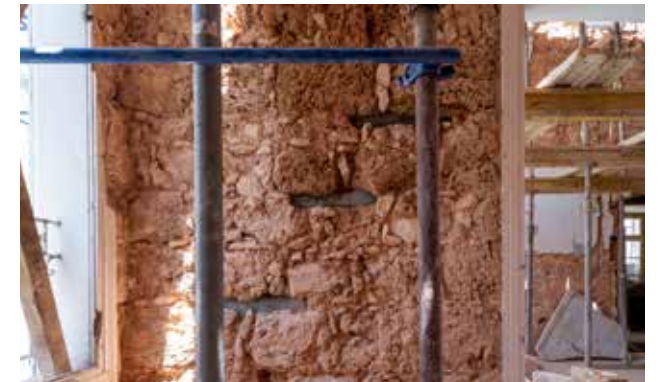
3- Stitching of the wall where large cracks are found

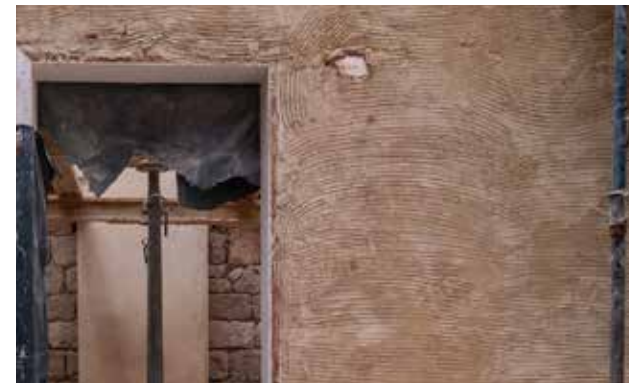
5- Application of a primary lime plaster coat (rough finishes)

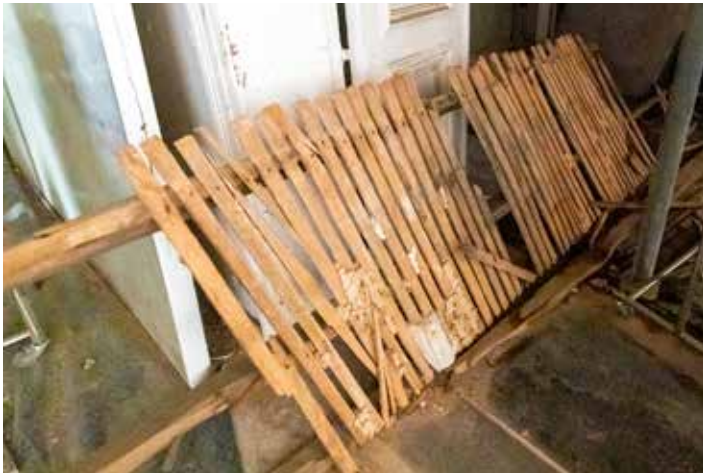
Baghdadi structure, D. Mrad

BHI, the consultant, and the contractor made sure that the *Baghdadi* ceiling was **restored using the original materials and techniques**, whereby wooden lathes were installed under the pitched roof's wooden beams and were covered with two layers of lime plaster: First a rough scratched coat and then a smooth coat. Afterwards, the wooden cornice was installed, the ceiling was painted and finally the central plaster decorative element put in place.

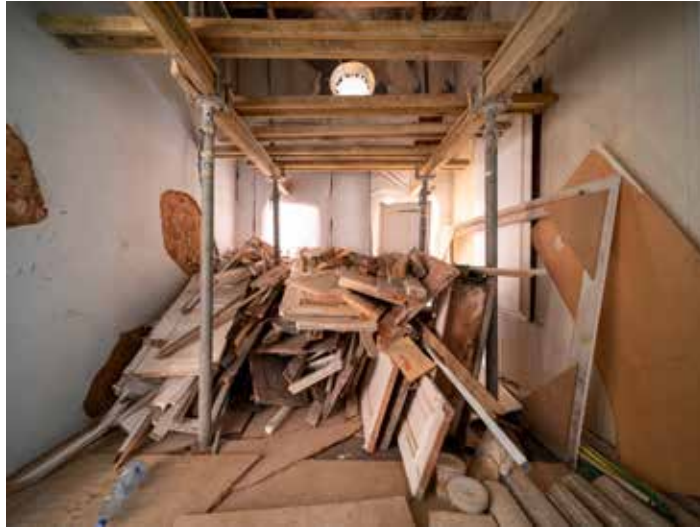
Damaged carpentry, *D. Mrad*

The *Qotrani* wooden windows, oculi, doors and shutters in Rmeil 722 were severely damaged by the blast and in some cases shattered into bits and pieces.

The carpentry was restored using salvaged elements and replacing decayed parts with new *Qotrani* wood. As for missing or highly damaged items, they were reproduced by the contractor with the instructions of the consultant to mirror the original design.

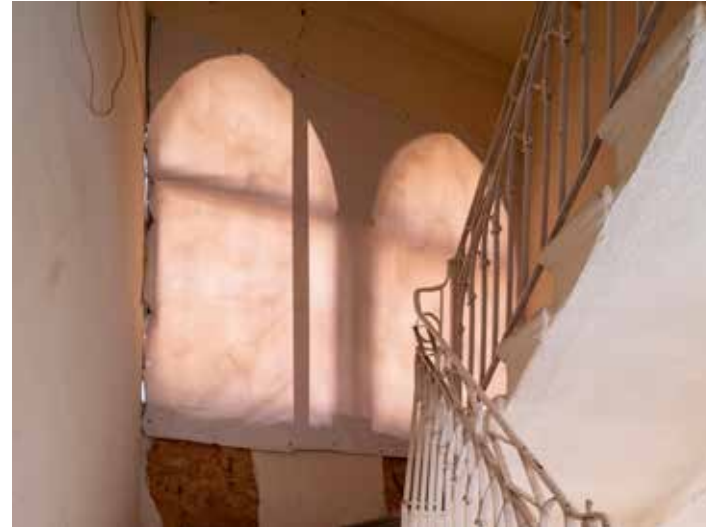
Loss of carpentry, *D. Mrad*

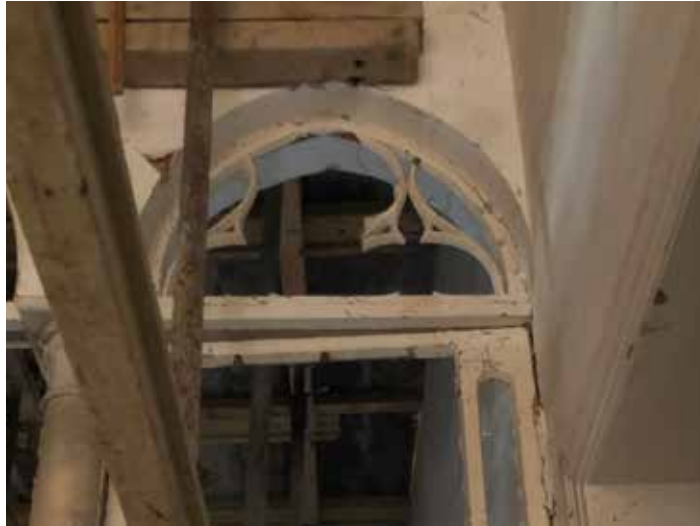
Damaged arch, *Y. Dagher*

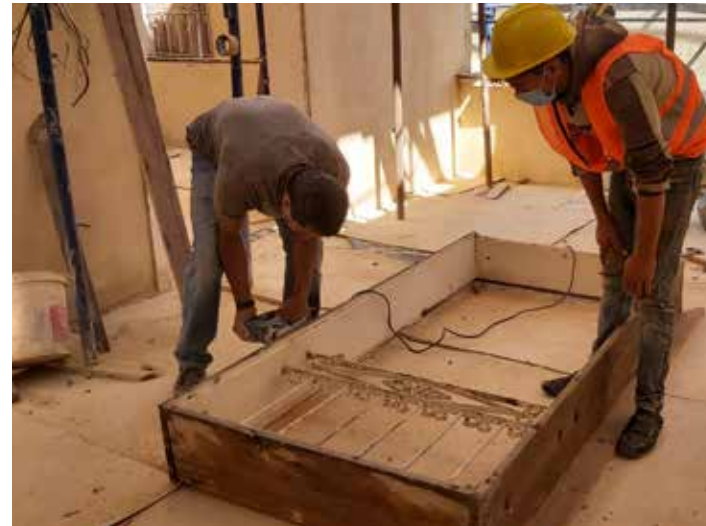
Fixing the existing window frame, *Y. Majzoub*
