# THE GHOLAM CLUSTER REHABILITATION: RMEIL 722

Restoration of a heritage building affected by the August 4, 2020 Beirut Blast.

April 2021 - December 2021

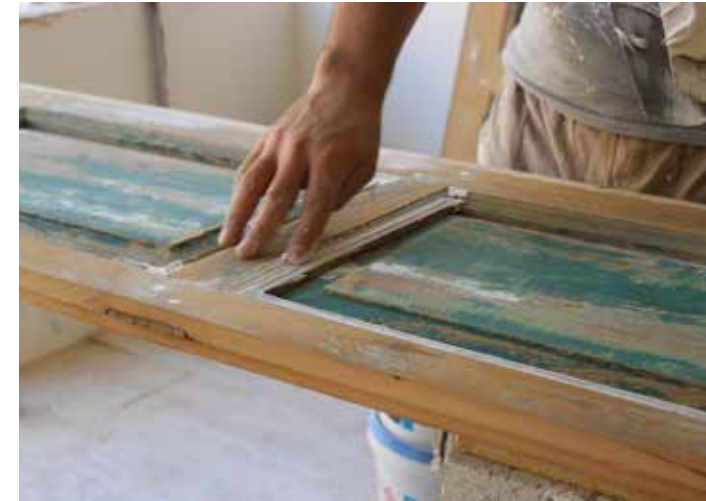
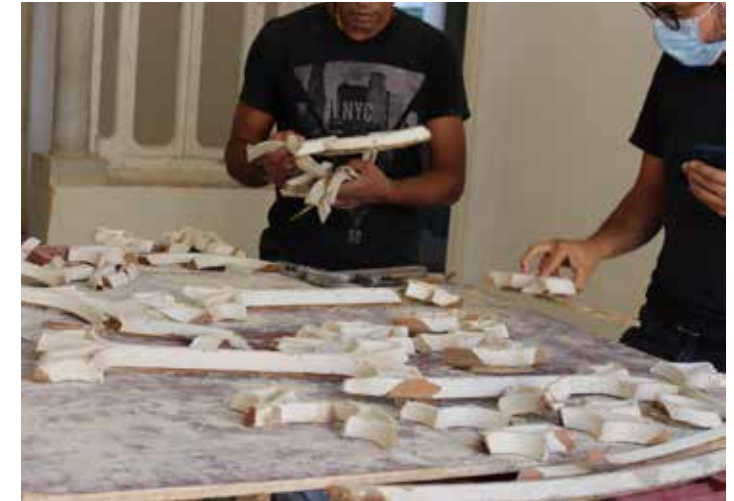
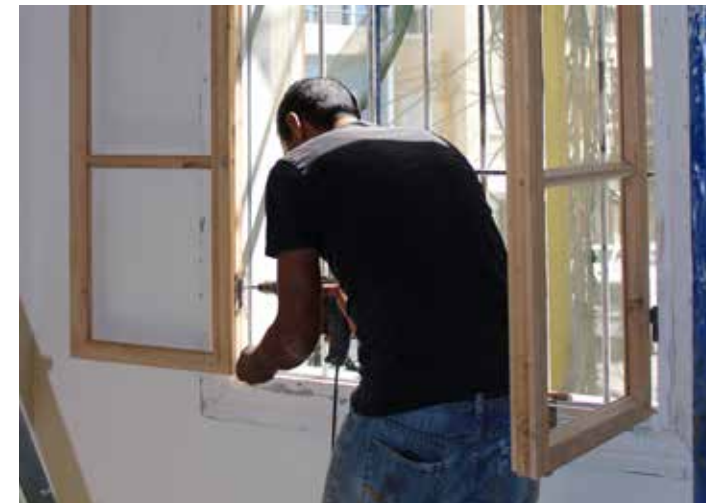
Restoration and installation of the carpentry, *J. Chalfoun*

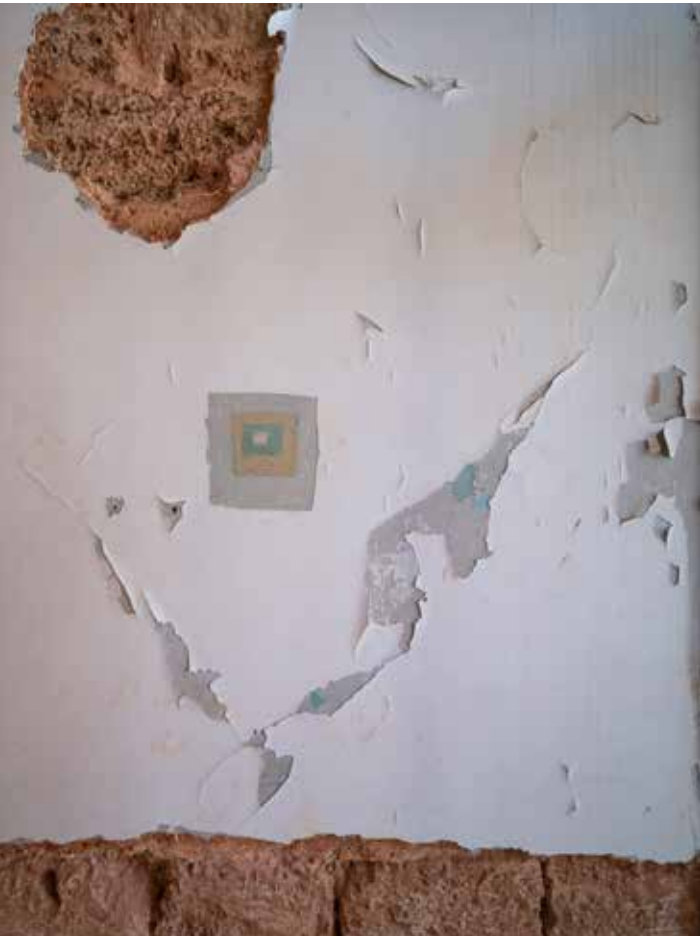
Revealing the old paint, *D. Mrad*

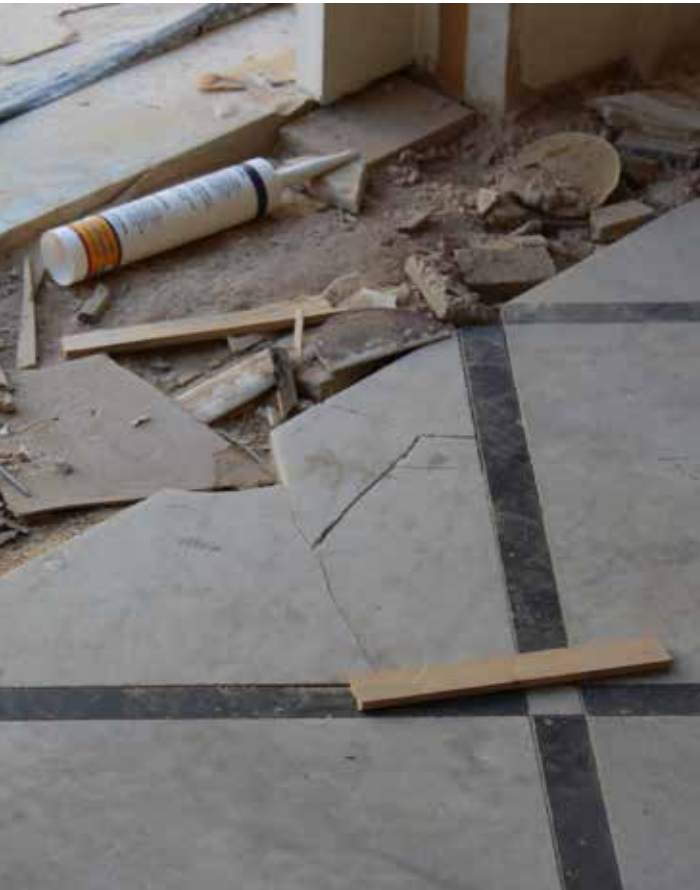
Broken carrara marble tiling, *J. Chalfoun*

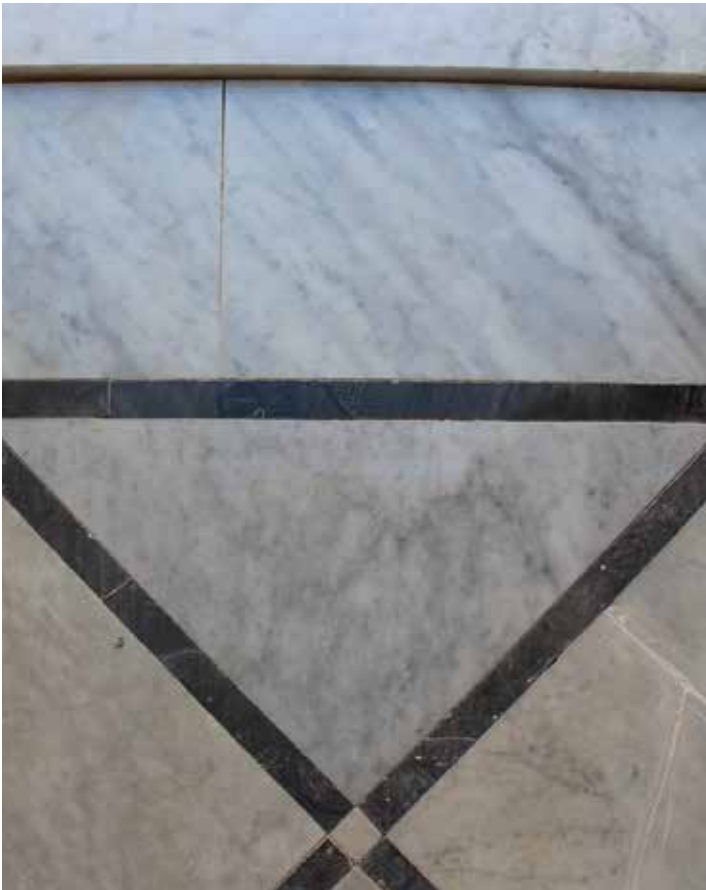
New carrara marble tiling, *J. Chalfoun*

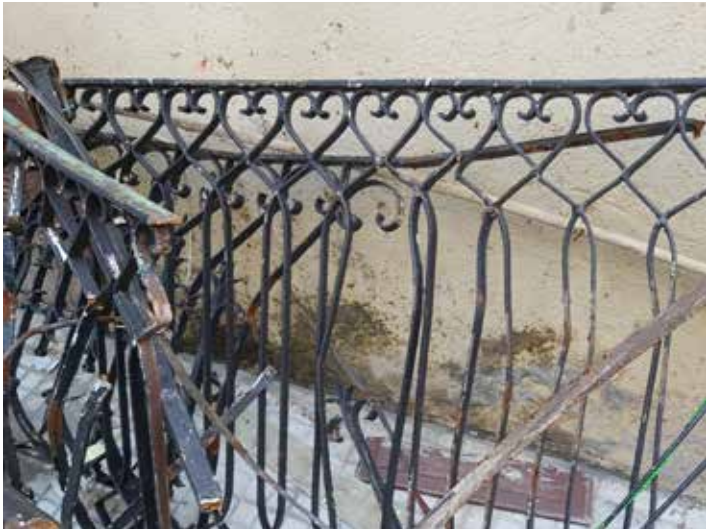
Damaged metallic balustrade, *Y. Majzoub*

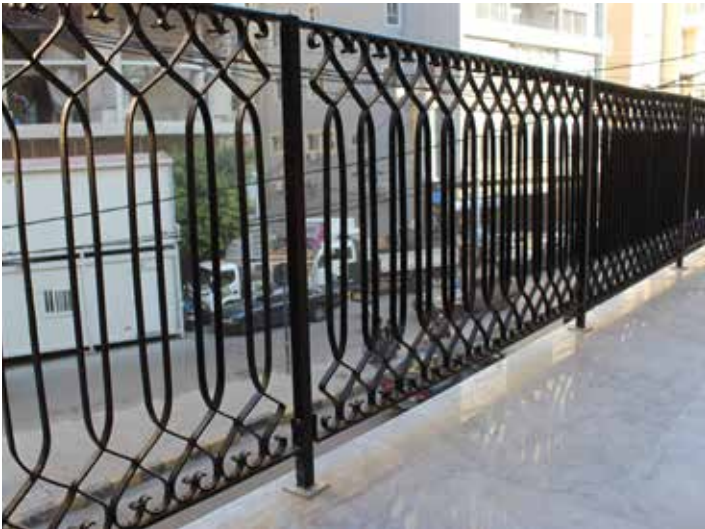
Restored and installed metallic balustrade, *J. Chalfoun*

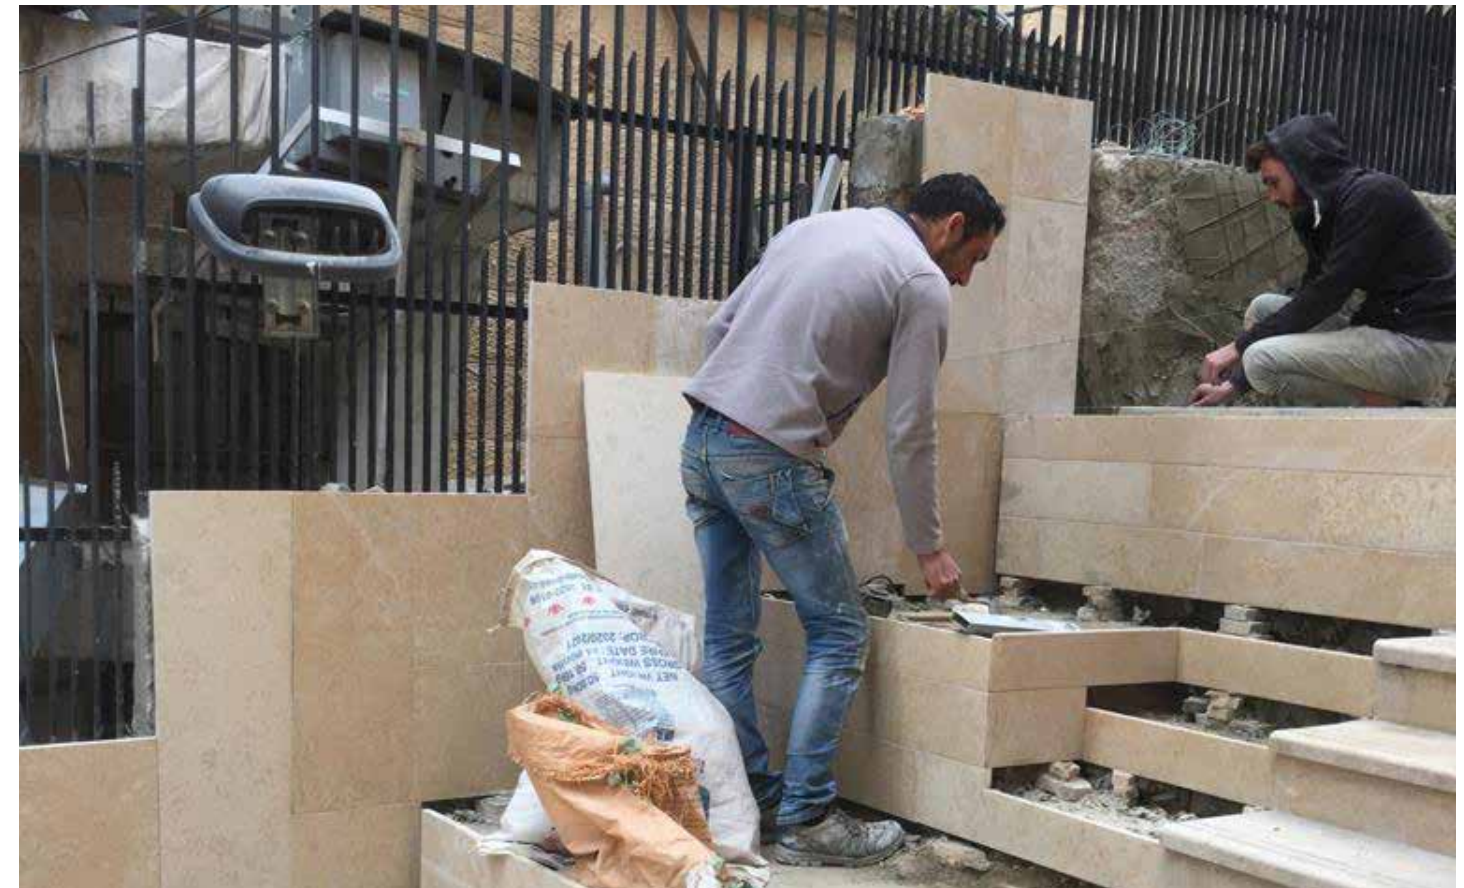
During the intervention, tiling installation, Y. Kassab

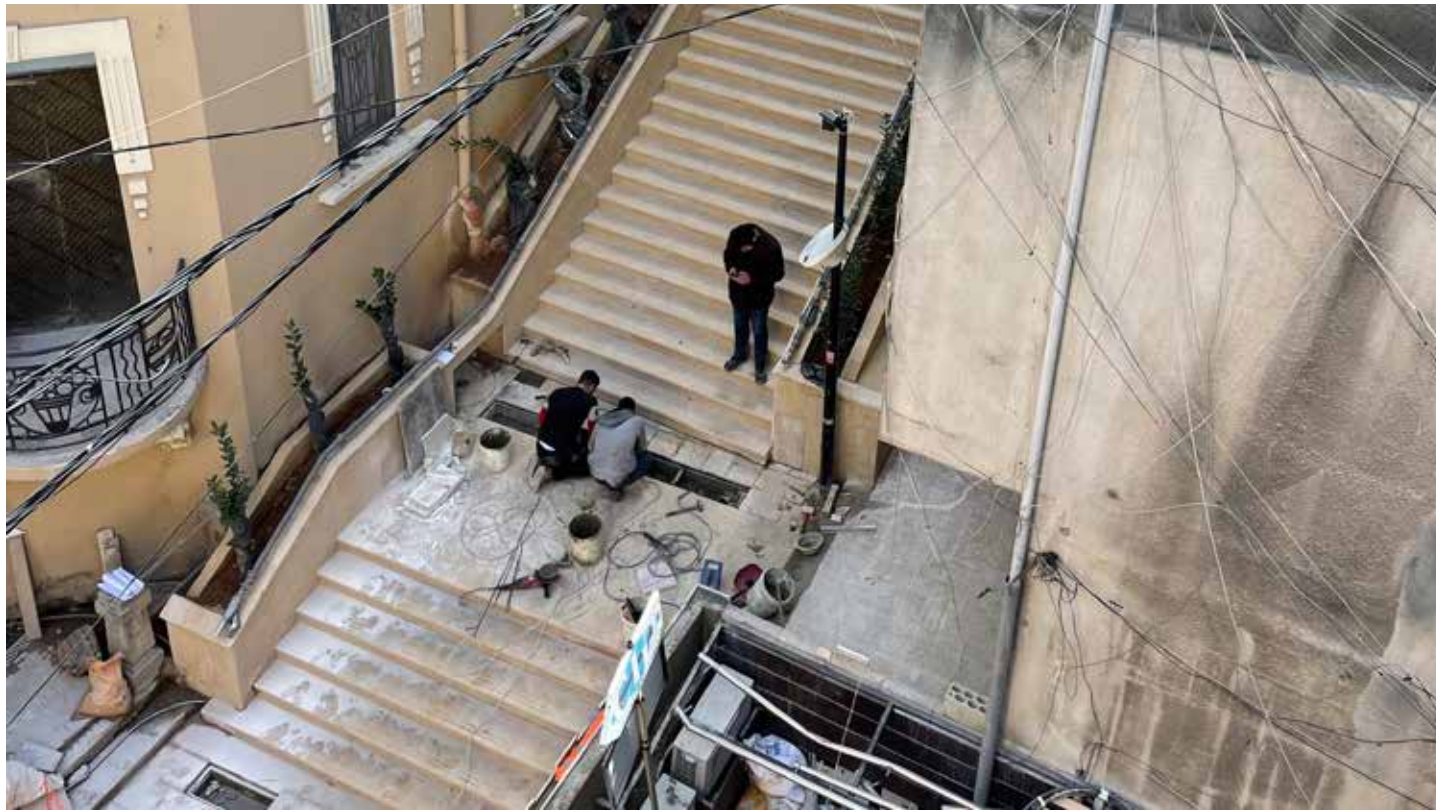
Installation of gutters, *Y. Dagher*
