## MEDAWAR 479 REHABILITATION: THE BLUE HOUSE

Restoration of a heritage building affected by the August 4, 2020 Beirut Blast.

◆ مبادرة بيروت للتراث  
BEIRUT HERITAGE INITIATIVE

November 2021 - September 2022

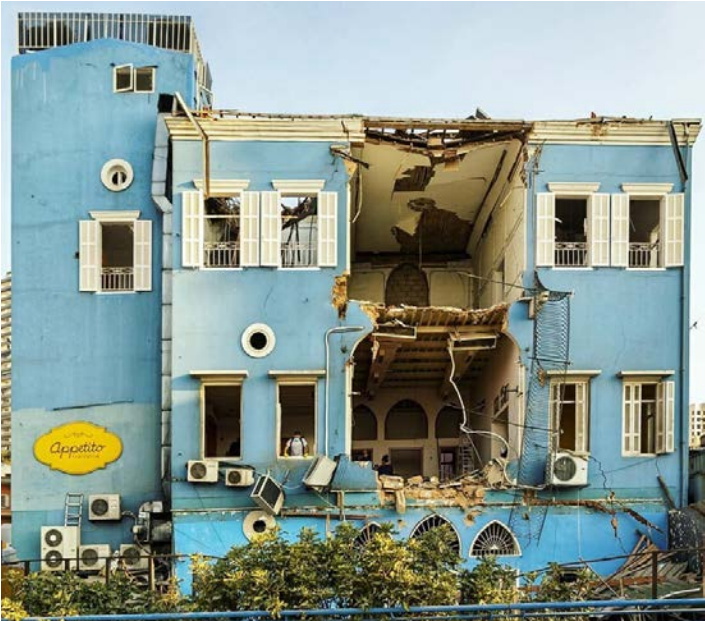
Unfortunately, on August 4, 2020, this 1890s central hall house was deeply affected by the impact of the explosion, due to its proximity to the port of Beirut and being one of the closest buildings to the epicenter of the explosion. After an in-depth study conducted by the *Directorate General of Antiquities (DGA)*, the *Beirut Built Heritage Rescue 2020 (BBHR20)* and the architect-restorer Joe Kallas, the Blue House has revealed treasures hidden from view, such as historical murals and a set of previously capped triple arches.

After the blast, *D. Mrad*

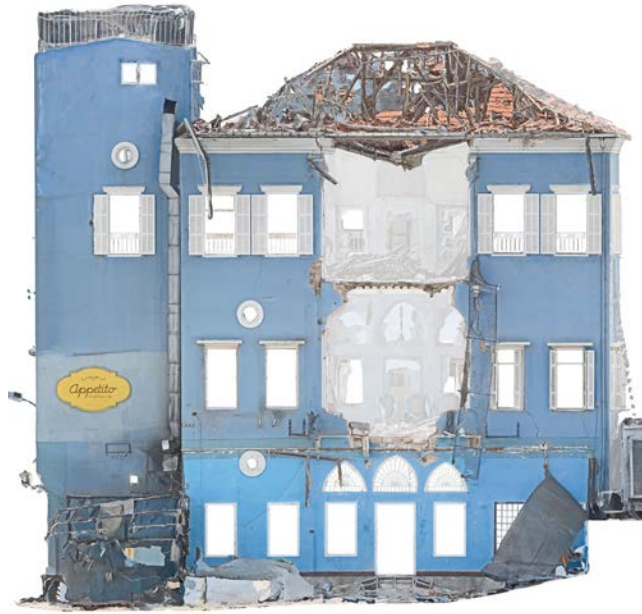
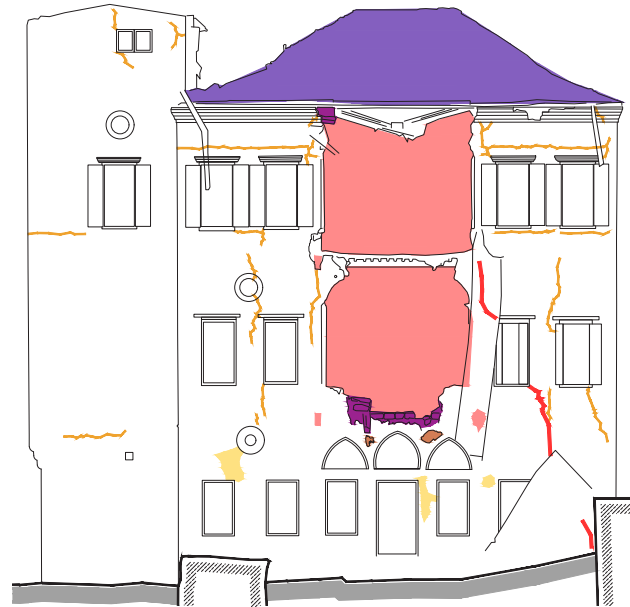
The North façade was severely damaged by the blast, which led to its partial collapse on the first and second floors, and out of plane walls. To restore it back to its original state, the former had to be completely rebuilt, using the original sandstones and lime based mortar used in the traditional building techniques. The whole structure was also enhanced using Structural Plastering.

North façade damage photogrammetry and assessment, J. Kallas (BBHR20)

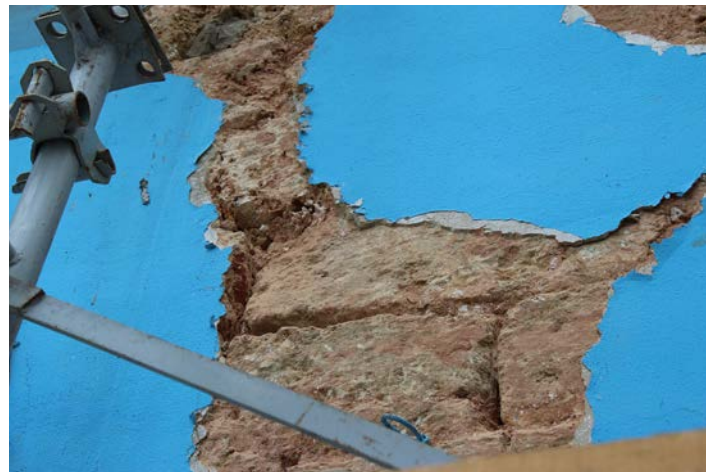
Damaged plaster and sandstone cracks, J. Chalfoun

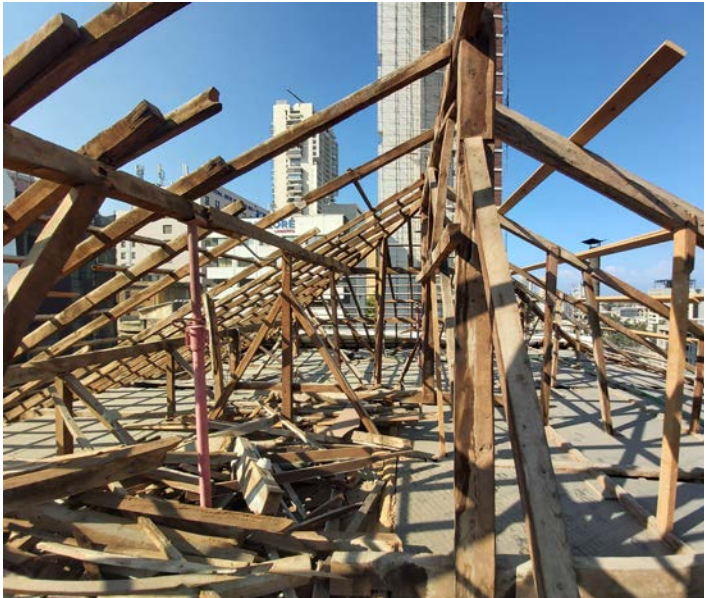
Assessment of the existing wooden structure, Y. Majzoub

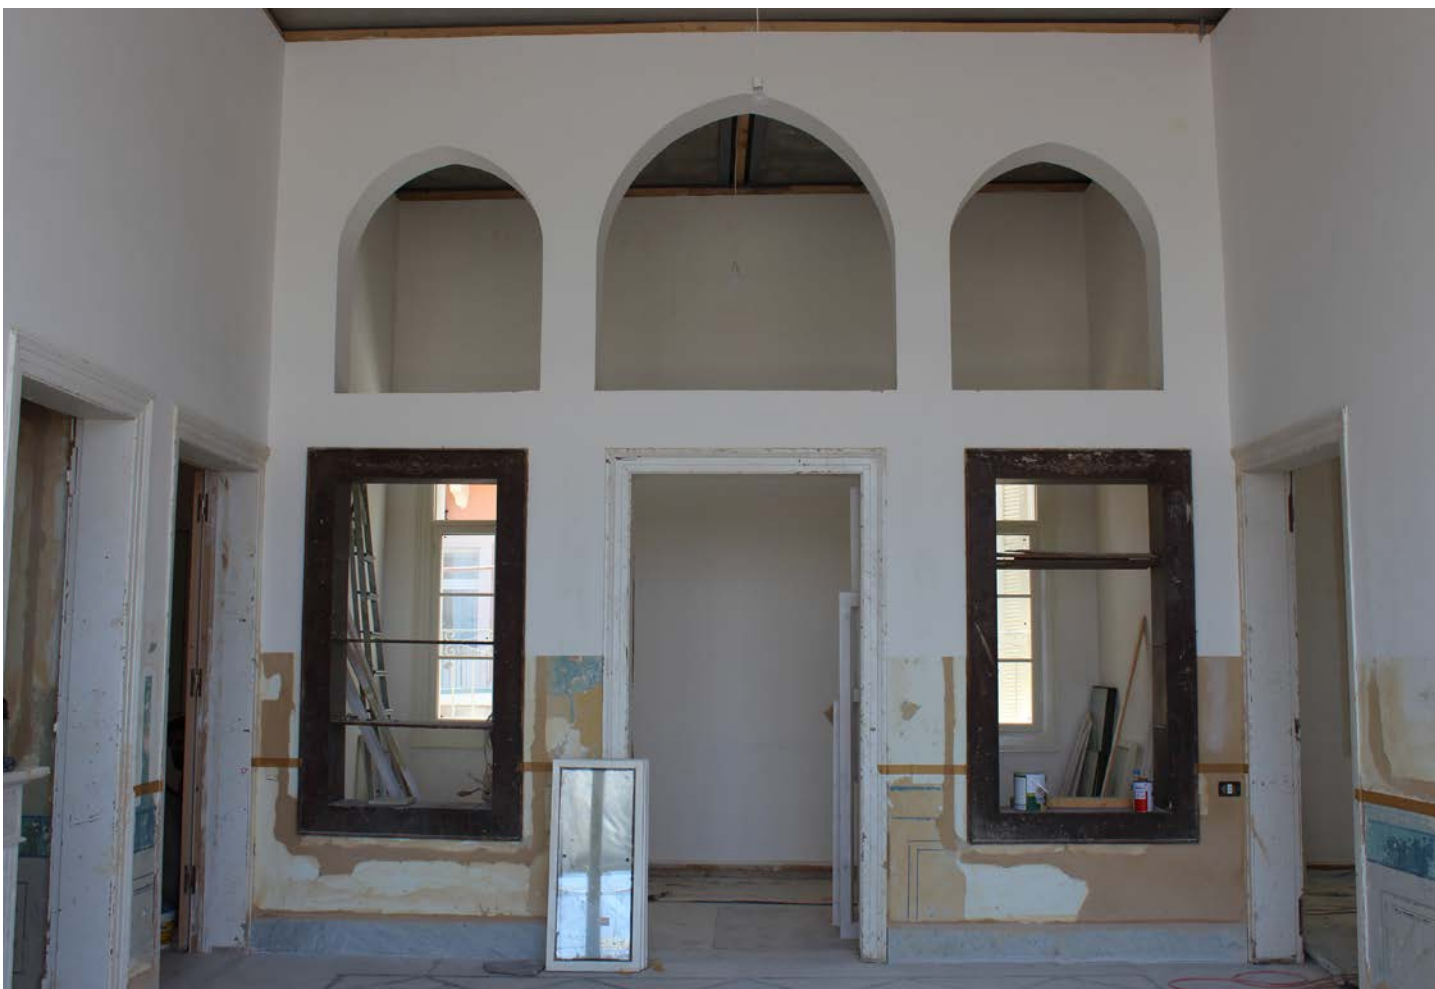
Murals were discovered in parts of the house during the assessment period, covered with a layer of cement plaster and paint. The original colors of the walls vary between light blue and dark blue, and have a stenciled design, consisting of a geometric pattern on the corners of the wall, connected by an outline. Unfortunately, with the existing cement blast and plaster, most of the paintings could not be saved. The team was able to save walls in the central hall on the first and second floors, which are now restored and preserved.

The historical wall paintings, J. Chalfoun
