**ARCHITECTURES OF BEIRUT, 1925-1970**  
Restoration Manual

## ARCHITECTURES OF BEIRUT, 1925-1970

### Restoration Manual

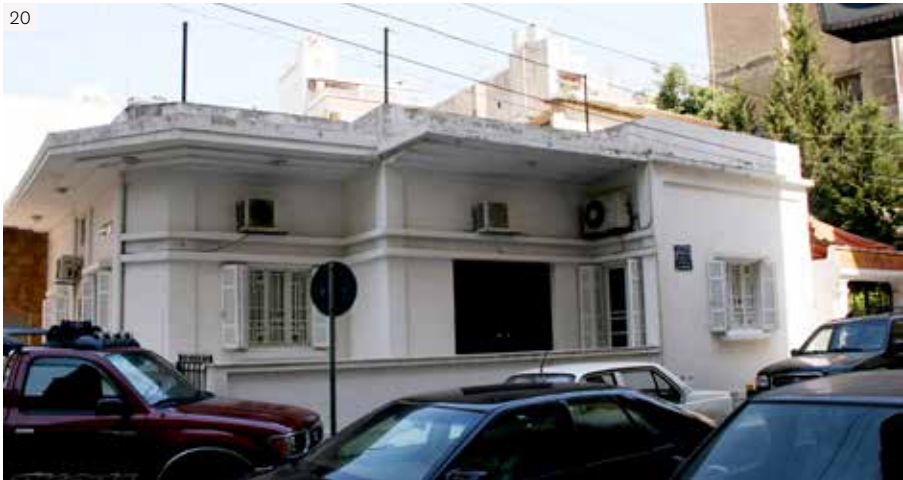
21

- Structural elements v/s Filling elements: many buildings from that period can be distinguished by the concrete structural grid (columns, beams, slabs) and the remaining masonry panels that close the grid cells. This is often driven by an effort to reduce the cost of construction whereby masonry walls are thinner than the structure, hence revealing it on the outer or inner skin of the building (20, 21, 22). Reinforced concrete is combined with prefabricated concrete blocks used as masonry.

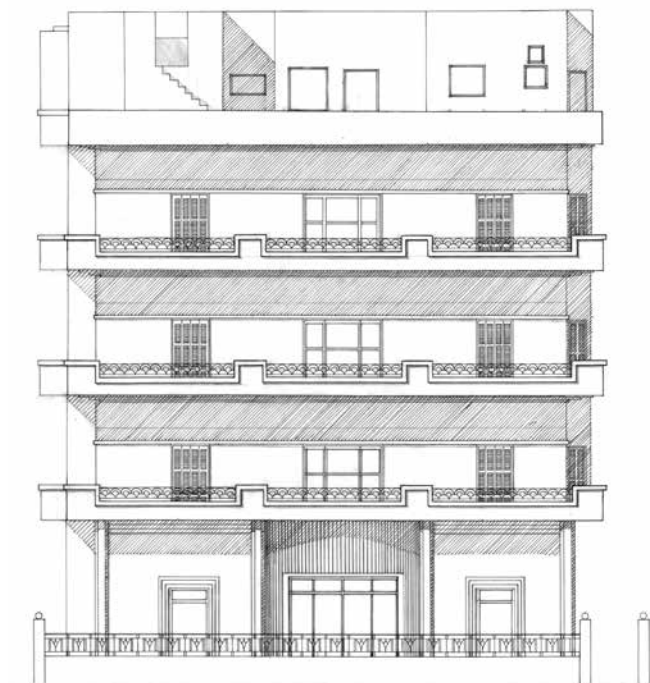
26

- Dimensions and thicknesses of slabs, columns, and beams, are moreare more tightly controlled in terms of technical performance and coherence to suit the architect's or engineer's design scheme. Structural elements like columns, beams, and slabs, constitute a skeleton that is complemented by a series of architectural elements giving to the building its desired character: The architect or engineer's design tools include blank or punctured walls, exposed columns, window frames or lintels, window shutters, balconies and balustrades, cornices, stairs, parapets, and so on (26, 27).

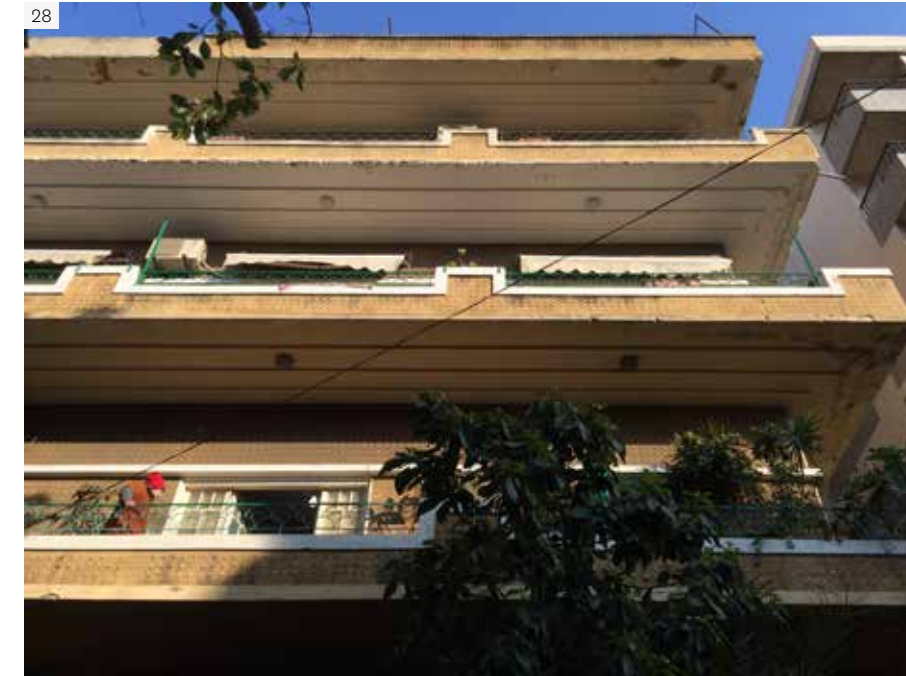
28

- The work of architects and engineers is paralleled with a wider spectrum of materials and more advanced execution means. During this period, we witness the extensive use of various plastering methods and textures allowing the architects and engineers to explore the builders skills and their ability to implement their ideas (Scratched plaster or *Kratz*, Tyrollean plaster, Float rendered plaster, etc.) (28).

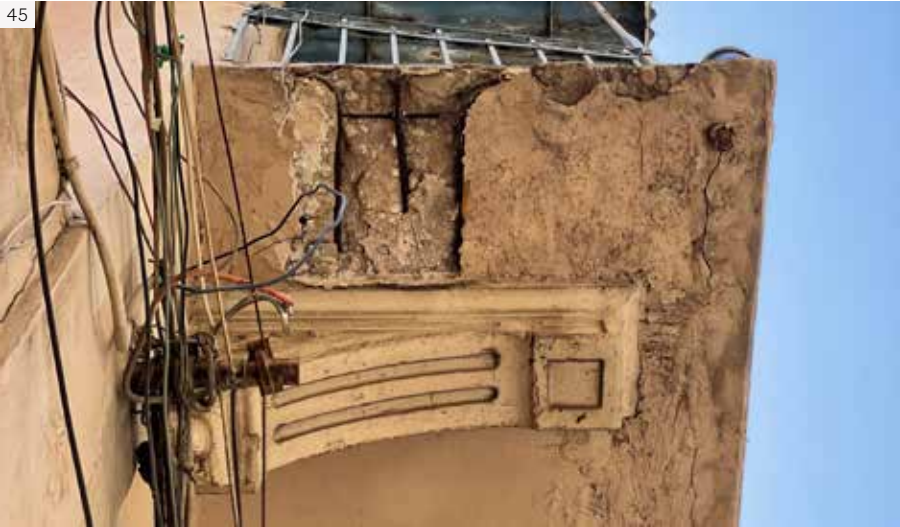
- Cause: meteorological and environmental conditions, due to unfavorable conditions such as rapid heating then cooling, wetting then drying, or erosion (45).
- Prevention: Ensure sufficient reinforcement allowing excellent tensile strength, use high-strength concrete, and a good protection system (finishing, waterproofing, etc.)

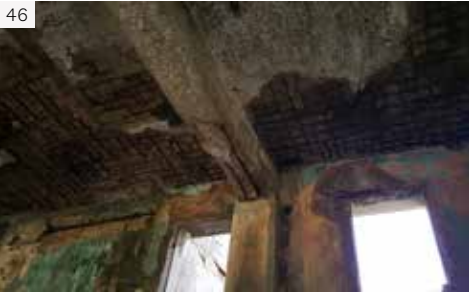
<div>Concrete Spalling</div> <div>Spalling is a term used to describe areas of concrete which have cracked and delaminated from the substrate. There are a number of reasons why spalling occurs including freeze thaw cycling, the expansive effects of Alkali Silica Reaction or exposure to fire. However, the most common cause of spalling is the corrosion of embedded steel reinforcement bars or steel sections.</div>	<div>46</div>

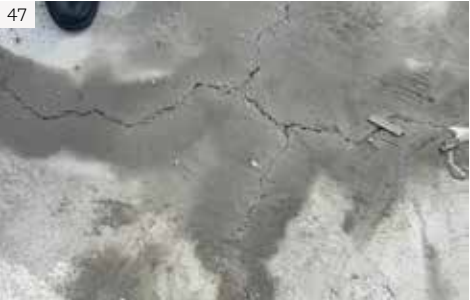
<div>Concrete Scaling</div> <div>Scaling is local flaking or peeling of a finished surface of hardened concrete as a result of exposure to freezing and thawing. Generally, it starts as localized small patches which later may merge and extend to expose large areas. It is recommended to use air entrained in the concrete mix to prevent the scaling effect.</div>	<div>47</div>

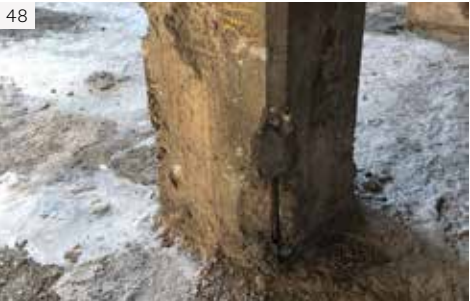
<div>Concrete Abrasion</div> <div>The concrete abrasion is the superficial de-bonding phenomenon of the concrete constituent.</div>	<div>48</div>

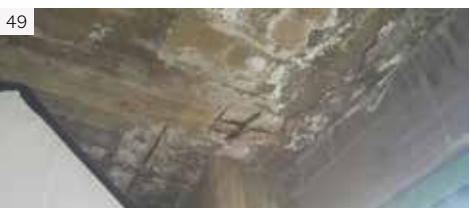
<div>Freeze-Thaw Effect</div> <div>Freeze-thaw weathering is an erosion process that occurs in cold areas where ice forms. When the temperature rises again, the ice melts and water fills the crack's newer sections. As the temperature drops, the water freezes again, and the ice expands, causing the crack to expand even more.</div>	<div>49</div>

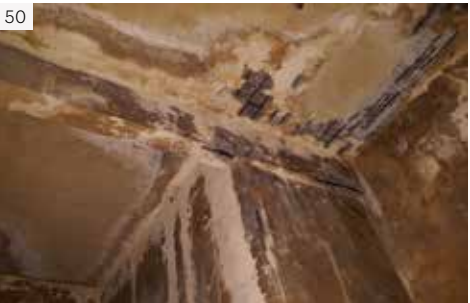
<div>Chemical attack</div> <div>Due to chemicals that attack the cement paste (organic or inorganic acids, acid solutions, sulfate, waste water, etc.).</div>	<div>50</div>

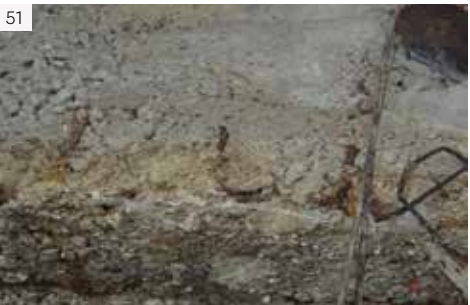
<div>Concrete disintegration</div> <div>Deterioration or decomposition of concrete into small fragments, most commonly caused by freeze-thaw, sulfate or charring.</div>	<div>51</div>

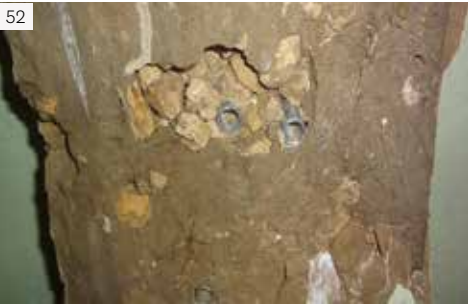
<div>Concrete delamination</div> <div>Separation of the paste layer on the surface, which creates a layer of concrete not bonded to the body of the slab. This problem develops with screeded concrete, usually in early spring and late fall with the placement of fresh concrete on a subgrade. The risk of concrete peeling increases when conditions for rapid surface drying, such as low humidity, sun and wind, are present. In effect, the surface looks ready for smoothing when in fact the concrete underneath is still like plastic.</div>	<div>52</div>

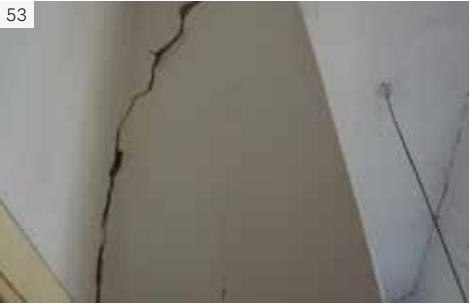
<p><b>Structural cracking</b></p> <p>Affects the integrity of the structure. It is important to assess these cracks. If they are stable, epoxy injection can restore the structural capacity. If the cracks increase, reinforcement may be necessary.</p>	<p>53</p>

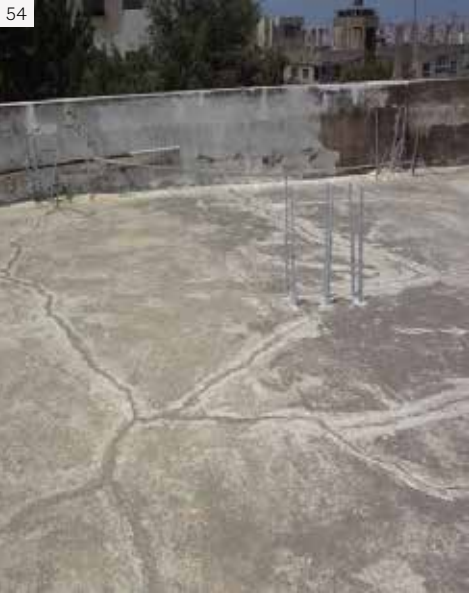
<p><b>Drying shrinkage cracking</b></p> <p>Typically, it is not a structural issue. As concrete dries, it loses volume and shrinks, which can cause cracking.</p>	<p>54</p>

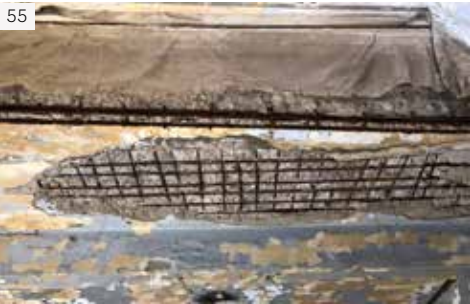
<p><b>Corrosion</b></p> <p>The corrosion of reinforcing steel and embedded metals is likely the single largest reason that concrete needs repair. Expanding rust causes cracks. Over time, corrosion products build up and cause larger cracks until the concrete pulls away from the bar. Corrosion is due to external sources, deicing salts or coastal locations (salt spray).</p>	<p>55</p>

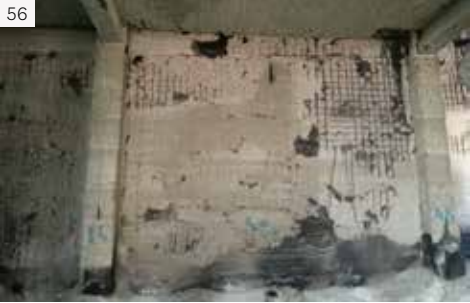
<p><b>Fire induced structural damage</b></p> <p>Peeling of surfaces due to extreme heat (fire). Moisture quickly turns to steam, causing localized spalling of small pieces of concrete. As the temperature increases, concrete experiences cracking, spalling and a decrease in stiffness and strength.</p>	<p>56</p>

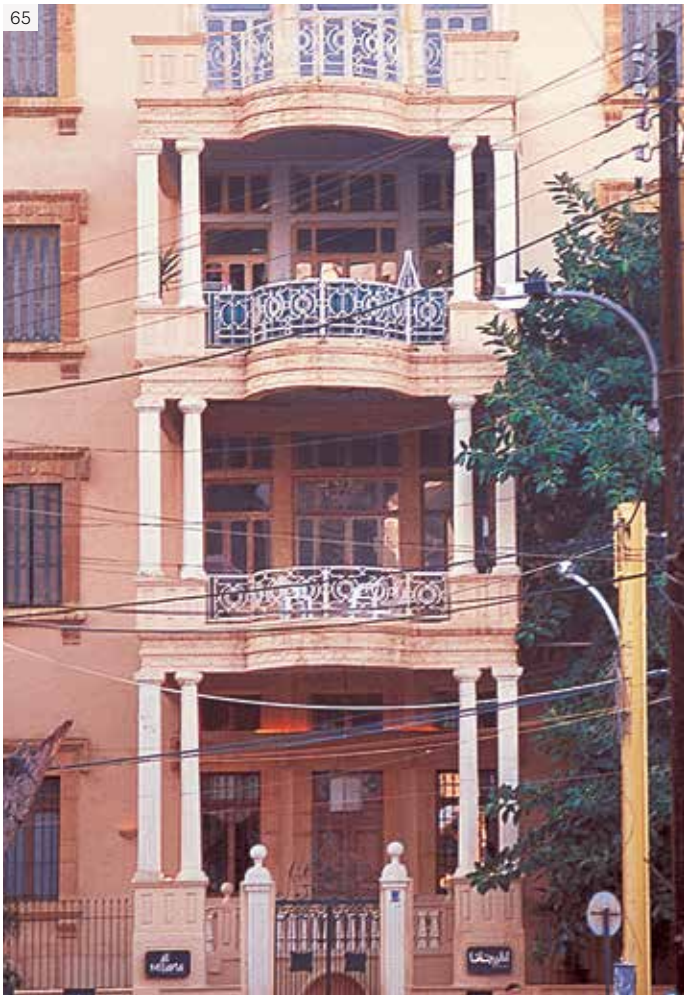
65

**1. The columns:** They usually adorn the porches and wide verandas (rectangular or semi-circular) of houses and buildings of the interwar period. The circular or square section shafts, 25 to 30 cm wide, rise above a square section pedestal at railing height (62, 63). They are either smooth or fluted and end with a capital that carries a fall beam that serves as an entablature (64). Initially, these columns were primarily Moorish (*mukarnas*) or semi-classical (simplified Corinthian, Ionic, etc.) in style. From 1930, however, their shape was adapted to the Art-Deco style; the profiles were simplified and characterized by their geometric shapes. The concrete was usually covered with a light whitewash (yellow, white, or pink) but was sometimes left raw, smooth, and with exposed gravel (65, 66, 67).

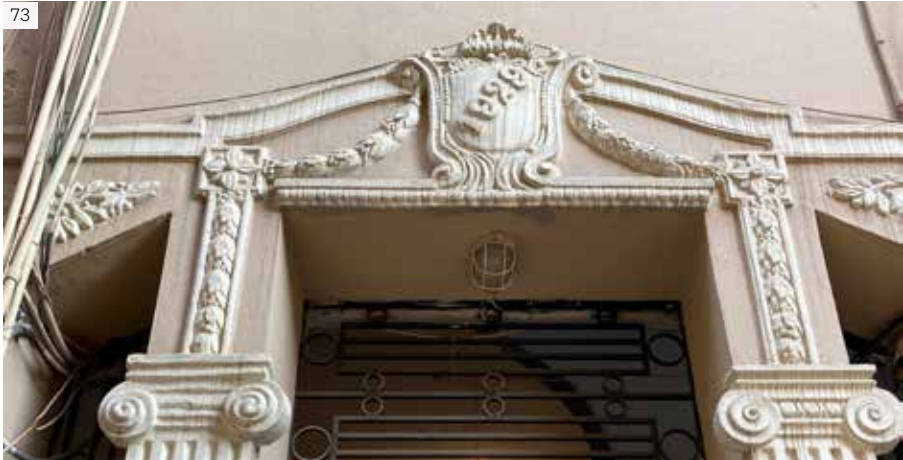
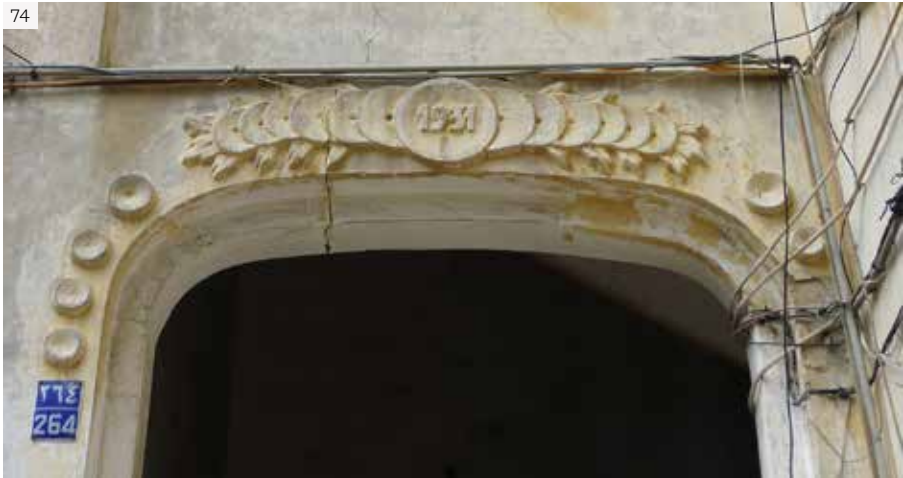
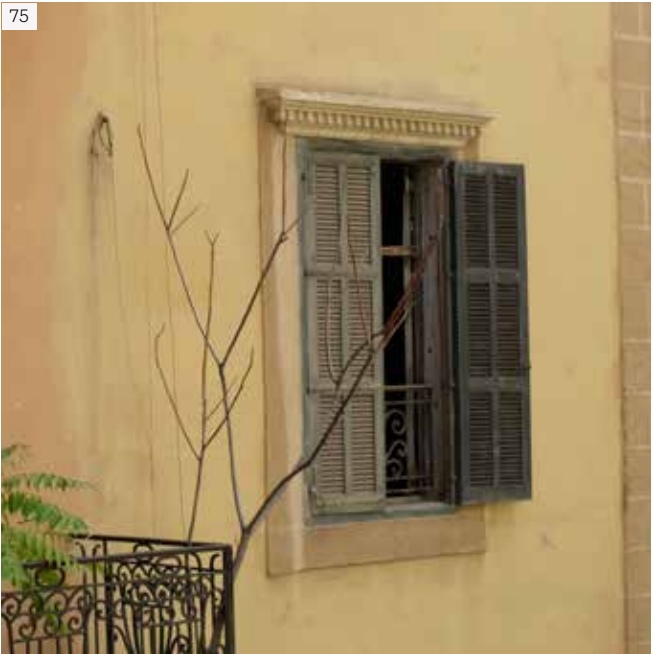
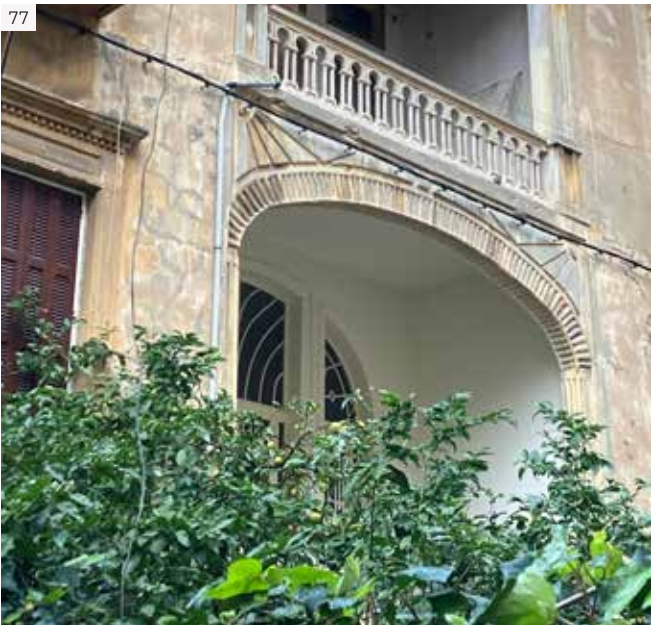
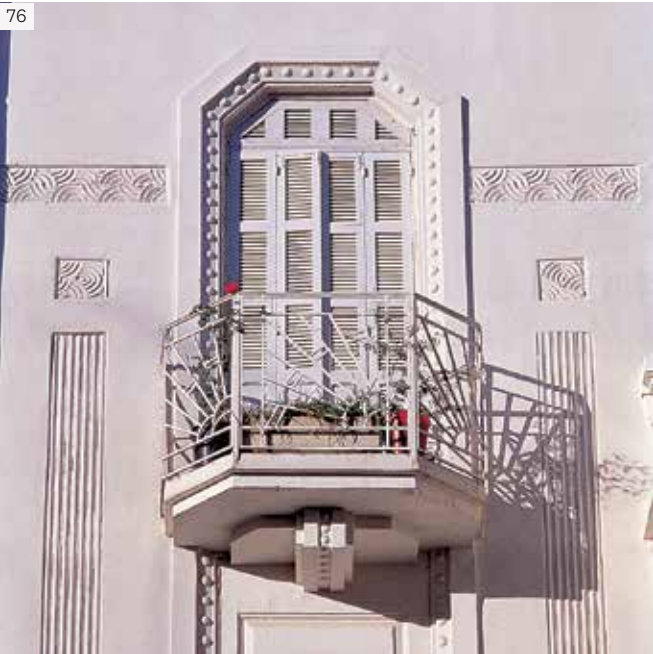
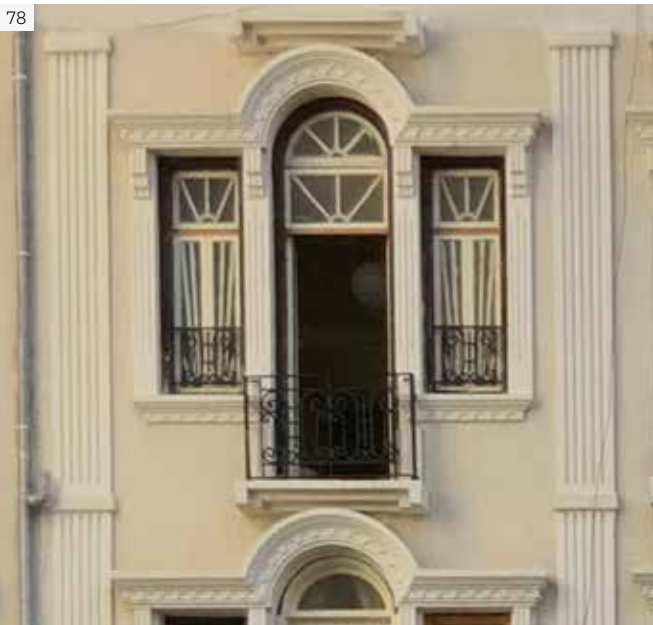
4. The consoles: The protruding balconies of the facade are placed on reinforced concrete brackets with either a simple inverted staircase design or an elaborate imitation of classic or Art-Deco profiles (79, 80, 81, 82, 83).

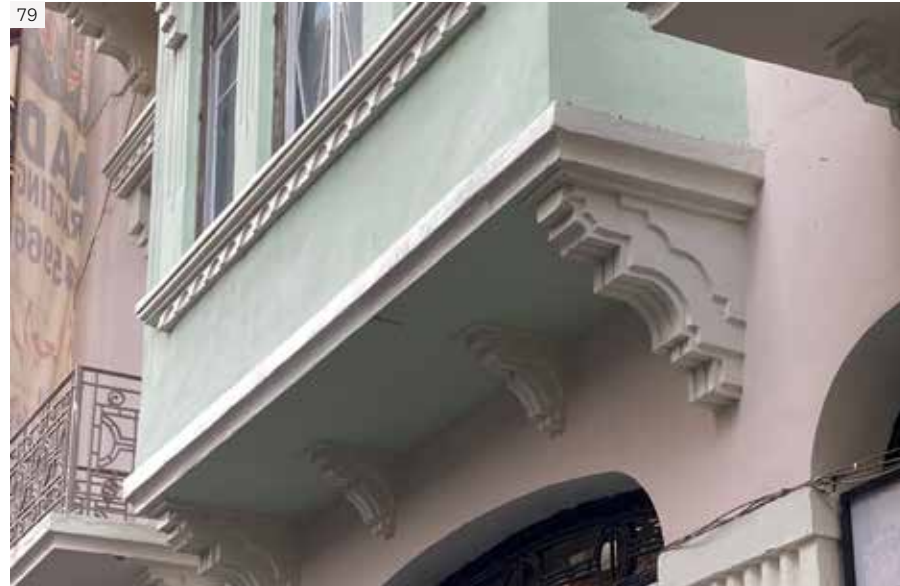
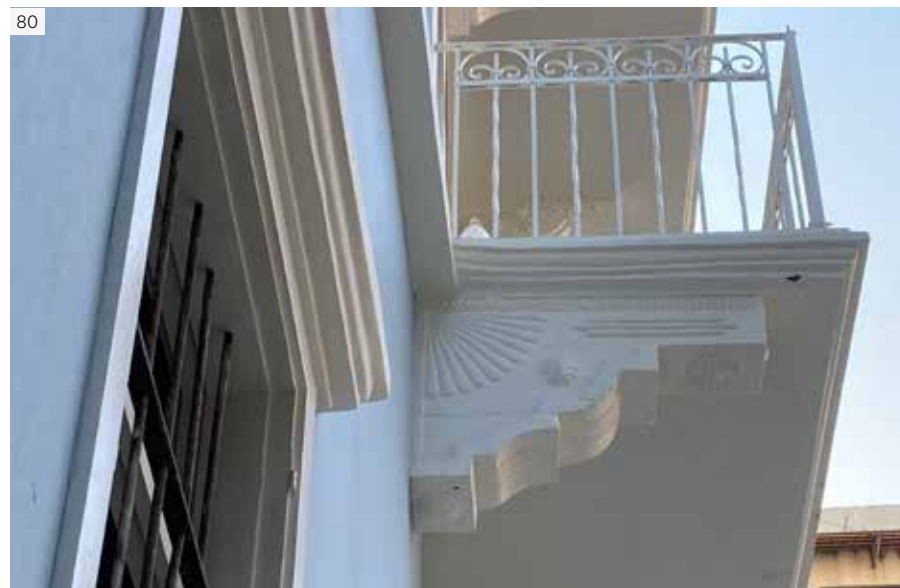
5. **Cantilevered awnings and balconies:** first introduced around 1930, when the first generations of engineers began to master the capabilities of reinforced concrete. A stepped soffit is created by these protruding elements (84, 85). Based on the optimal structural calculation of the bending moment, the section of the protruding reinforced concrete floor is refined as it advances.

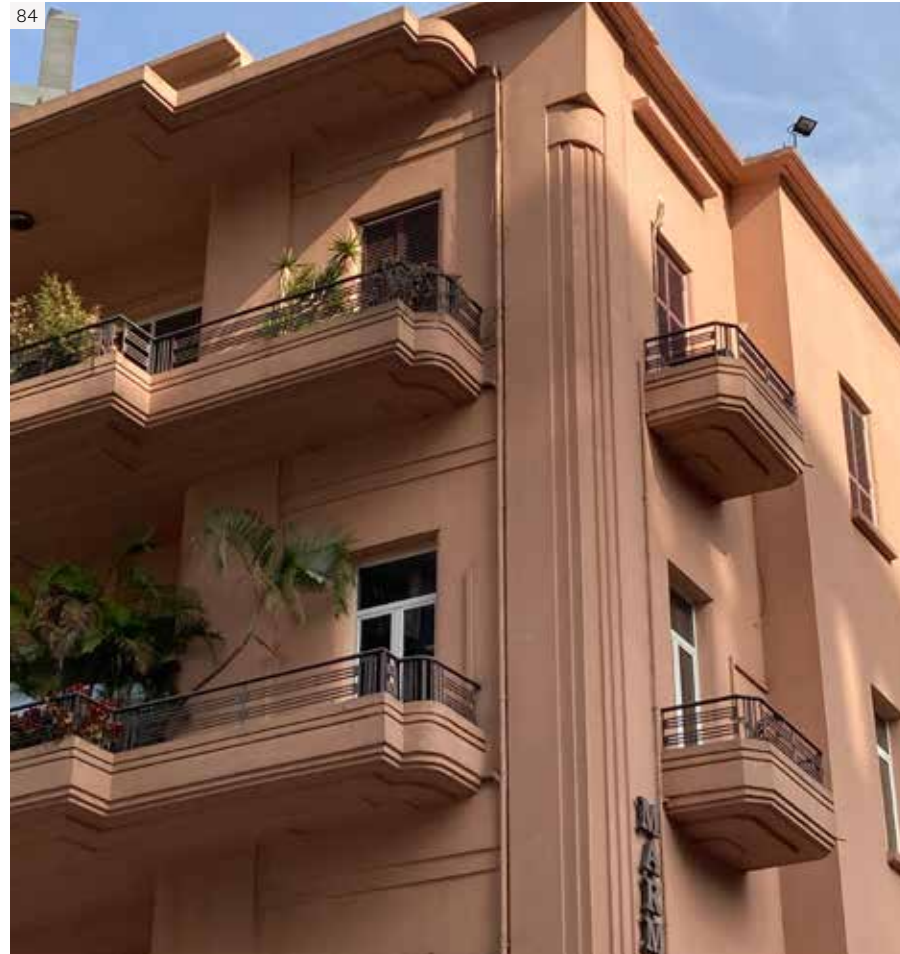
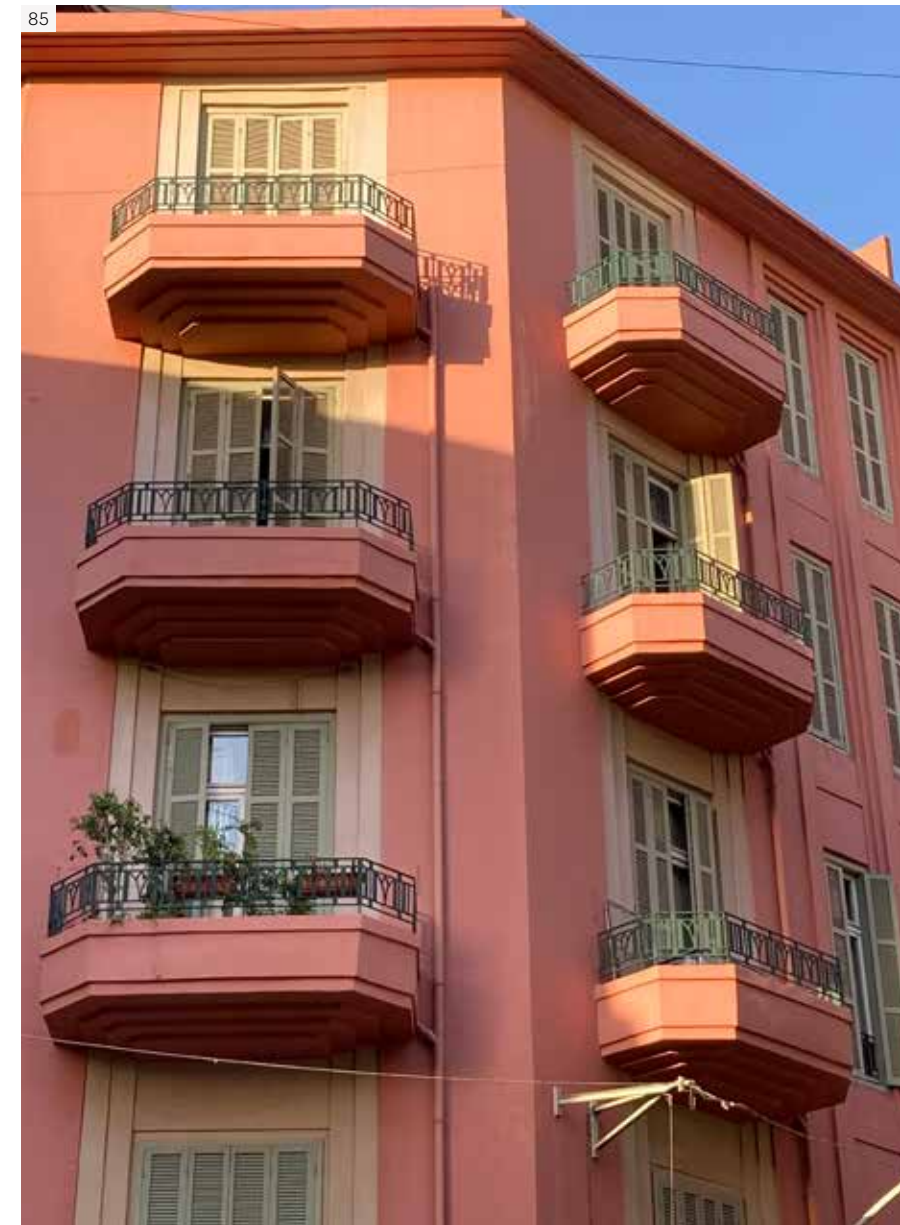
These Bauhaus-inspired elements frequently have rounded shapes. The balconies are finished with parapets made of hollow and plastered bricks or wrought iron railings (86, 87, 88).

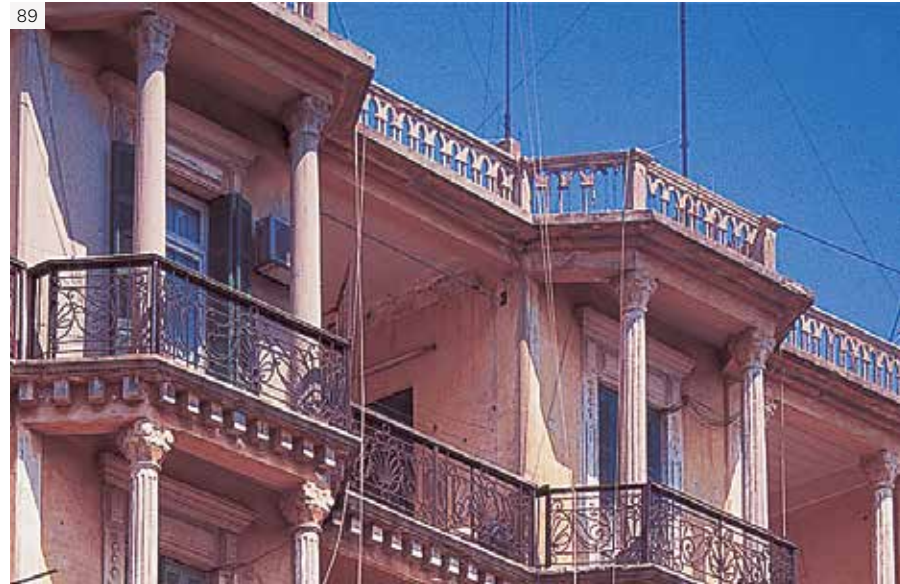
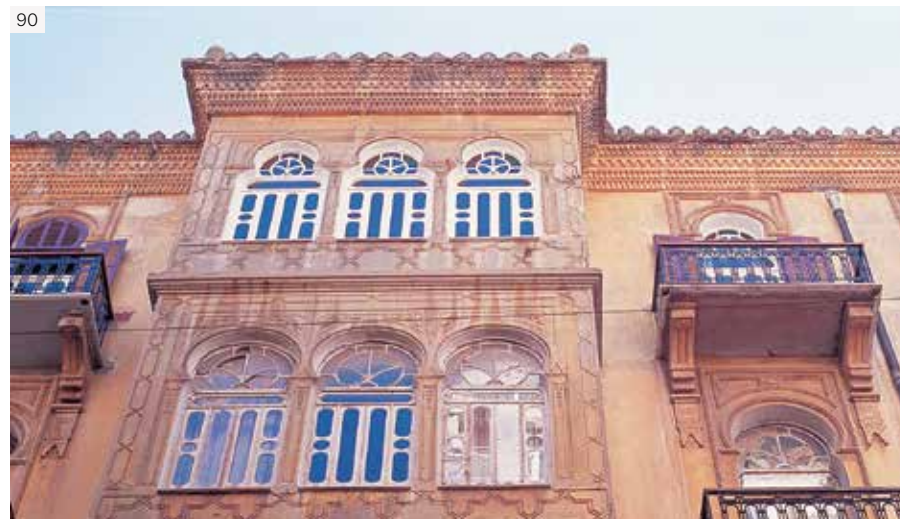
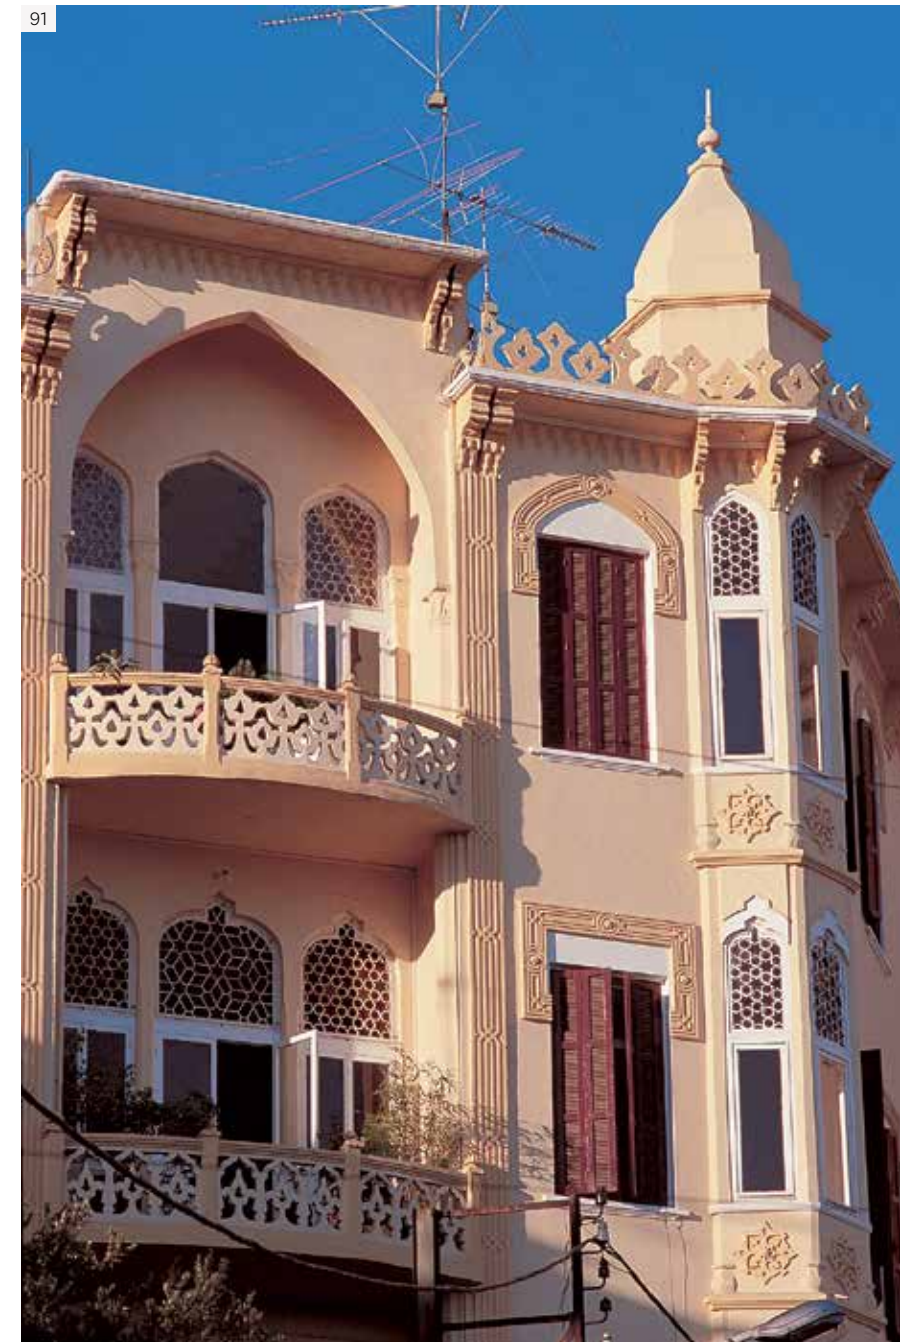
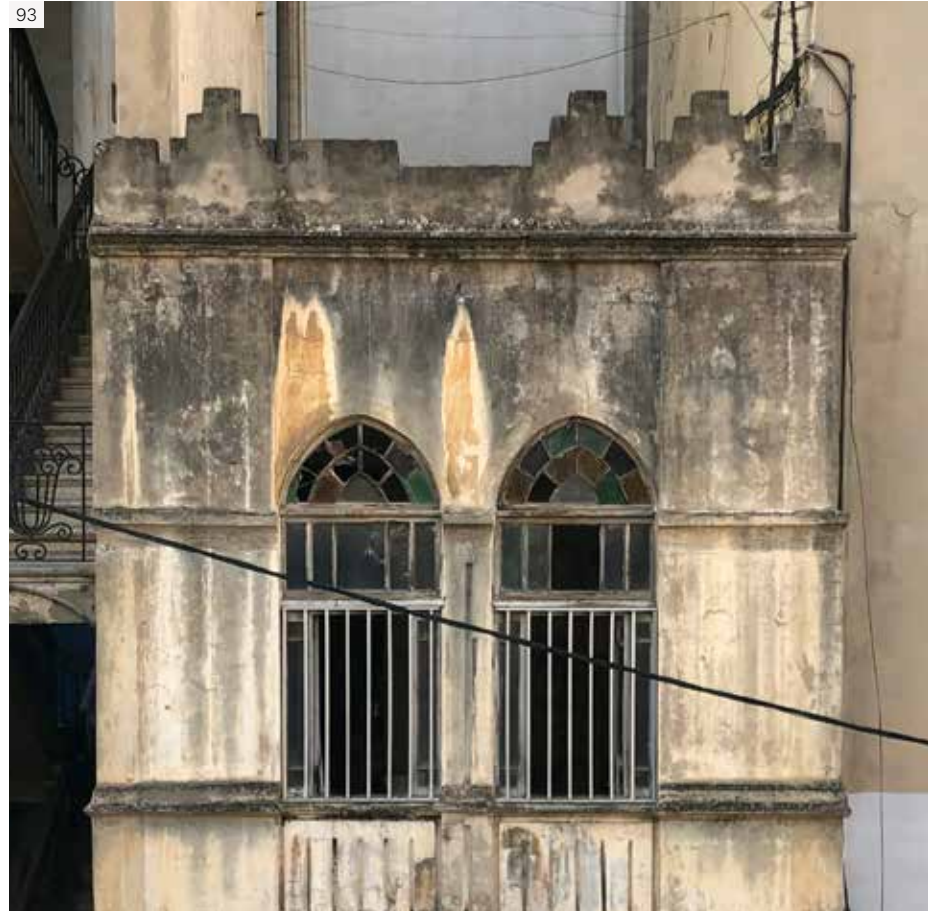
6. The crowning: parapets and cornices: These elements are located at the top of the building, above the parapet or crowning cornices of the roof, and they stand out against the sky (89, 90). They cap the vertical lines drawn by the columns or the corner pilasters and emphasize the vertical dominance of the composition (91). The vocabulary of acroteria includes vases, palmette or stepped motifs (92, 93).

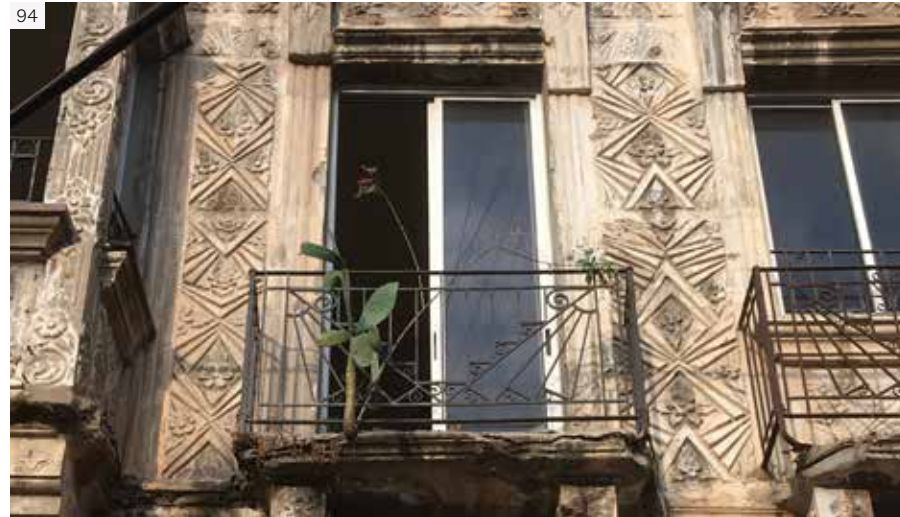
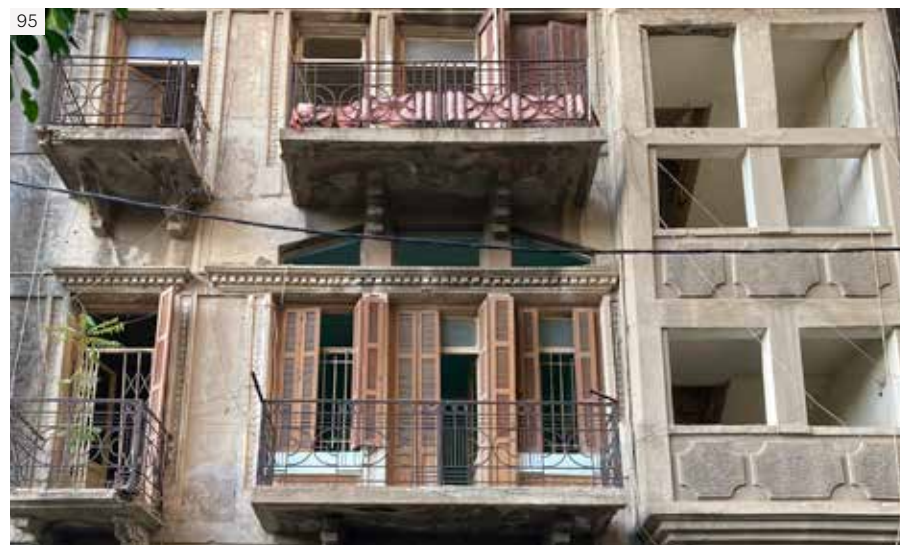
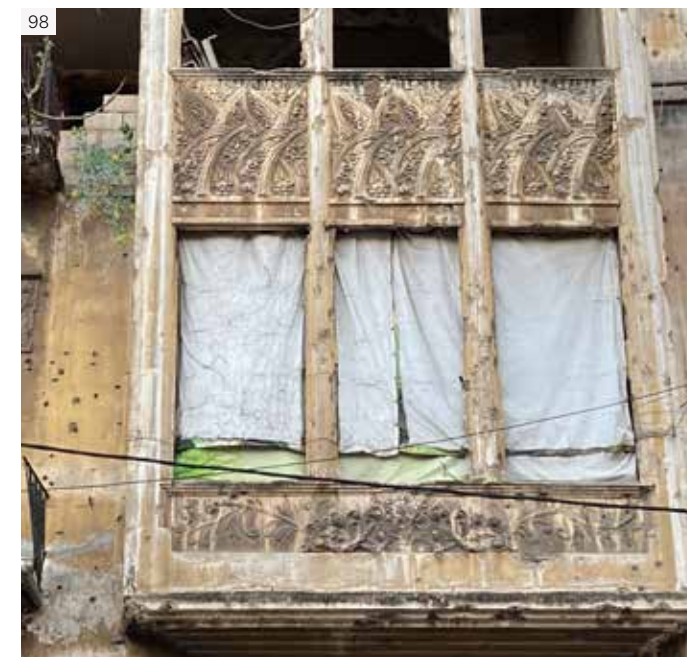
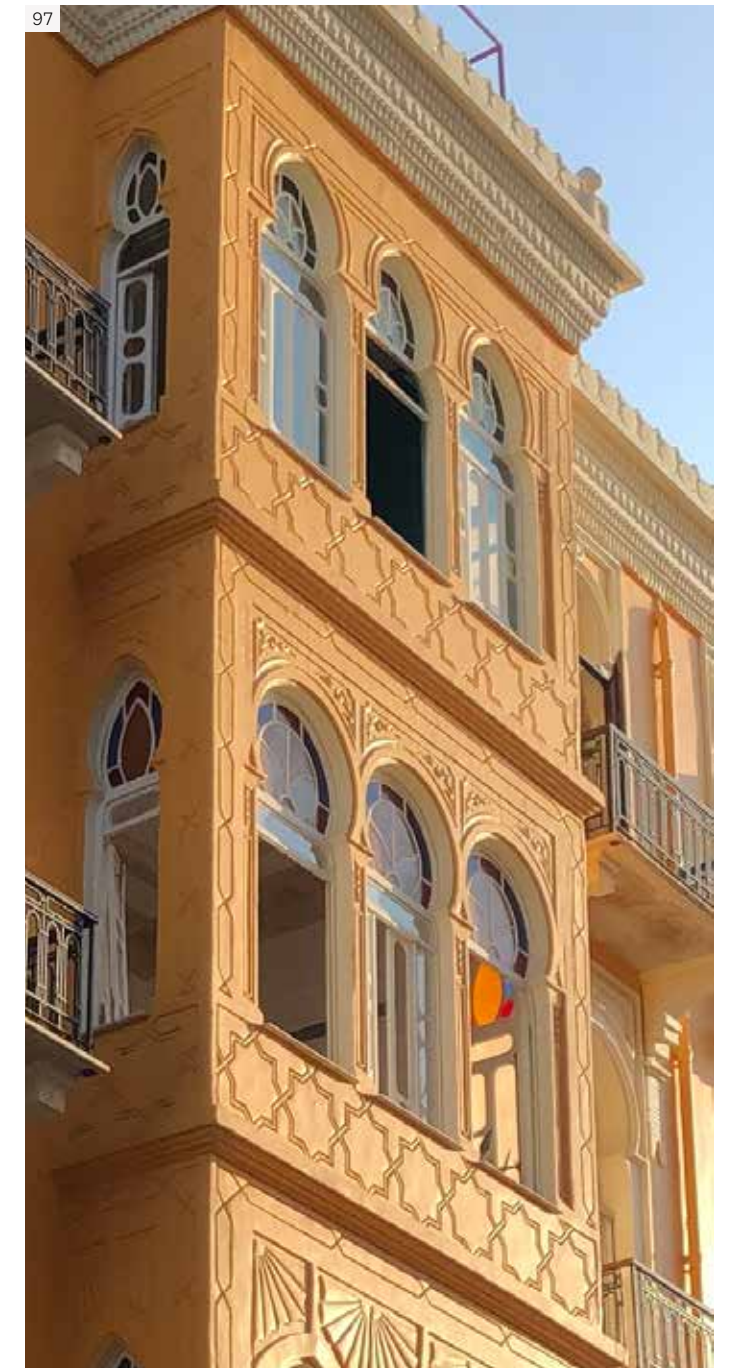
**7. The decorative panels:** These molded elements adorn the intermediate spaces located between the lines that structure the façade (pilasters, frames, and slab noses). They are embedded in the masonry during construction. They are rectangular or square (94, 95) in shape. The motifs are composed of vegetal forms (bouquets, sheaves...) or geometric Art-Deco designs (radiating lines, interlacing...) (96, 97, 98). They are sometimes developed and extended to the point where molded geometric labyrinthine patterns completely cover the façades. This ornamental model creates subtle shadow lines that animate the façade

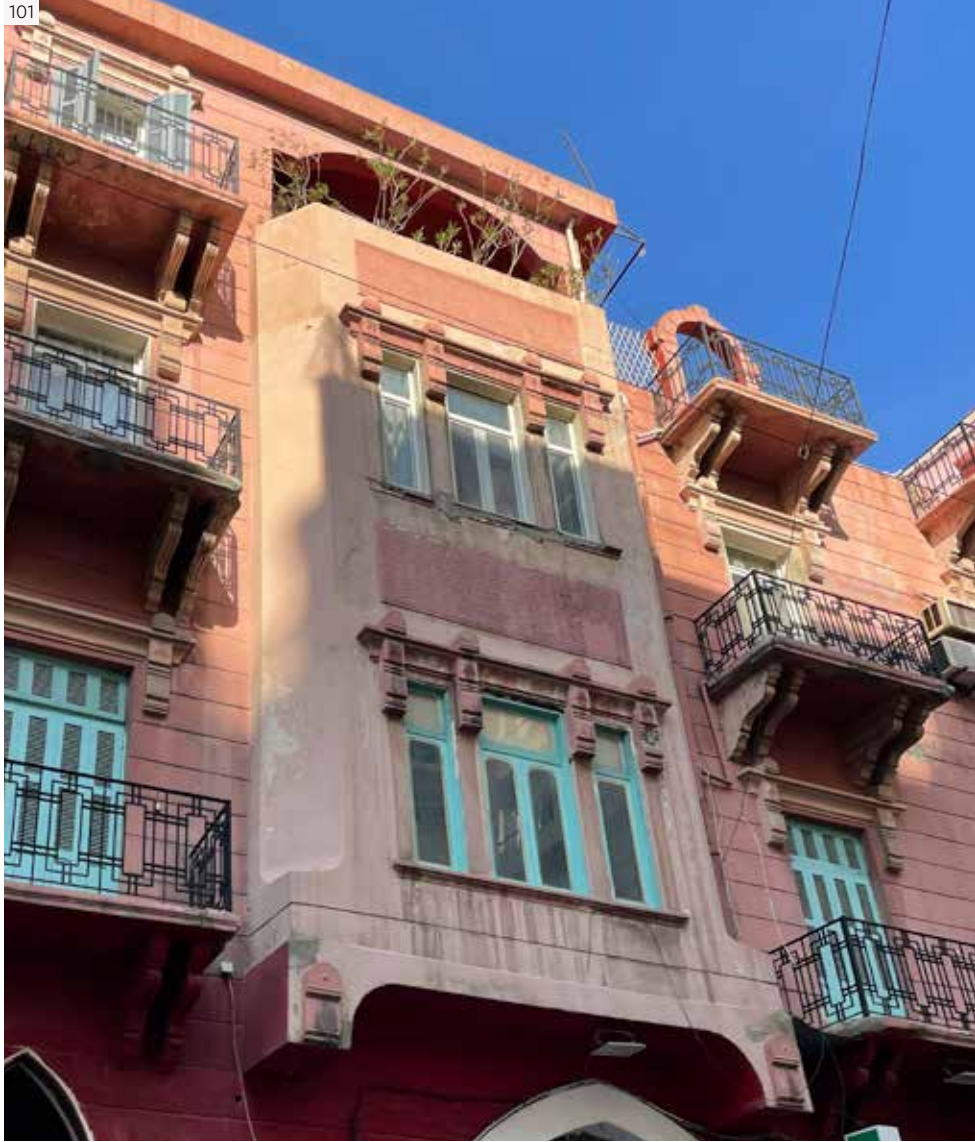
101

8. The bay window or protruding kiosks: between 1925 and 1935, buildings frequently featured protruding pieces projecting from the street façade: staircase landings or projections from the central hall were expressed as corbelled pieces placed on consoles in molded reinforced concrete (99, 100). Their facade has ornaments molded into the surface of the concrete; it is divided into two or three bays by square section columns, with a molded panel in the lower part, wood-framed windows in the center, and an upper decorated transom (101). These architectural elements are similar to advanced oriental kiosks, and they often have thin side openings facing each other to benefit from cross ventilation and visual perspectives on the street (102).

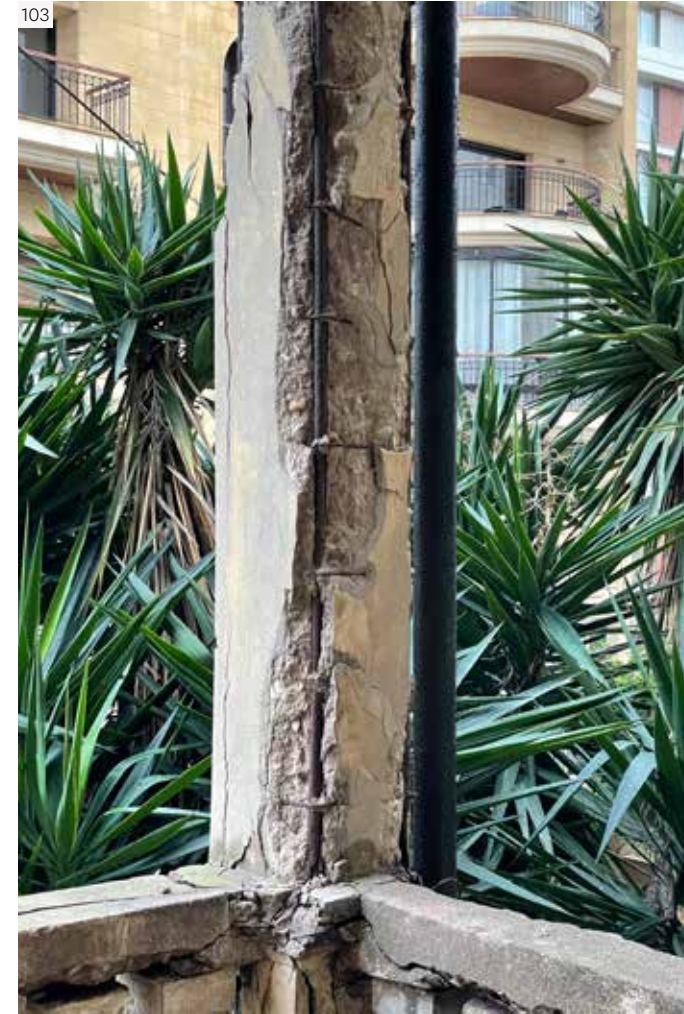
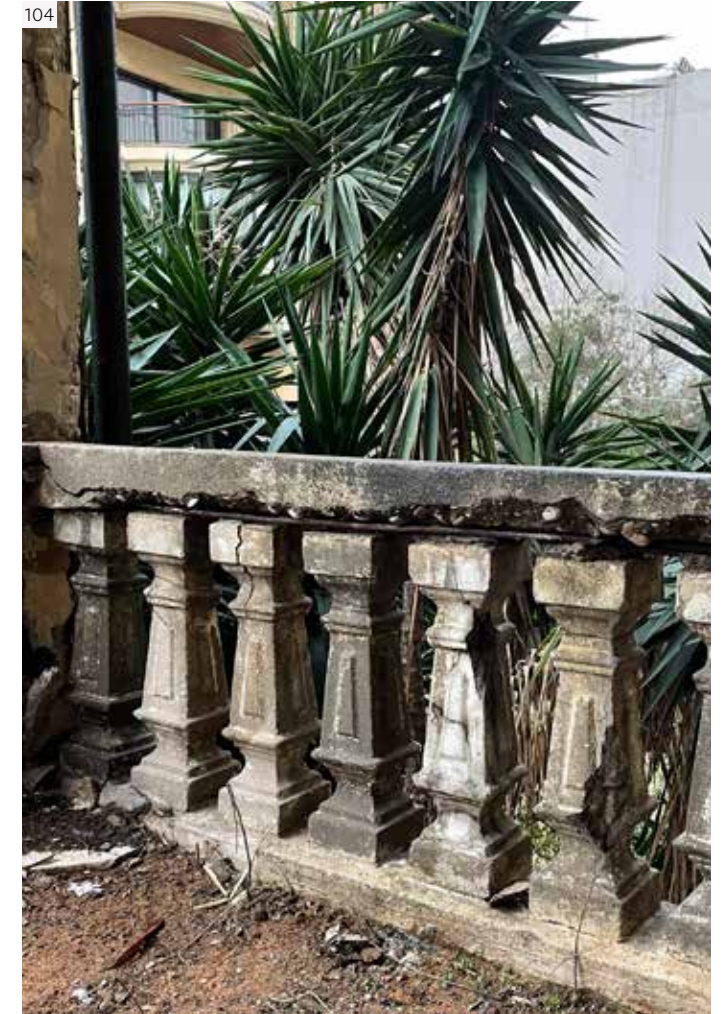
**1. Corrosion of steel reinforcements:** This is the most common and serious. Indeed, concrete is not a waterproof material, especially when it was poured in an artisanal way and without a sealing aid (unavailable at the time). As a result, reinforcing steels are subjected to corrosion, which results in swelling and wear of their section and causes cracking of the concrete coating. This pathology particularly affects the protruding moldings (nose of slabs, consoles) and the elements of railings whose coating is the least thick (103, 104).

The type of treatment adopted will depend on the extent of the damage observed. Minor damage may be repaired with a coating or a finishing cement without shrink (non-shrink grout) after inspection and brushing of the reinforcements, eradication of rust, and protection of steels (see pages 58-61).

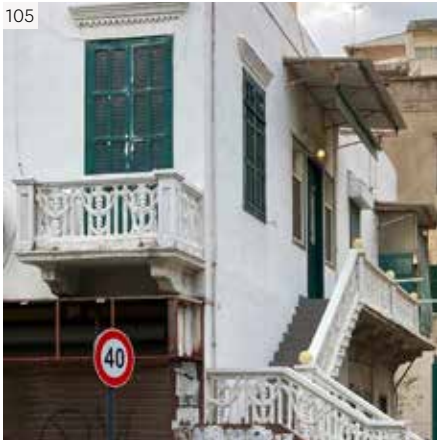
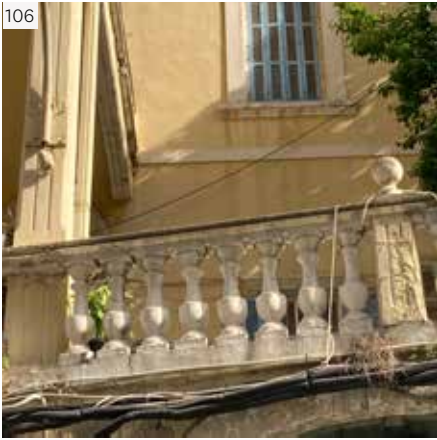
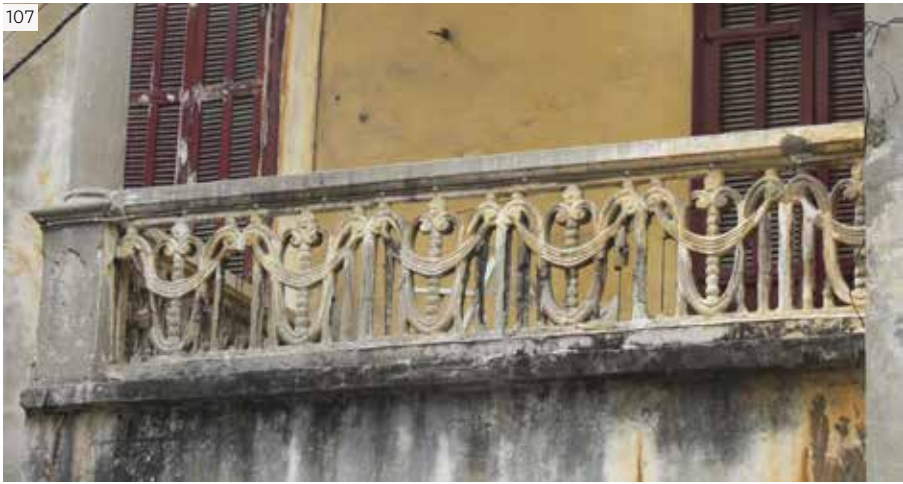
The first use of cement in residential buildings railings dates back to the 1920s, when this material was introduced in Lebanon. Beirut’s development of self-supporting verandas introduced a fairly diverse formal register into the construction of these works. Railings with square or pear-shaped balusters are among the most basic (106). In other cases, the handrail may be supported by larger elements of various shapes, such as the archaic zither seen in many buildings. The material’s flexibility allows for ornamental exploration that can go beyond traditional forms by using local motifs such as the cedar of Lebanon or complex systems that group together different representations within the same structure (105, 107, 108). In the mid-1930s, the last railings installed had a geometric composition inspired by the Art-Deco movement, similar to the wrought iron production (109).

These structures, which are molded in metal or wood formwork, have a smooth steel reinforcement in the form of round bars. The precision and skill of the master craftsman are generally reflected in the quality of the intricate pattern execution. Some railings are made with special care in the raised parts, where any trace of the formwork is minimized, if not invisible. Concrete railings can also be distinguished qualitatively by the grain size of the mortar used. The finer it is, the better its adhesion to the reinforcement. Because it does not contain large gravel, this type of recipe ensures a more precise definition of the most elaborate decorative elements.
