**ARCHITECTURES OF BEIRUT, 1925-1970**  
Restoration Manual

## ARCHITECTURES OF BEIRUT, 1925-1970

### Restoration Manual

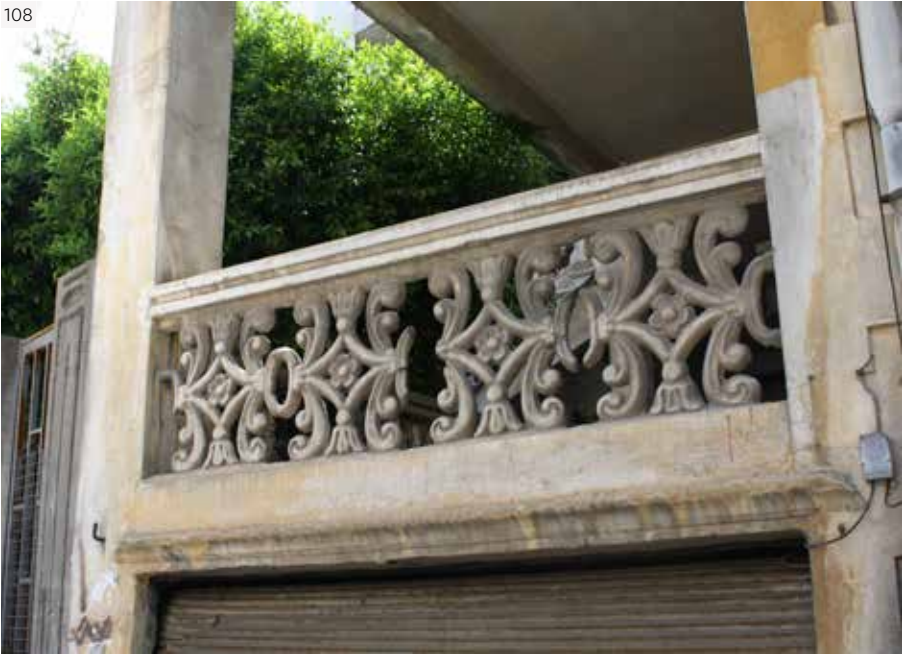
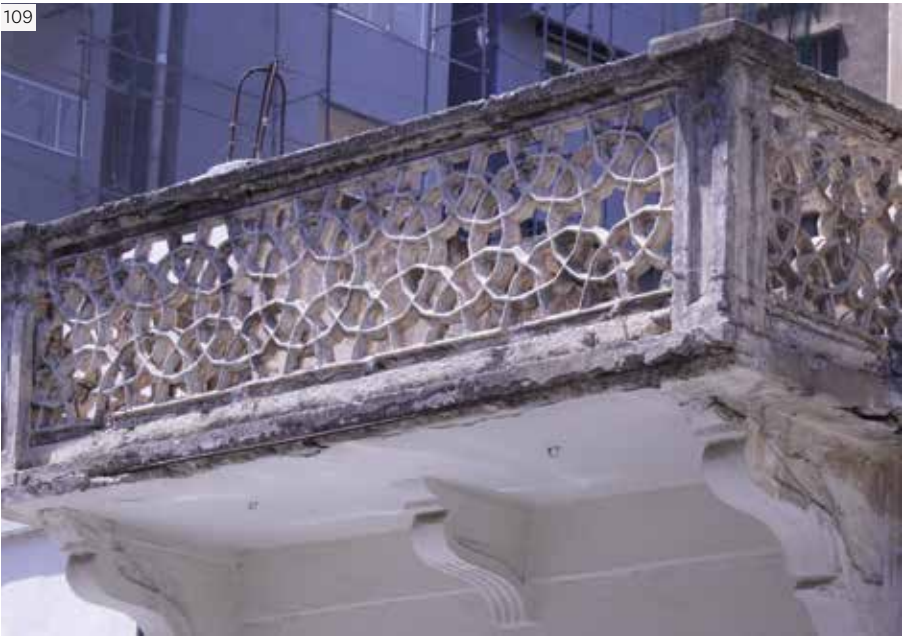
The first use of cement in residential buildings railings dates back to the 1920s, when this material was introduced in Lebanon. Beirut’s development of self-supporting verandas introduced a fairly diverse formal register into the construction of these works. Railings with square or pear-shaped balusters are among the most basic (106). In other cases, the handrail may be supported by larger elements of various shapes, such as the archaic zither seen in many buildings. The material’s flexibility allows for ornamental exploration that can go beyond traditional forms by using local motifs such as the cedar of Lebanon or complex systems that group together different representations within the same structure (105, 107, 108). In the mid-1930s, the last railings installed had a geometric composition inspired by the Art-Deco movement, similar to the wrought iron production (109).

These structures, which are molded in metal or wood formwork, have a smooth steel reinforcement in the form of round bars. The precision and skill of the master craftsman are generally reflected in the quality of the intricate pattern execution. Some railings are made with special care in the raised parts, where any trace of the formwork is minimized, if not invisible. Concrete railings can also be distinguished qualitatively by the grain size of the mortar used. The finer it is, the better its adhesion to the reinforcement. Because it does not contain large gravel, this type of recipe ensures a more precise definition of the most elaborate decorative elements.

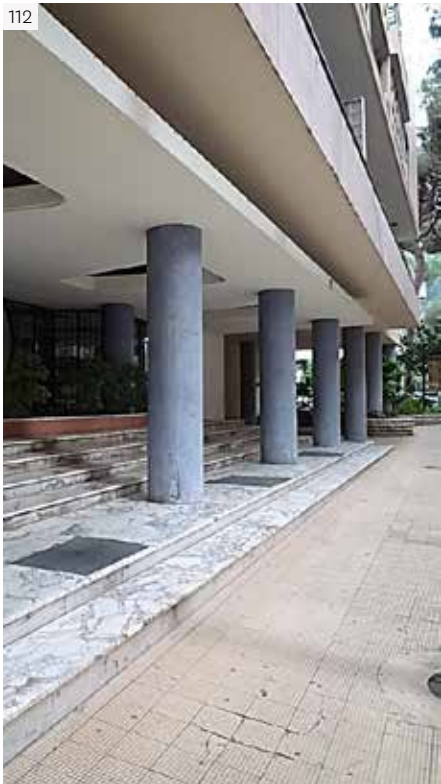
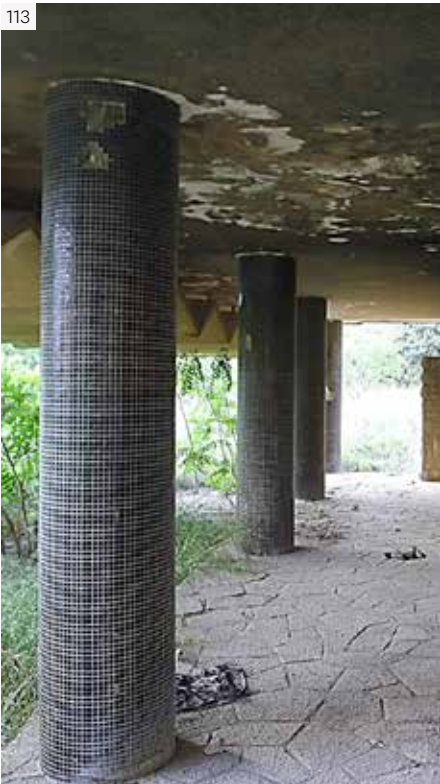
These reinforced concrete elements, which are circular in shape, are covered with a smooth or rough coating, terrazzo, or molten glass mosaic tiles (114, 115). The pilotis are part of the building's supporting structure and are transformed into rectangular-section pillars on the upper floors.

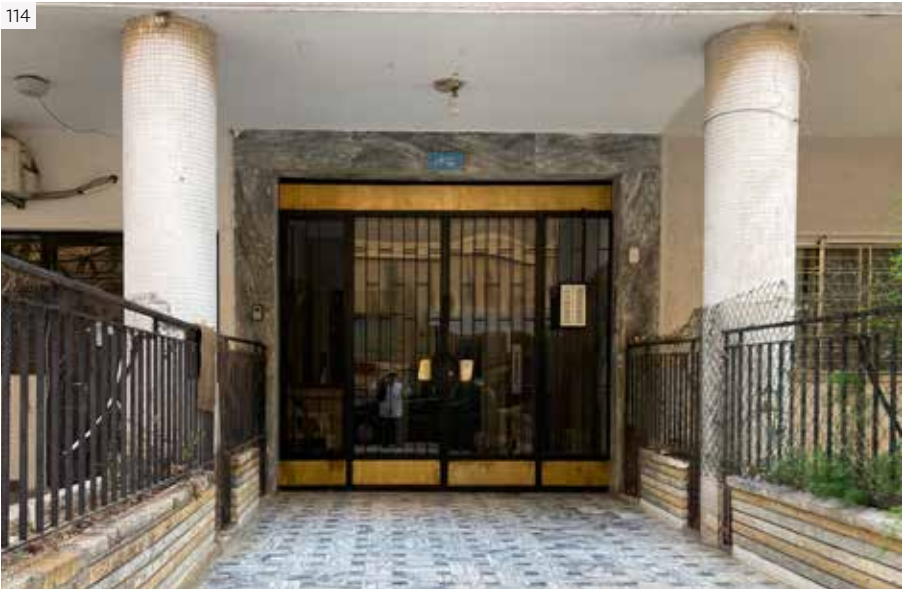
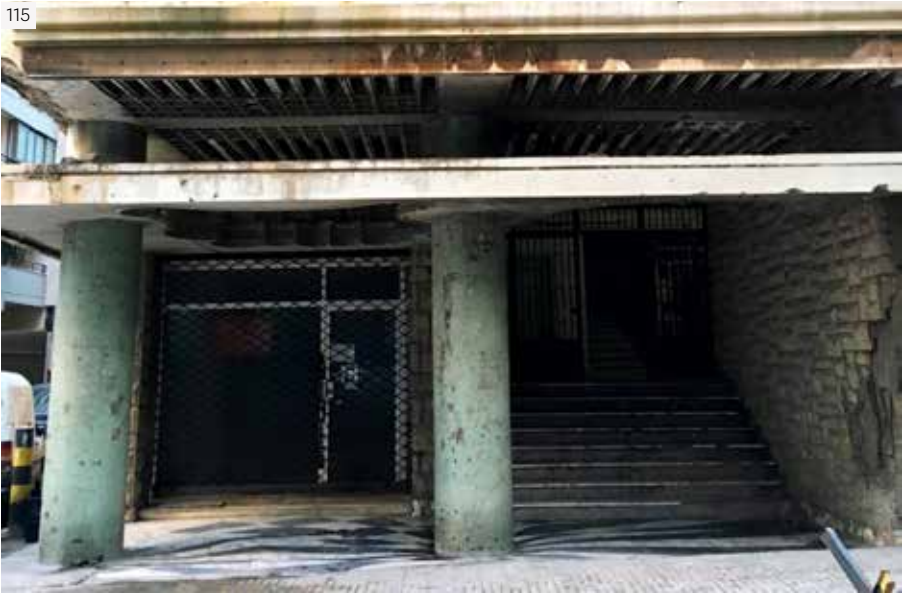
The canopies (*Rifraf*), or awnings, are elements that are cantilevered or supported by columns and form a shelter on the ground floor before the entrance door (116, 117). These structures, like the Pilotis, define the intermediate space between the public (sidewalks and streets) and the private (entrance hall).

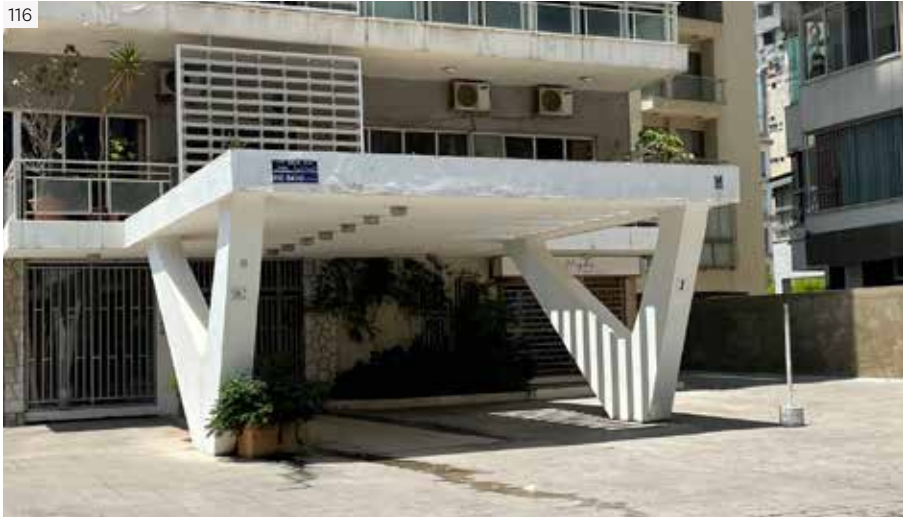
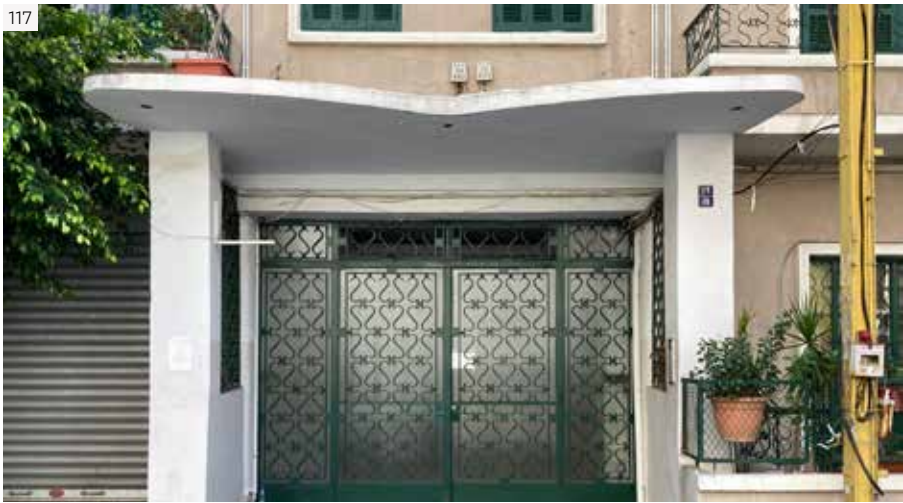
The pillars that support the canopies can be thin in section, allowing the canopy to have a floating effect (118, 119), or thick in concrete, integrating into the entrance (120). These pillars are not part of the building's supporting structure, and their purpose is to support the canopy that welcomes residents and visitors. The canopy slab frequently slips beneath the first-floor slab.

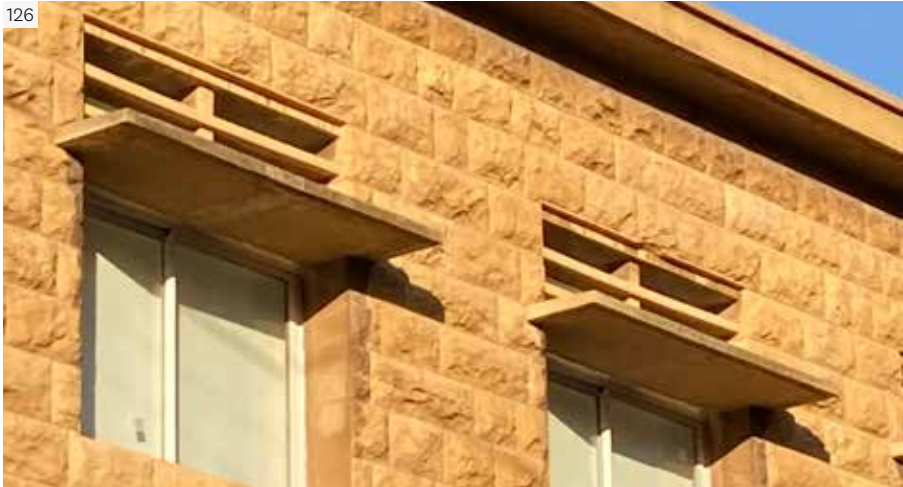
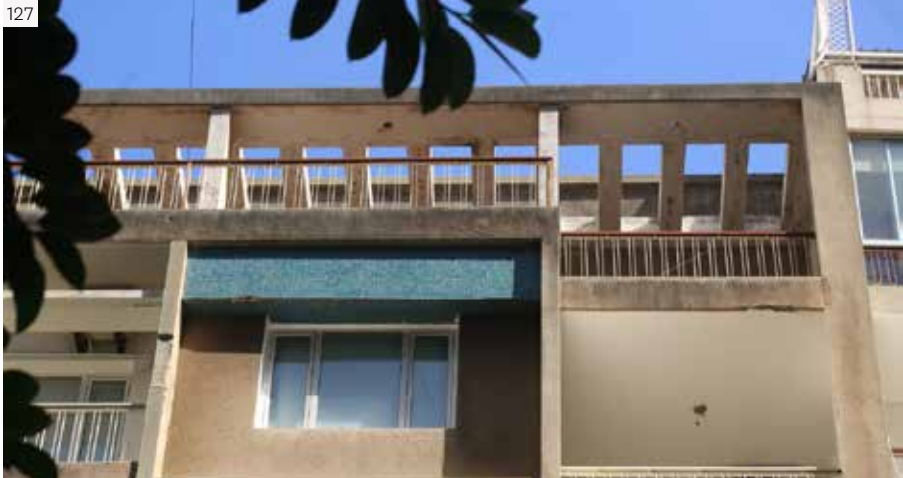
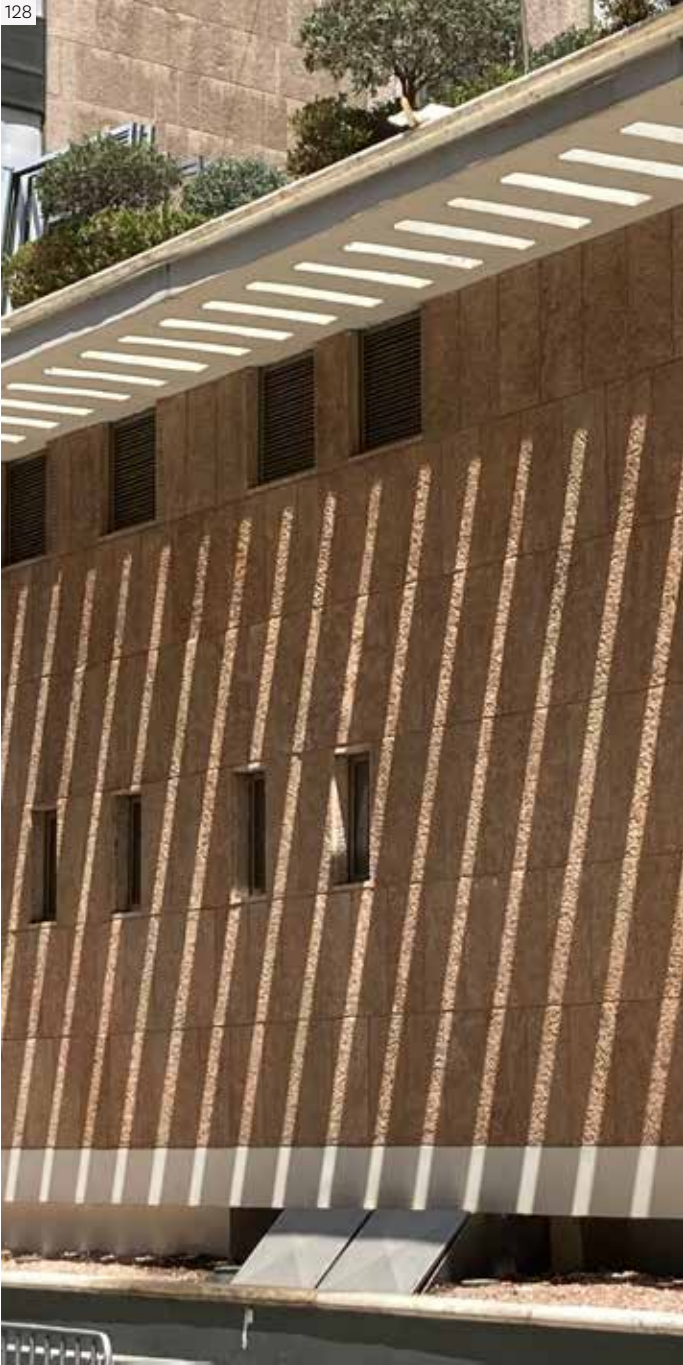
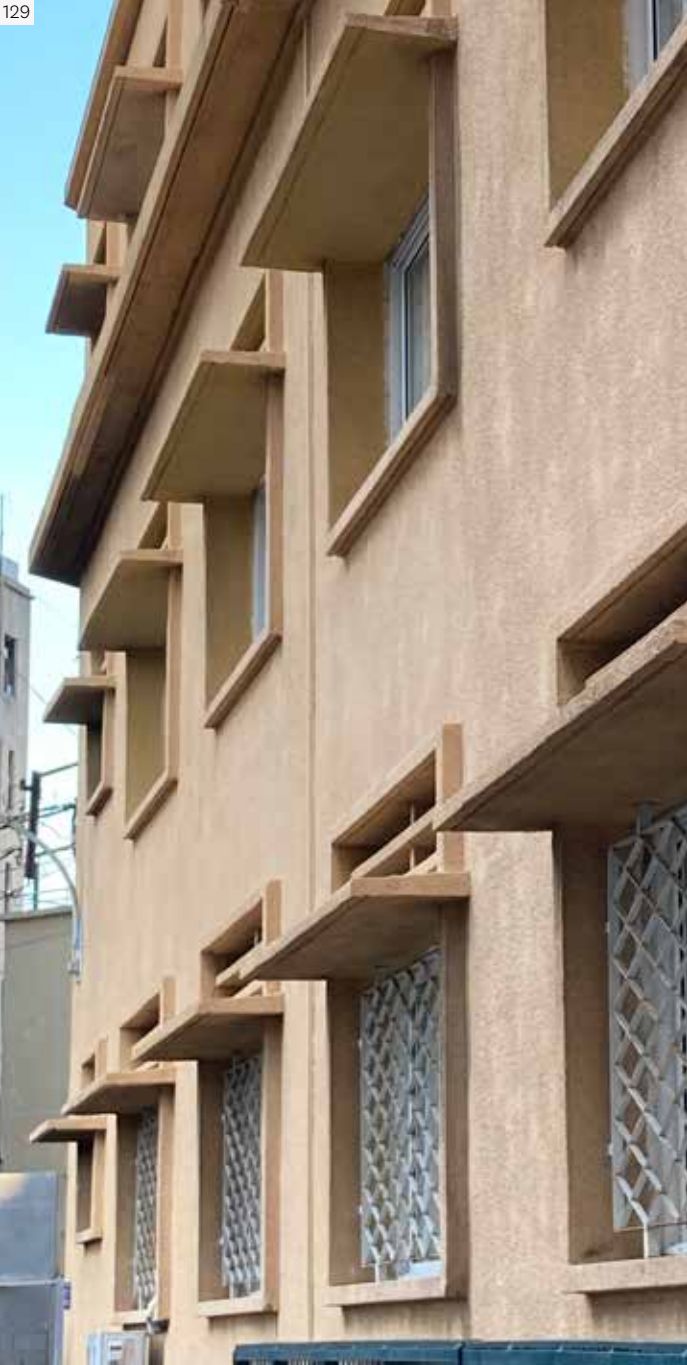
The spread of the principles of modern architecture and functionalism imposed a simplified model of the façade by the end of the 1930s. The smooth façades open more widely, and let the sun penetrate interior rooms. The balconies and large windows of the south, east, and west façades are adorned with protruding sunshades made of coated reinforced concrete, forming either a horizontal or vertical grid depending on their orientation (126, 127, 128, 129). The use of sunshades will be systematized in the 1950s and 1960s to protect the facades of the Mediterranean sun. Architects then use the solar diagram to anticipate the penetration of rays and determine the depth or protrusion of the elements. These sunshades sometimes completely mask the exposed façade (such as in the headquarters of *Dār al Sayyad* and the EDL) (137). They also sometimes take the form of a claustra placed in the upper part of the openings of main balconies.

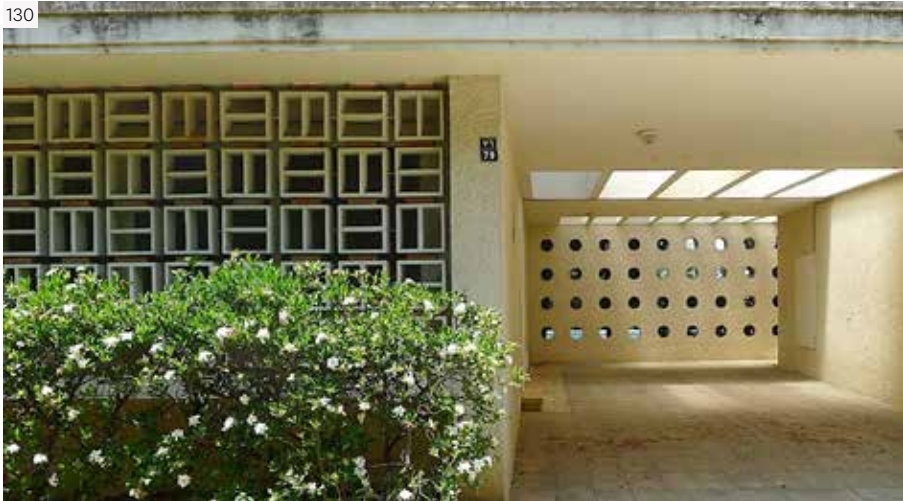
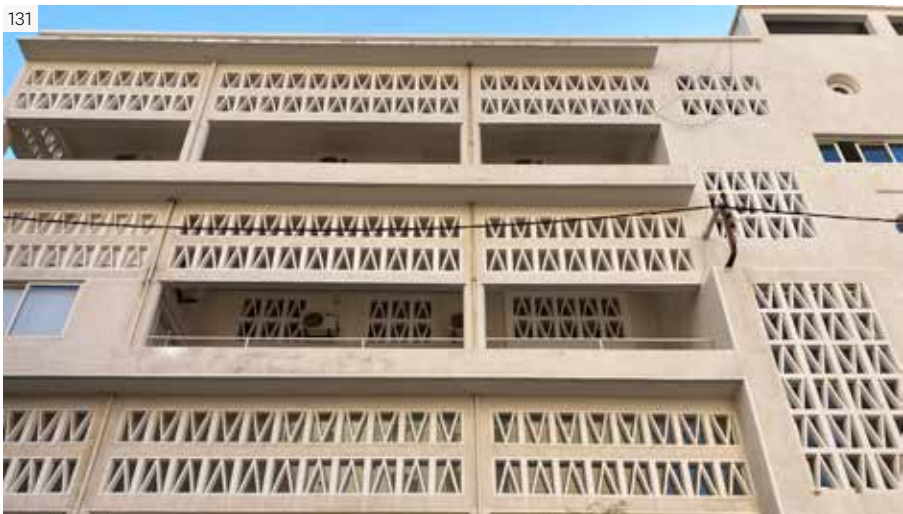
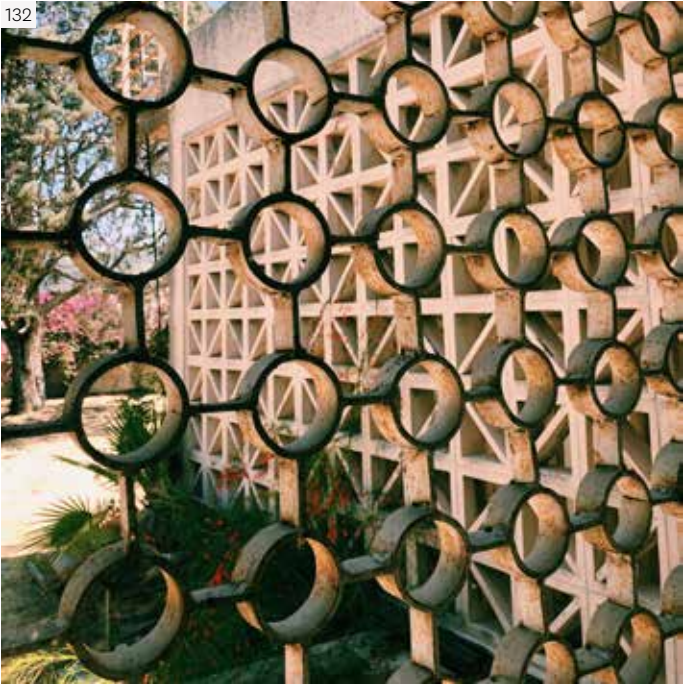
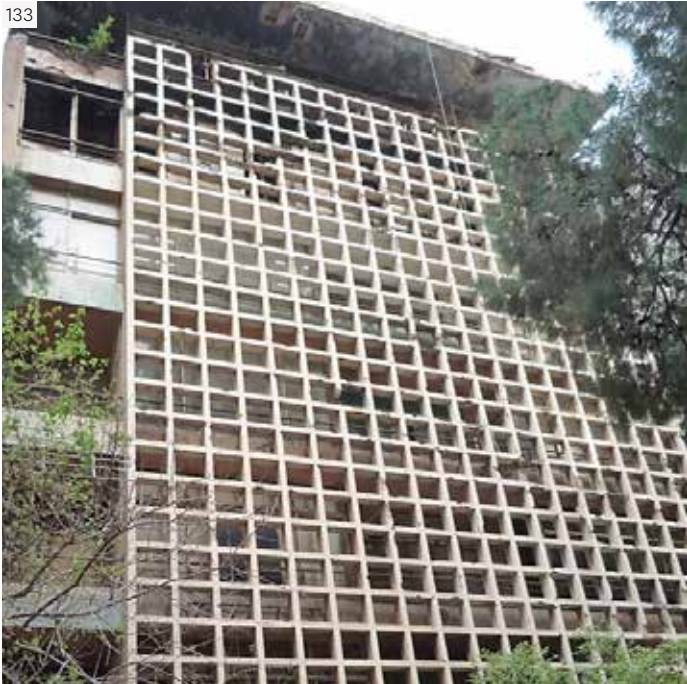
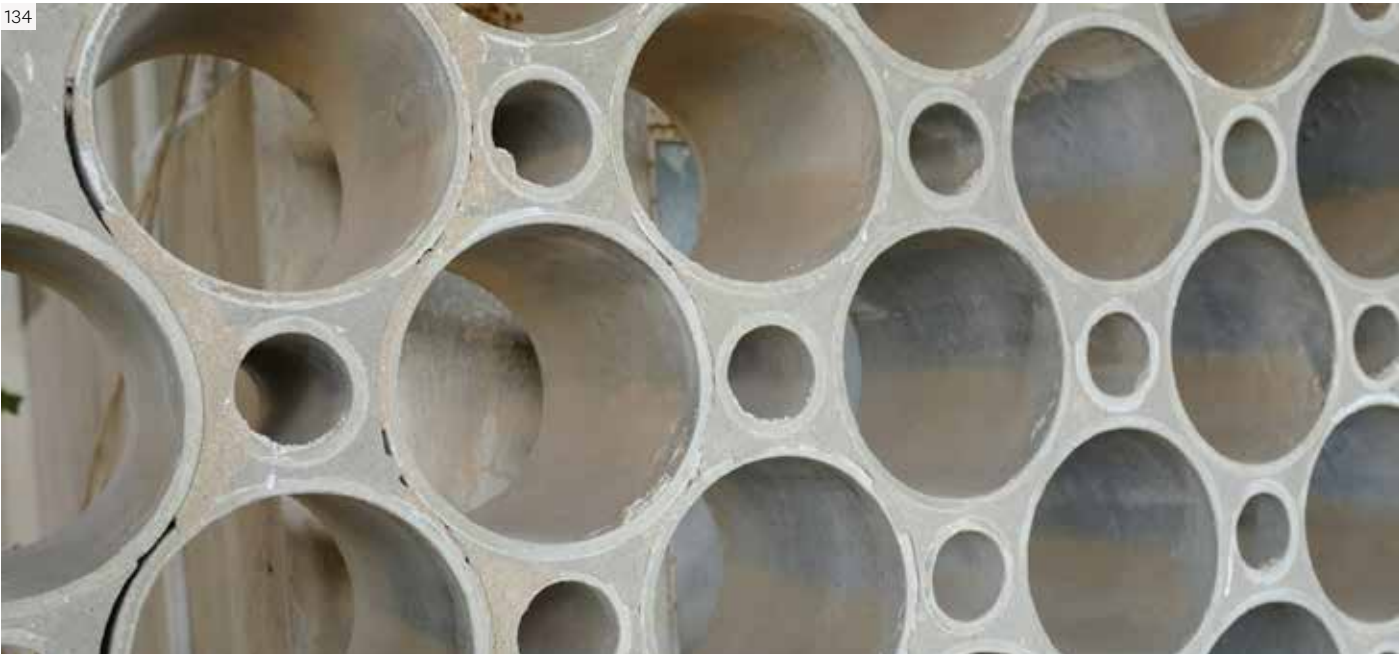
Claustras are mainly used to completely hide the façade of service spaces. Their use became widespread in the 1950s and 1960s. They consist of an assembly of modular prefabricated parts adopting simple or elaborate geometric designs, 20 cm across, in cement (gray or white) and without reinforcements. Some architects will use claustras to articulate and animate the façades (Schayer), and sometimes, contrary to functionalist logic (J.P. Karam), for purely aesthetic composition (130, 133).

From the 1960s, the material of claustras and sunshades diversified with the introduction of fiber cement (*eternit*, asbestos-cement sheets) and aluminum (132, 134).

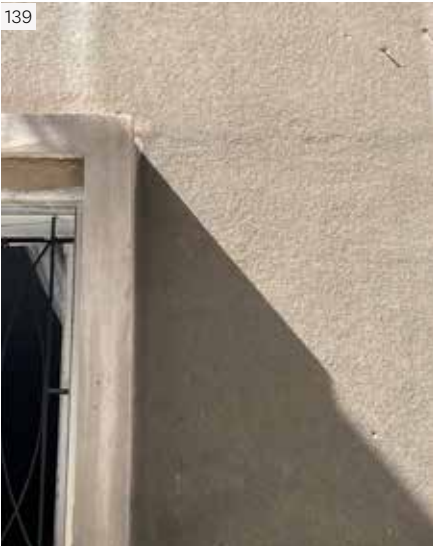
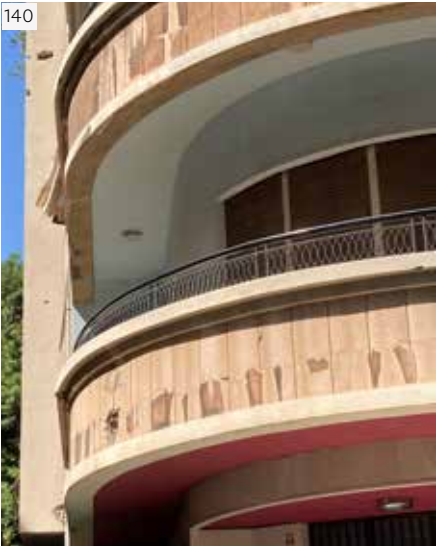
**The priming** - This layer allows the plaster to adhere to the wall. It is composed of one volume of cement for one-to-two volumes of coarse-grained sand (0 to 5 mm). The sand will have to be washed. Water is added until a very liquid mortar is obtained. The mortar is then applied to the previously moistened wall. This layer does not need to be even and can vary between 4 to 7 mm in thickness.

**The topcoat or smooth finish** - After giving the mortar time to dry slightly, the coater smooths out the mortar by lightly moving the wooden float in circular movements. This is done gently and without pressing down the float to avoid the suction cup effect and to obtain a smooth, flat finish. Before the coating dries out completely, the surface is smoothed with a sponge float, then subjected to a finishing whitewash. Whitewashes from the 1930s to 1960s were made with a mixture of water, lime, and dye (yellow or red ochre, ultramarine blue [*nile*], etc.) and directly applied on the smooth coat using a brush and without a primer layer (*ma'ajouné*).

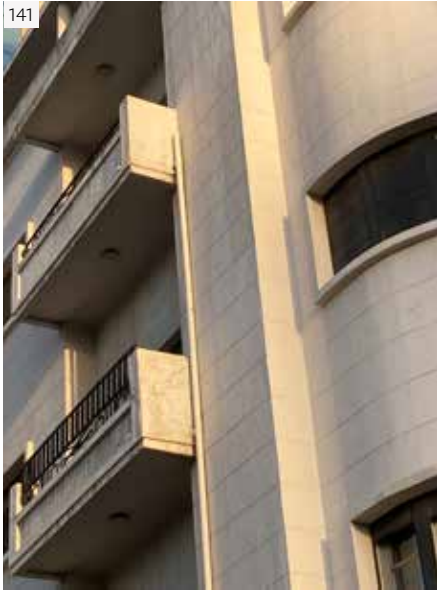
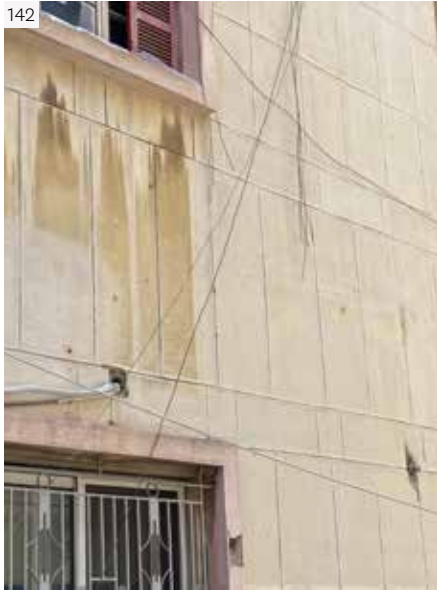
1. **The stained coating:** The stained coating is finished with a float, as described above. According to the degree of smoothing desired, a wooden float is used for a regular finish, and a sponge float is used to obtain a smoother finish (141, 142).

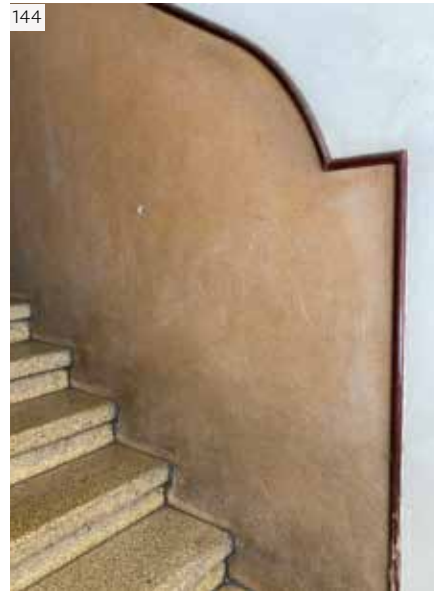
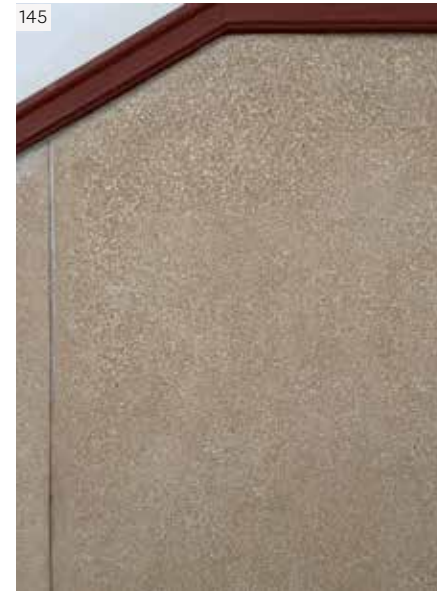
**2. The smooth and polished plaster (terrazzo, locally called *mosaic*):** This type of plaster is chiefly used in common indoor areas: in skirting boards with a height of about 120 cm from the base of the walls and parapets of stairwells, landings, and hallways (144, 145). It is also sometimes applied to freestanding circular columns –especially those on the stilts of buildings. Highly resistant, the polished plaster retains its smoothness and does not require special upkeep from heavy wear or contact (146). Moreover, it can be washed with water. The plaster's junction with the upper part of the brushed wall is often highlighted by a stained and molded beech wood rod.

The mixture of the top layer of the terrazzo coating is made with white cement, stone powder, and fine aggregates (0 to 3 mm) of stone or marble depending on the desired shade and density. The sponge float topcoat will be about 10 mm thick. The surface is water-sprayed twice daily (in the morning and the evening) for 2-3 days so that it does not crack under the effect of removal. When the layer is dry (a week after laying), it is sanded to obtain a smooth and satin finish that exposes any aggregates on the surface of the coating.

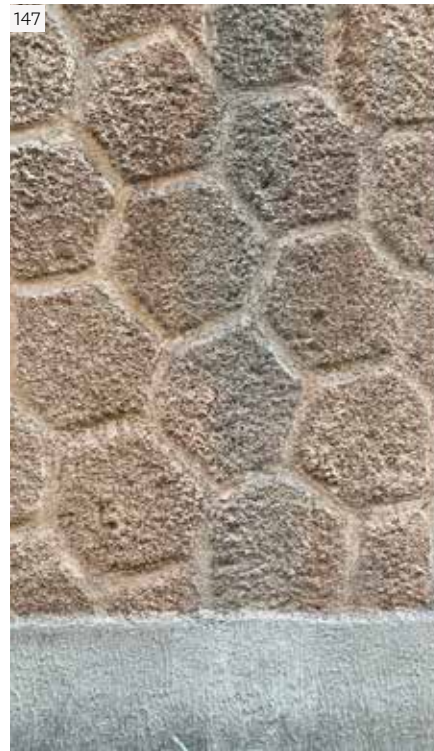
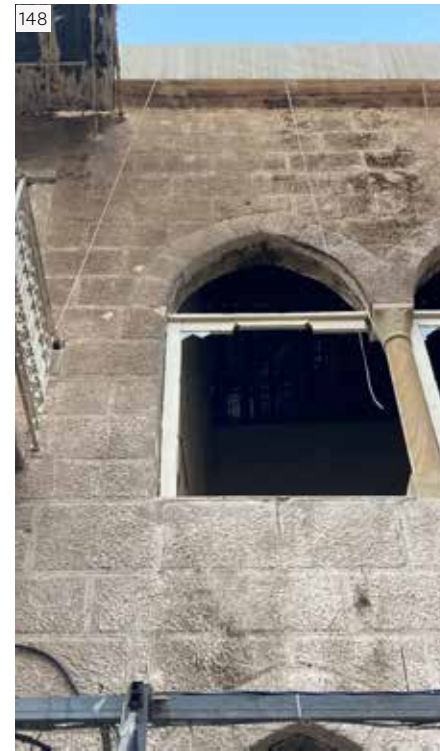
**3. Tyrolean plaster:** Tyrolean plaster is a granular finish coating obtained by spreading on the vertical walls with the aid of a zip line. This technique appears on the facades of some triple-arched houses in the early years of the twentieth century. The drawings and patterns, which can imitate stone beds or come in hexagonal patterns (nicknamed *zelehfe*, or turtle) (147, 148), are obtained by applying openwork wooden molds that are removed after spraying the plaster.

Cost-effective, durable, and practical, plain Tyrolean plaster is commonly found in the finish of the facades between the years 1935 and 1960. The widespread use gave the city's urbanism a uniform, sculpted look (149). Noteworthy, Tyrolean plaster was not applied to the walls accessible to passers-by because its granulated surface can be scratchy or even injurious to the touch. Moreover, the edges of the walls were often left smooth on a peripheral section with a width of 15 to 20 mm to keep them forming a clean line. This section is called *zamlé*.

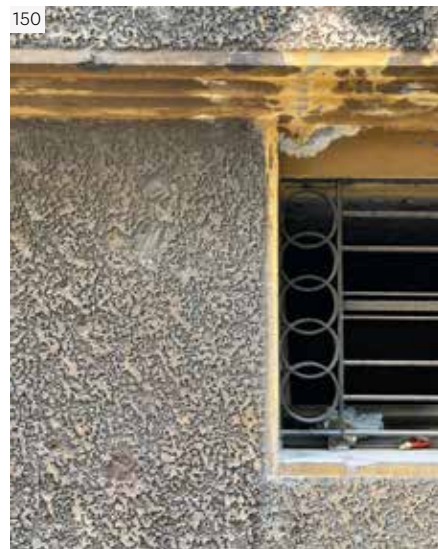
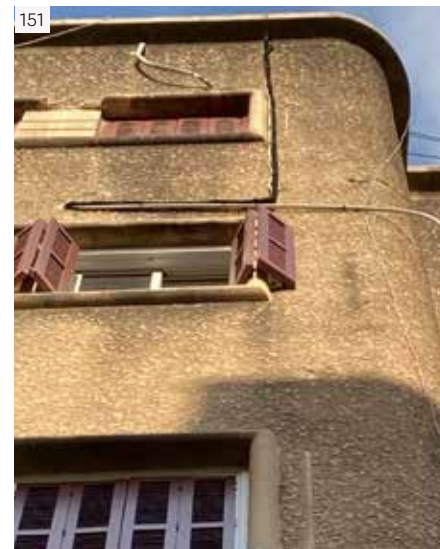
4. **The crushed plaster:** Commonly found in yellow or pink ochre finishes, crushed plaster is a benchmark of the late 1930s and 1940s. It is a Tyrolean coating on which the float (*melij*) is applied to flatten any roughness. The crushed surfaces are smooth and cloud-shaped –revealing hollow, granulated gaps (unlike plain Tyrolean plaster, crushed plaster surfaces are harmless due to the smoothness of the recessed parts) (150, 151, 152, 153).

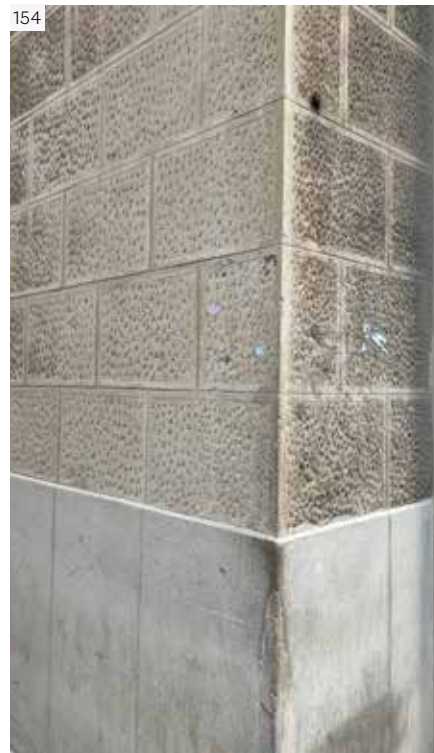
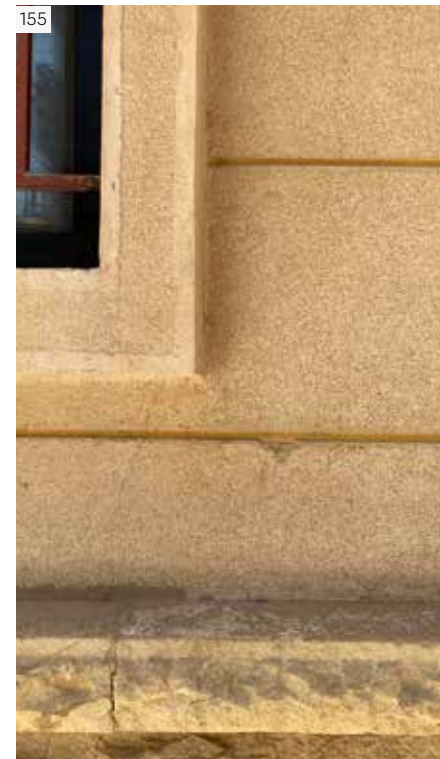
5. The bush-hammered plaster: The need to animate finishing plasters by reproducing as closely as possible stone masonry is revealed in the bush-hammered coatings popularized between 1945 and 1960. The light or ochre-color float finish is treated before it is completely dry. The desired effect is obtained by hitting the surface with a bush-hammer (*abouchard*) or a spade (*bîk*) for a *mzanbar* effect (154, 155, 156). To simulate stone fronts, joints were often drawn by scratching the surface of the plaster with a nail tip and a ruler in horizontal beds and alternating vertical lines. These seals also make it possible to coat the walls in stages, because coating in larger sections allows the surfaces to dry out before getting texturized, compromising the overall desired effect. The walls end with a smooth ribbon (*zamlé*) to prevent the bush-hammer from breaking the edges (154).

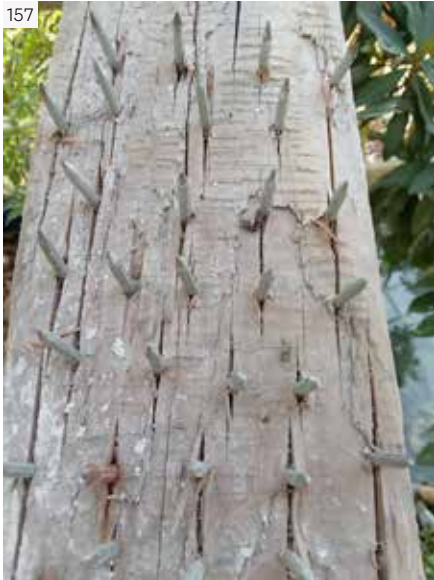
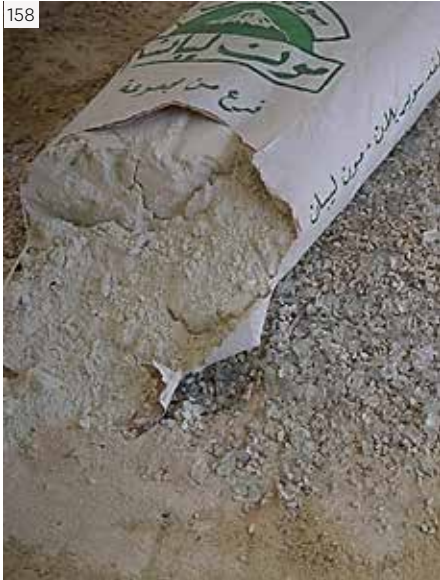
6. The scratched plaster or *kratz*: Widely used in architecture between 1950 and 1965, the *kratz* is a thick, textured plaster that is scratched using an artisanal brush formed by embedding iron nails with protruding tips into a wooden float (157). This type of coating makes it possible to form surfaces (suspended planes or built masses) with a monolithic appearance.

The mixture of the topcoat includes white cement, stone or marble powder, and medium aggregates (4 to 10 mm) in the following proportions: 1 bag of white cement, 4 bags of stone or marble powder and 4 bags of aggregates (158). Some architects add broken glass to the aggregates for a sparkly look in the sun. The topcoat is 20 to 25 mm thick (part of which falls off during scratching). Before the coating is completely dry (about six to twelve hours after its application), it is scratched by rubbing the nail brush on its surface, until a compact, non-hurtful texture is obtained (159, 160).

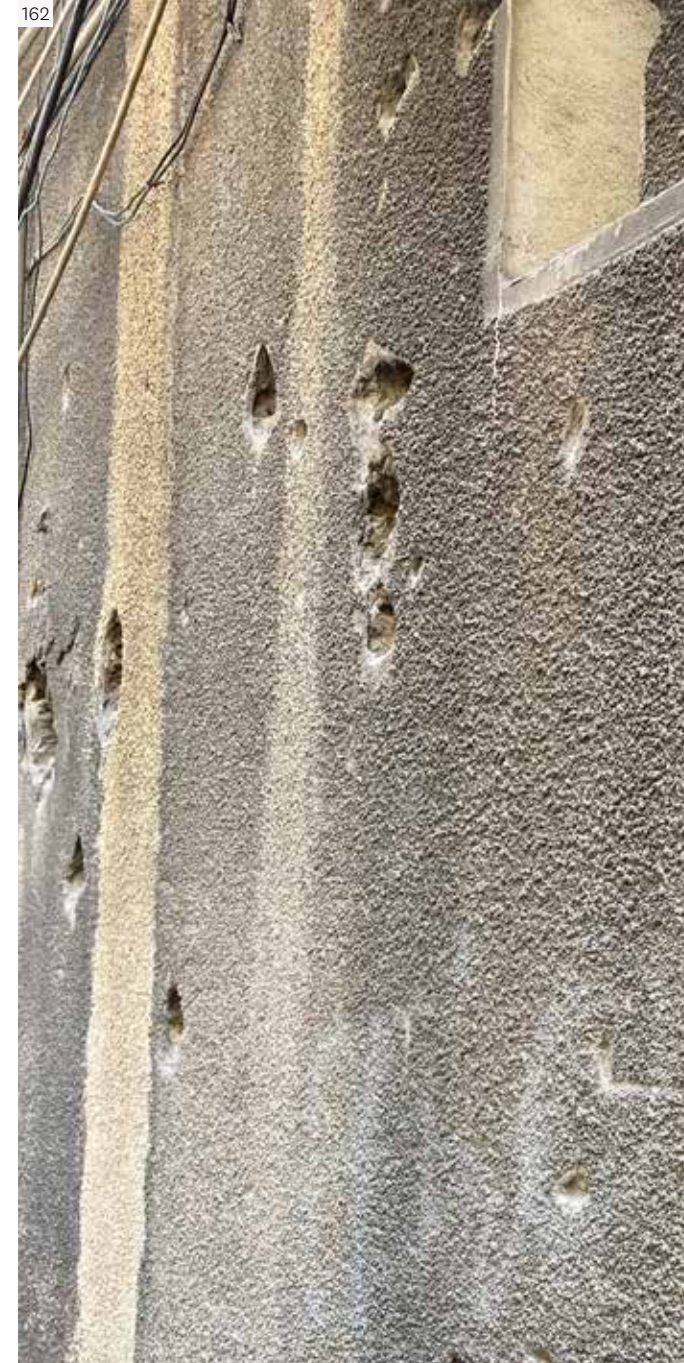
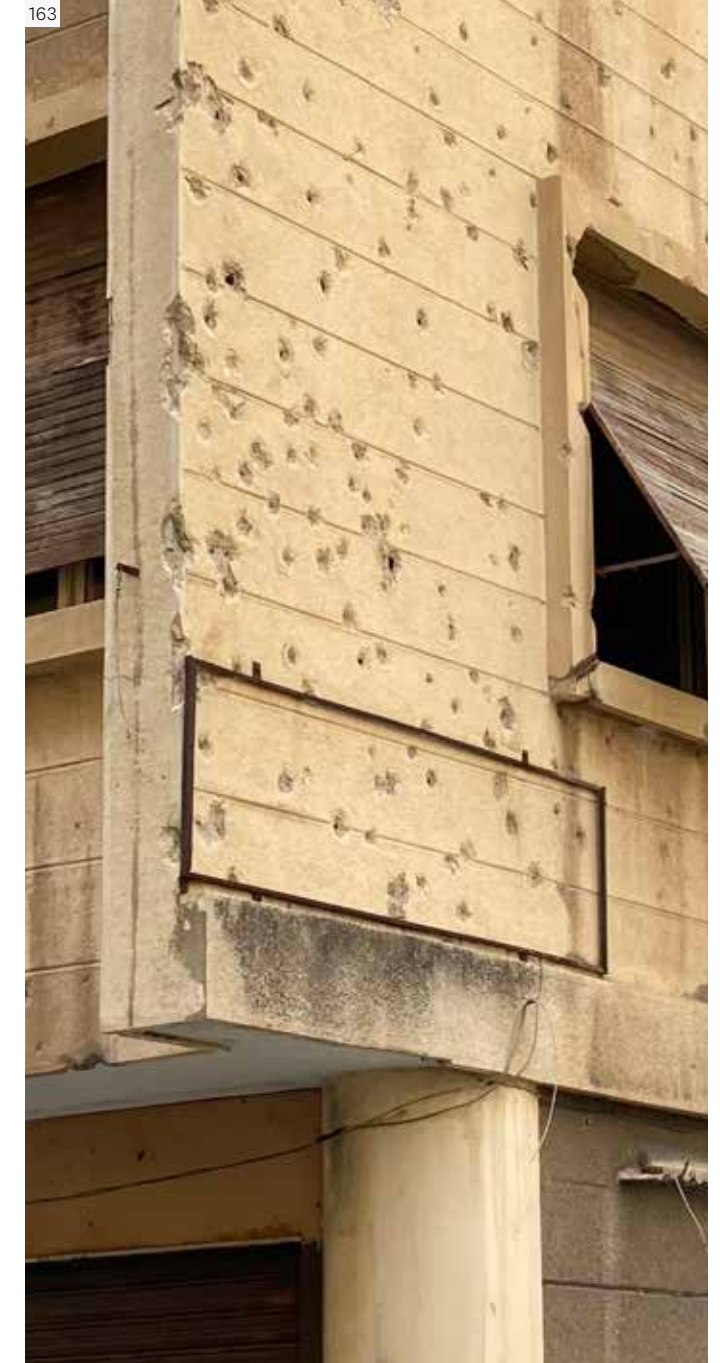
1. **Dirt** - Textured surfaces retain dust, pollution or bird droppings, and soils that become embedded in crevices over time and rainwater runoff. This pathology is the simplest to treat. The façade can be washed down with a low-pressure water jet so that its surface does not sustain any damage. Eventually, a soft brush can be used in addition to the water jet.
2. **Breakage** - The cracking or breakage of plaster comes from the wear of the reinforced concrete that supports it. The cracking happens due to the oxidation of steel reinforcements or the impact of bullet holes, shrapnel and other blows sustained during the civil war or the August 4th explosion (162, 163).

The edges of the plaster around the damaged part must be cut into fish bones (zigzag pattern) to create a key for the new coating. The three layers of plaster previously mentioned are then applied in accordance with the artistry and composition of the old plaster revealed by the detached parts. Finally, the topcoat should be treated so that it blends with the original coating.

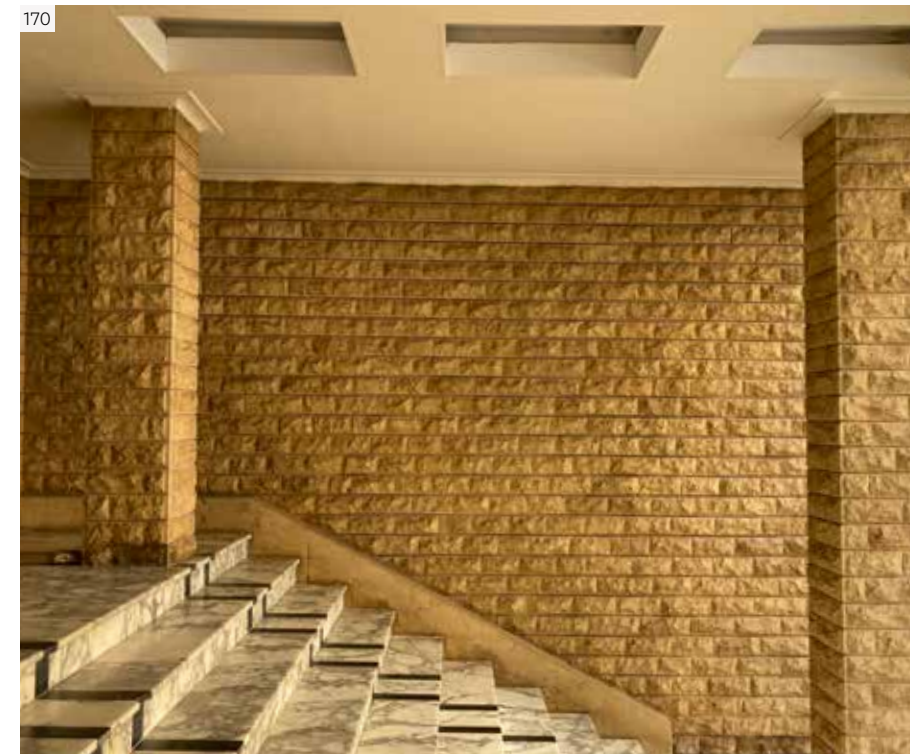
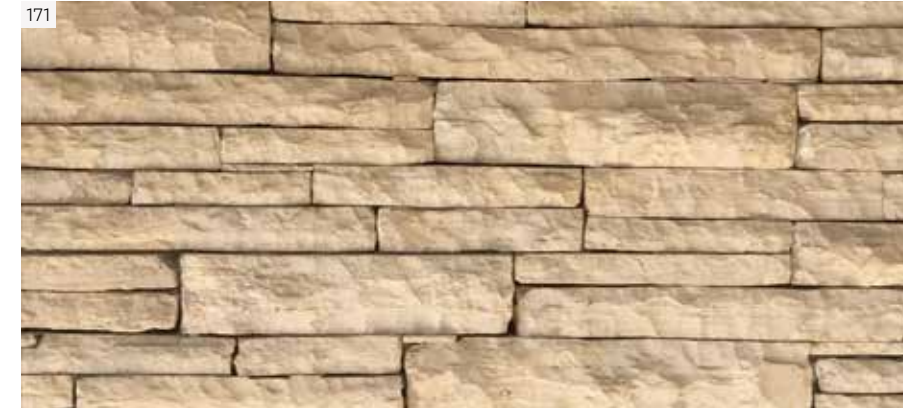
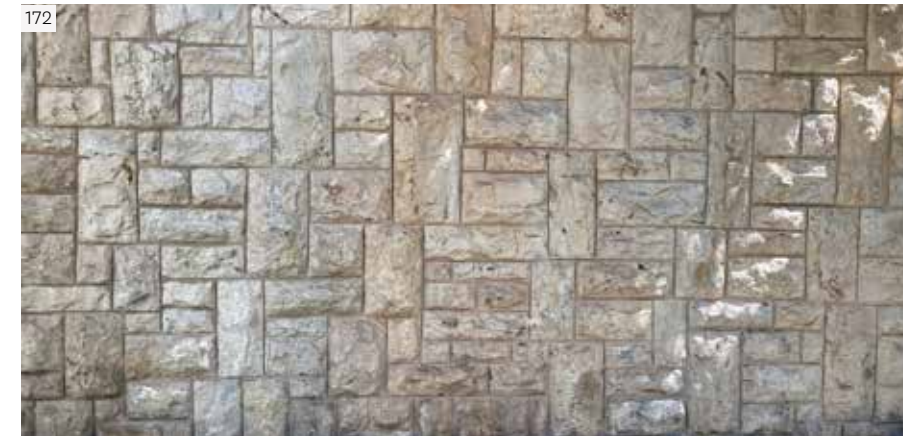
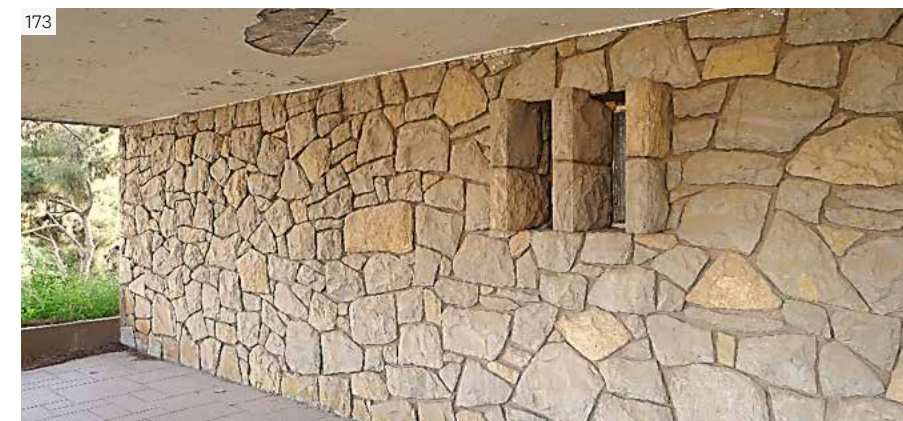
4. Walls and floors in Opus Incertum (*zelehfé* = turtle) or *Crazy Paving* (173, 175): Irregular polygonal stones were assembled freely using joints clogged with smoothed cement mortar about 15 mm wide. On vertical walls, this type of free laying instantly marks the non-load-bearing function of the stone and stands in contrast with the straight lines of modern architecture.

5. Floors: The tiles are laid in parallel strips with free joints. Sealed with cement mortar (*rawbé, kehlé*), the thickness of the joints varies according to the required model (174, 176).

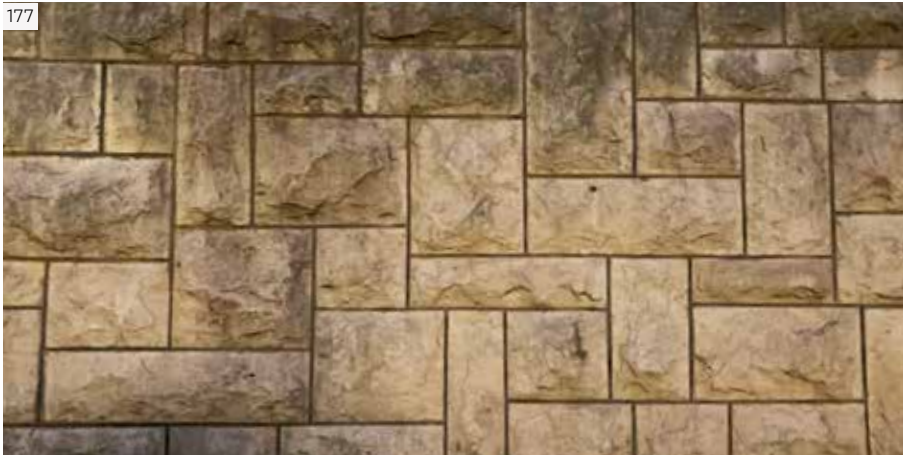
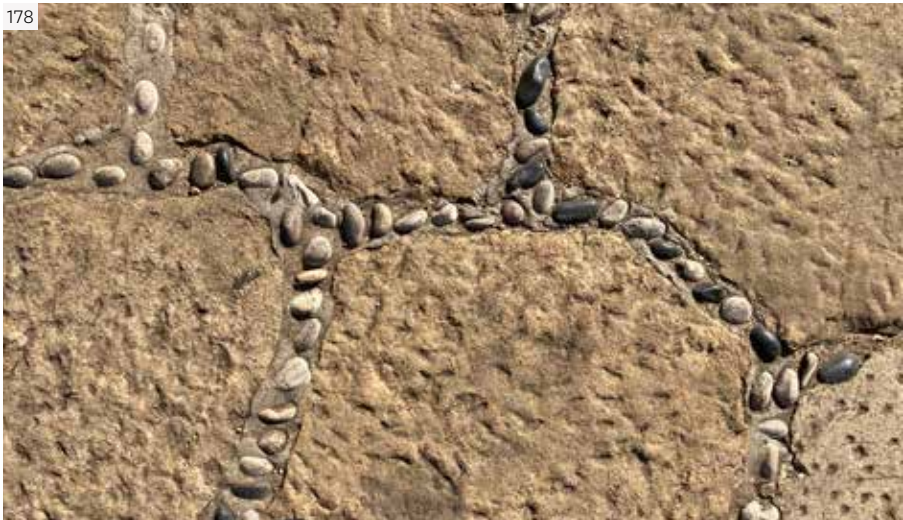
Solid stone coatings do not show any particular pathologies due to the wear and tear of time. They may have been damaged by bullet impacts, shrapnel or metal debris during the civil war or on August 4, 2020, or by ground settlement. It is also common for the walls to be covered with graffiti or superimposed layers of posters and various leaflets applied with glue. Finally, organic dirt (animal waste, plant soiling, etc.) also sometimes altered the surface (177).

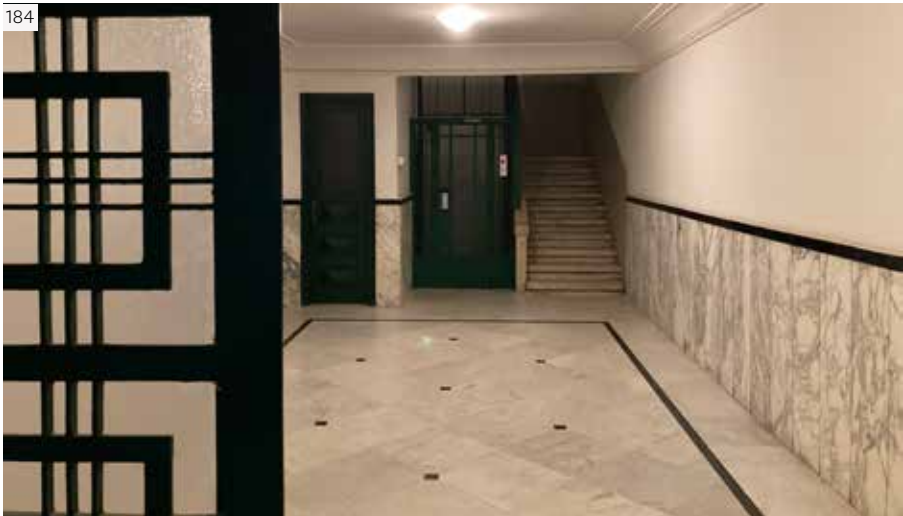
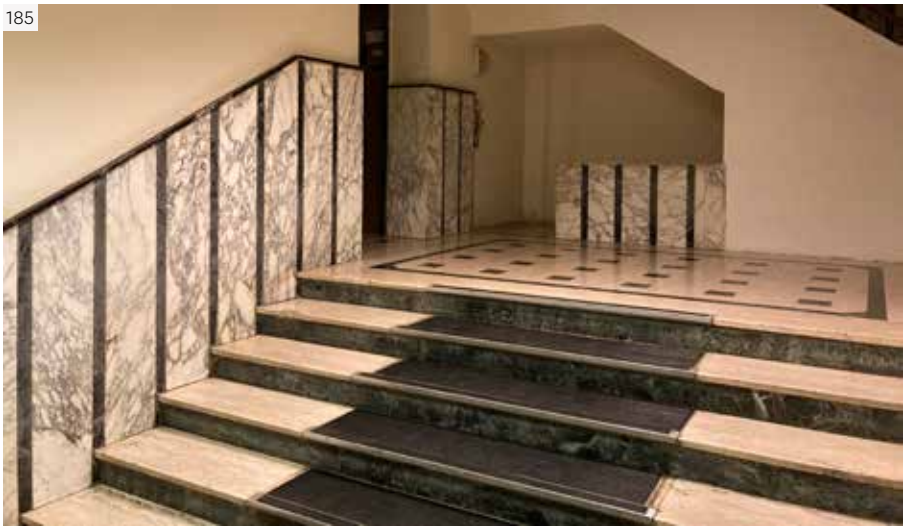
Coatings made of solid stone and marble slabs did not suffer particular pathologies due to the wear and tear of time. Rather, they may have been damaged by bullet holes, shrapnel, or metal debris during the Lebanese civil war, the August 4th blast, or by later ground settlements. It has also been common for walls to be covered with graffiti or superimposed layers of posters and leaflets. Finally, organic soiling (animal droppings, plant soiling, etc.) has also altered the coatings' surfaces sometimes.

- **Dismantling and reinstalling in the same space (settlement problems) (186, 187):** Clean the marble with a soft tissue and remove all residue, while giving a code for each tile on the survey papers. Mark each tile with duct tape according to the coding system. Find a cracked stone to be the first tile to be gently removed. Carefully remove the grout around the tile without damaging the neighboring tiles, using a chisel or a flathead screwdriver and a hammer. The back of the marble should be cleaned by using a hammer and a trowel and soaking the tiles in water for about 30 minutes to soften the mortar if needed. Scrape off the mortar with a trowel and brush off remaining particles of mortar with a medium brush. The marble tiles should be stored in plastic boxes, with a geotextile between the tiles. The floor will consolidated, and will receive a new layer of sand and lime mortar, before re-placing the tiles in their original location. For jointing, humidify the floor, then spread a grout with a well-dosed binder.
