**ARCHITECTURES OF BEIRUT, 1925-1970**  
Restoration Manual

## ARCHITECTURES OF BEIRUT, 1925-1970

### Restoration Manual

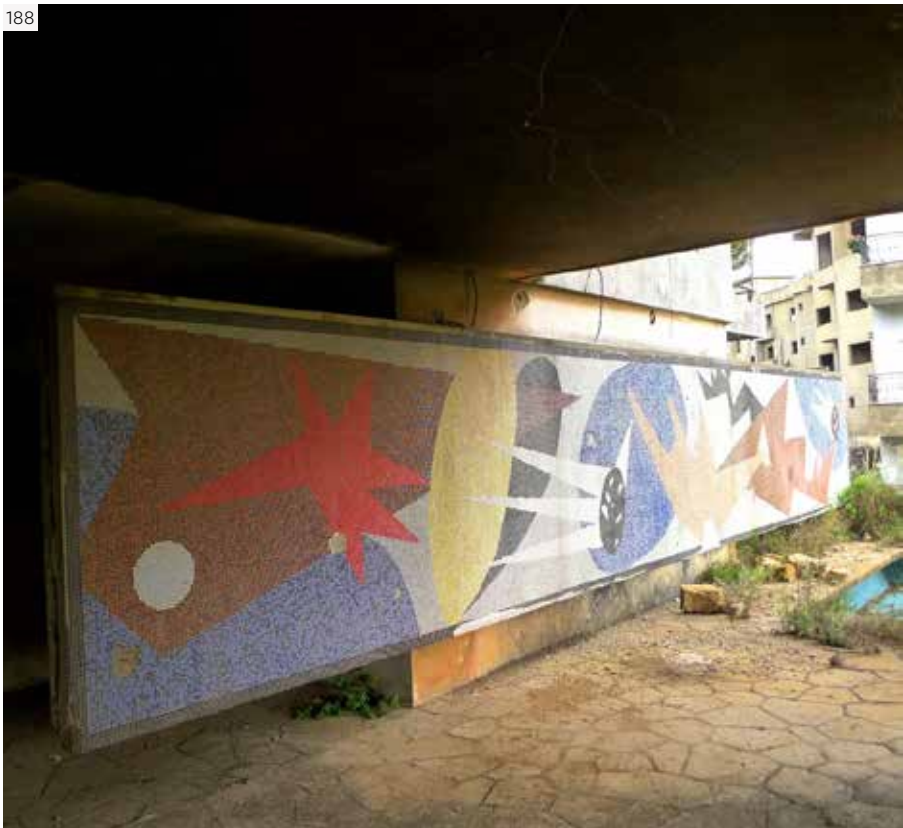
Since ancient Rome, glass paste has been used in decorative arts and architecture. It became popular in Europe and America at the end of the nineteenth century and in the first half of the twentieth century in Art-Nouveau and Art-Deco architecture, facade cladding, and large decorative mosaic panels (188). The tesserae are created by mixing glass powder with a binder, molding them, and baking them at 800 degrees. It is a very durable facing, with a virtually unalterable surface. Produced on a large scale after WWII, particularly in Italy, it was introduced to Lebanon in the 1950s and would become a major cladding material in modernist architecture until the end of the 1960s. Aside from facade cladding, glass paste was commonly used as an interior for bathroom floors and walls (until today).

2- In figurative or abstract paintings, applied to a large section of the facade or a ground-floor front wall (188).

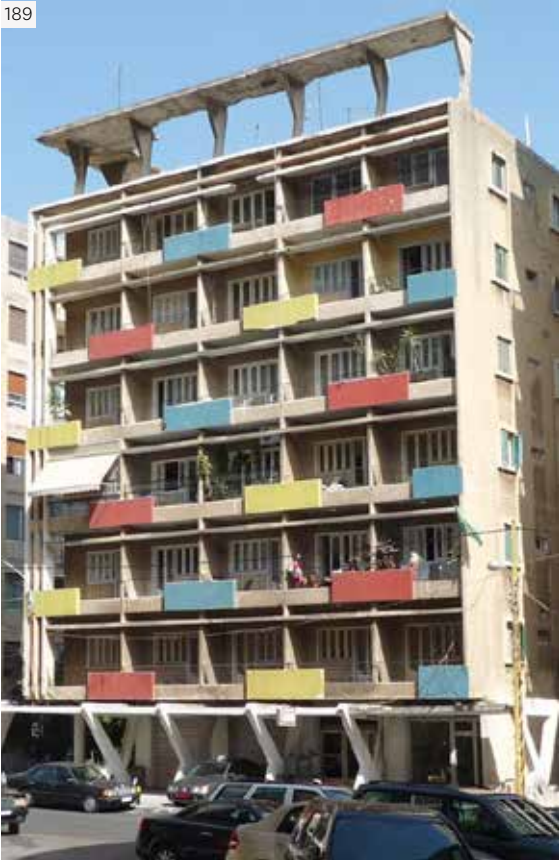
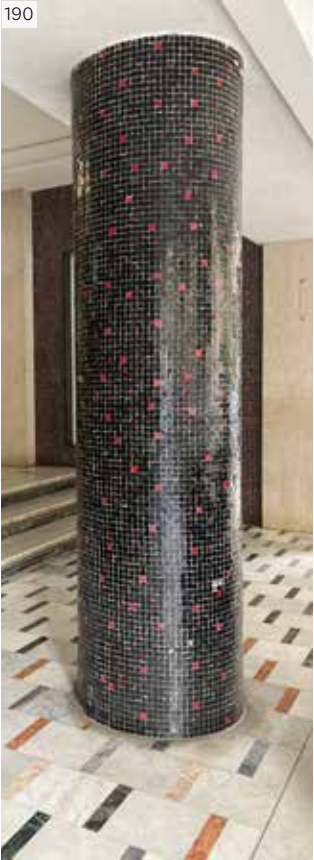
1- Use monochrome panels on facade elements such as balcony or window parapets and lintels, planters, cylindrical pilotis columns, and so on. While most architects stick to a single color (green-blue, bronze-auberGINE, etc.) on the main facade, others will use a variety of primary colors to animate it (189, 190).

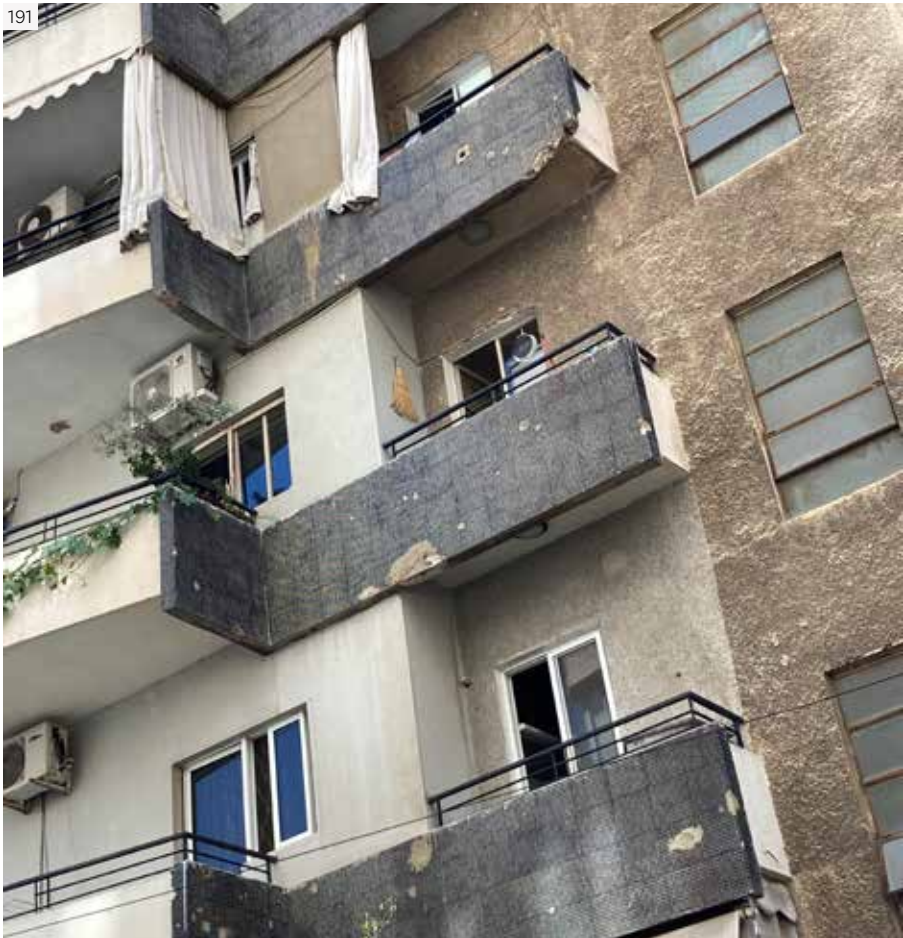
2- *The breakage of tesserae* caused by the impact of bullets or shrapnel during violent acts (civil war, explosions of August 4, 2020, etc.) (191, 192).

In both cases, the missing or broken pieces must be replaced with tiles and tesserae of similar appearance and color. The abundance of international manufacturers and suppliers, as well as the material’s market availability, will make it possible to find the colors and formats required to faithfully restore facades and interiors. Defective parts will be carefully removed one at a time. Brushing and washing will be used to remove all traces of old glue from the substrate. Along the way, we will ensure that the preserved tesserae adhere to the facade. Finally, the missing parts will be replaced by gluing new parts. The joints between tesserae will be cleaned by washing with low-pressure water. The joints between the old and new parts will be filled with a leveling product that is identical in appearance and color to the original.

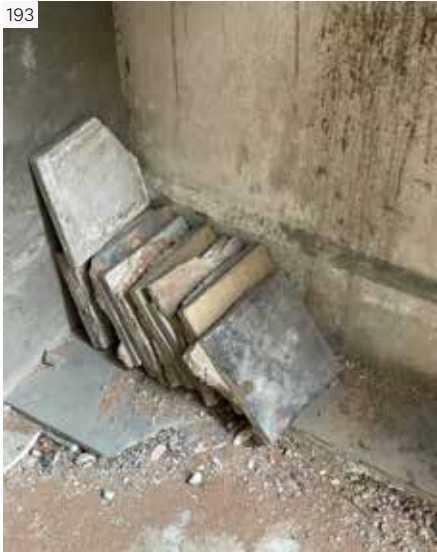
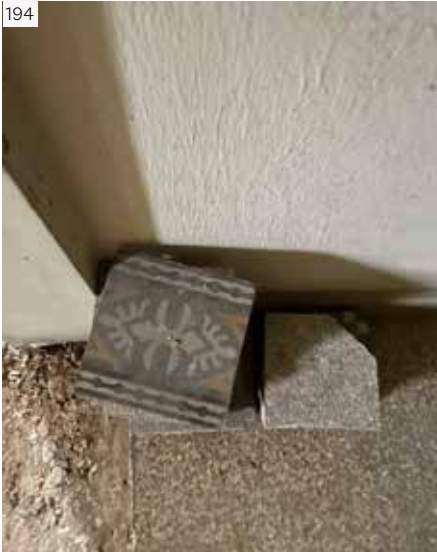
- The colored cement: consisting of a thin layer of white cement, stone powder or sand, and pigments, without any gravel or stone fragments.
- The foundation of the tile: consisting of stone powder, fine gravel, and black cement.

- The semi-liquid colored mixture is poured into the indented compartments of the forma.
- The stone powder is sprinkled on the surface of the tile as a bonding agent, and the forma is lifted by its handle.
- The foundation of the tile is then poured.
- The tile is placed in a press before it is left to dry.

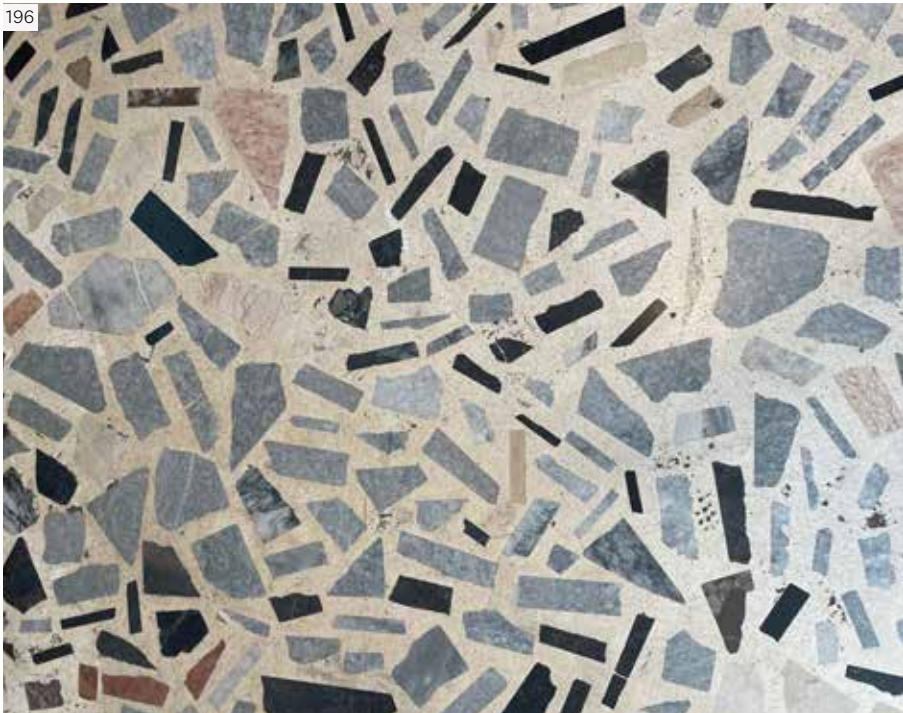
Between 1935 and 1970, however, the industrial production of terrazzo (mosaic) tiles supplanted the use of cemento and marble for floor coverings. This was due in part to its largely advantageous cost, and also because it agreed with the simpler and more streamlined finishes prized by modernists (197). Terrazzo is a mixture of colored or uncolored cement and aggregates or marble scraps (196, 199). The standard size of tiles is 20 x 20 cm, and their thickness is 25–30 mm (197, 198). It is common to find tiles of larger dimensions (30 x 30 cm or 40 x 40 cm) in prestigious spaces, buildings’ entryways, or living room spaces. The size of aggregates or pieces of marble varies according to demand. Once polished, terrazzo tiles reveal a surface of uniform color and texture.

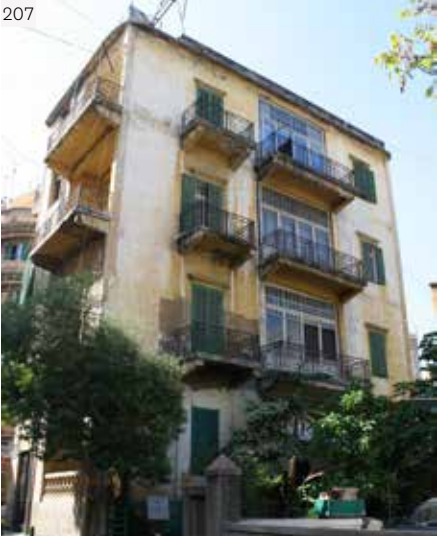
The introduction of wooden folding shutters in the patio doors of the central hall was a major change in the residential architecture of the mid-1940s (207). Traditionally, the central space, or *dār*, was bathed in natural lighting streaming in from the large, triple-arched (or rectangular) bay windows. Wooden shutters were reserved only for other rooms in the apartment, such as bedrooms requiring more privacy. Starting from the second half of the 1940s, however, the use of wooden shutters became widespread across all chambers of the house. Equipped with foldable, multi-paneled shutters, the occupants’ regular living space is in turn protected from the sun and wandering eyes alike (208). The new layout thus seems to establish a new relationship between the household and the outdoor space—one where a person can isolate themselves completely within the house.

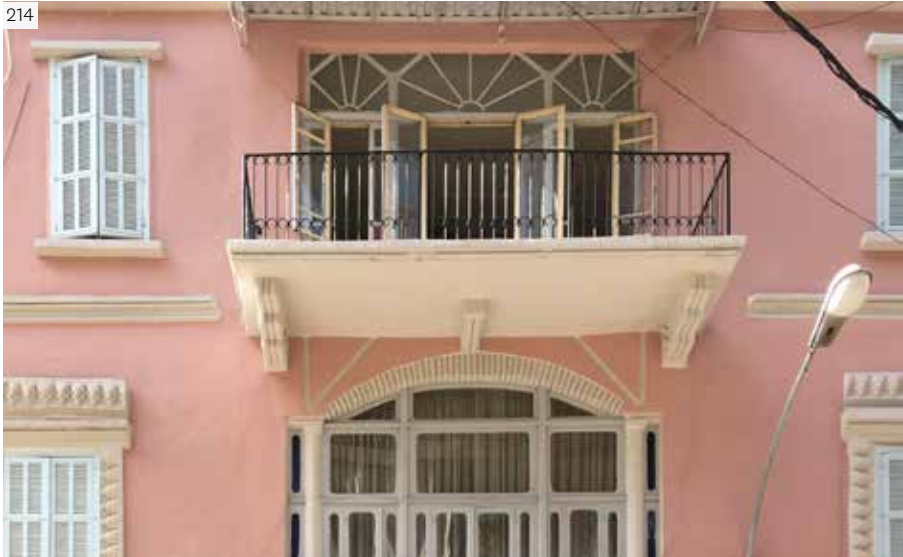
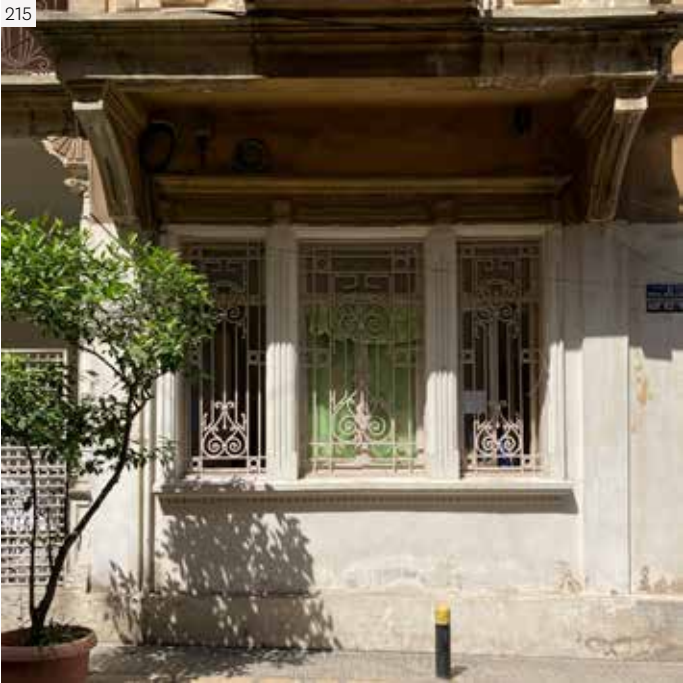
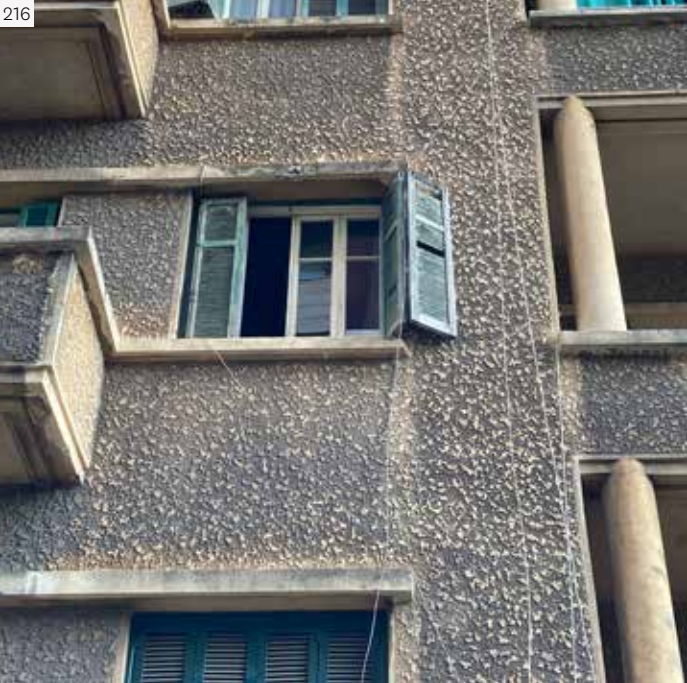
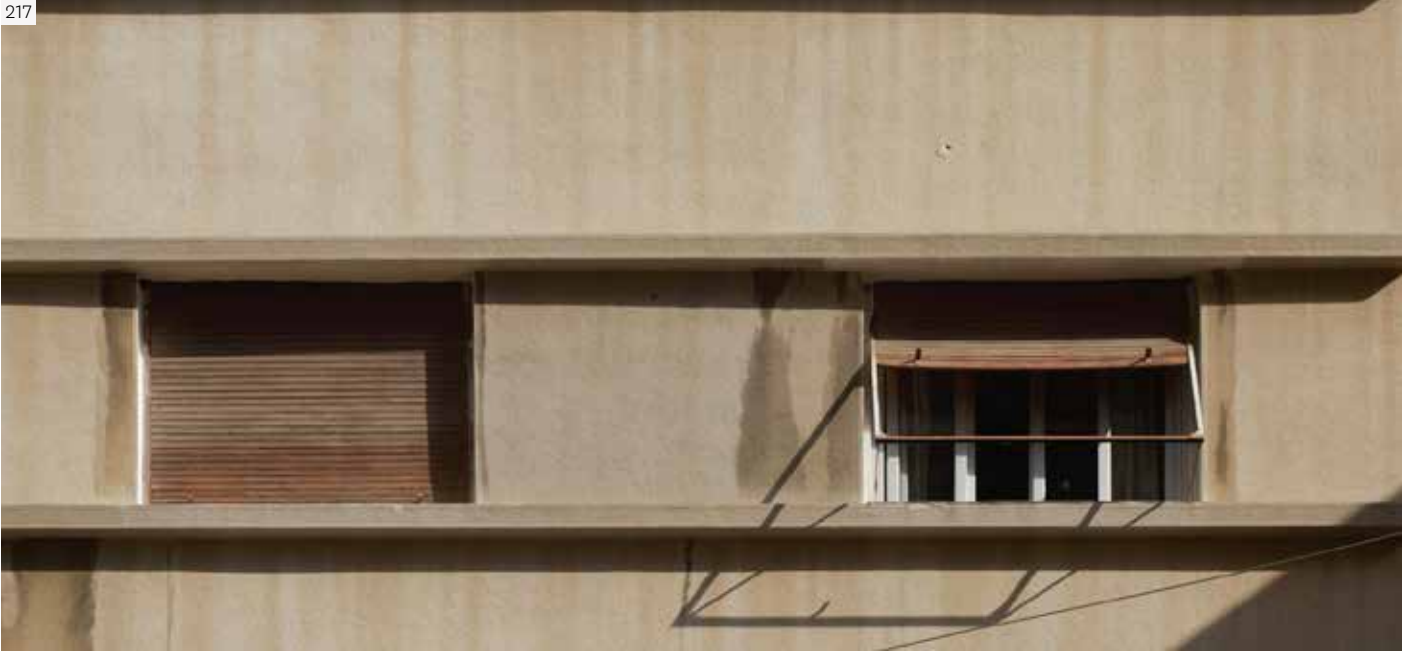
The composition of the plans and facades remains true to the typology of a central hall. The vertical rectangular *Qotrani* wooden windows (100 cm wide, 200 cm high) have two inner glazed leaves (topped by a glazed transom) and double-leaf shutters, with outside shades (218, 219, 220). The louver blades are frequently manually adjustable using a wooden rod. Mastic is used to secure the glazed panels to the frame.

The differences from the previous period are minor: the glazed panel is one piece that spans the height of the leaf and the width of the transom; the inside corners of the frames are rounded and beveled; the fixed frame shrinks in-depth and industrial accessories spread.

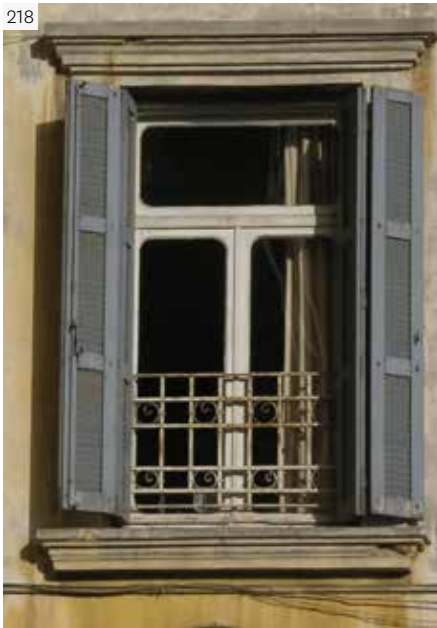
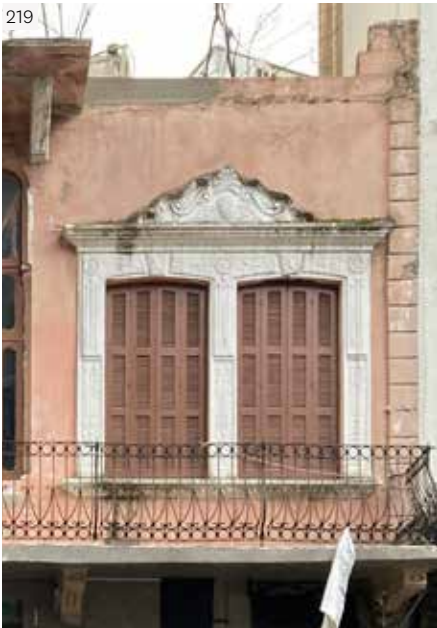
The large bay window in the central hall retains its symmetrical design. The three arches are replaced by a unitary composition of a simpler design, divided vertically into three parts and resulting from the use of reinforced concrete rather than stone masonry: a large low-arch spanning the entire width of the central bay (221), a straight lintel, or an inverted staircase (*en escalier inversé*) (222)... Moorish geometric designs or those closer to Art-Deco simplicity replaced the interlacing ornamentation of Gothic inspiration (223).

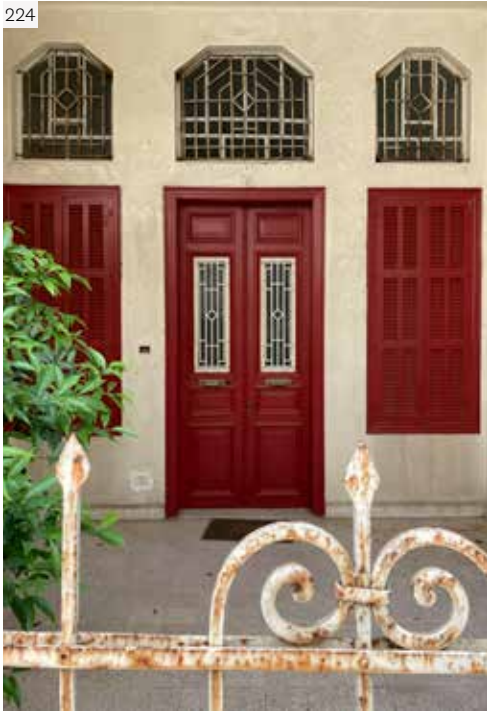
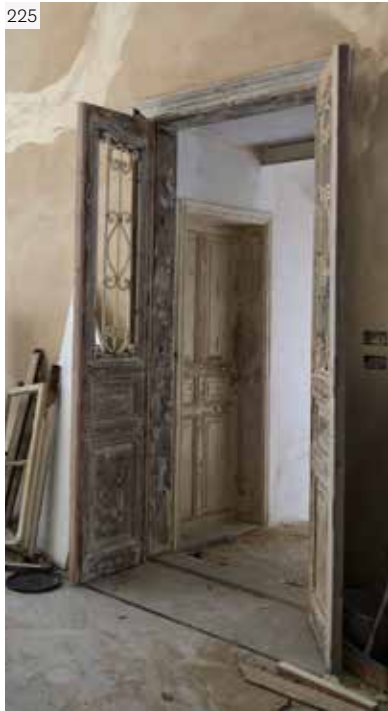
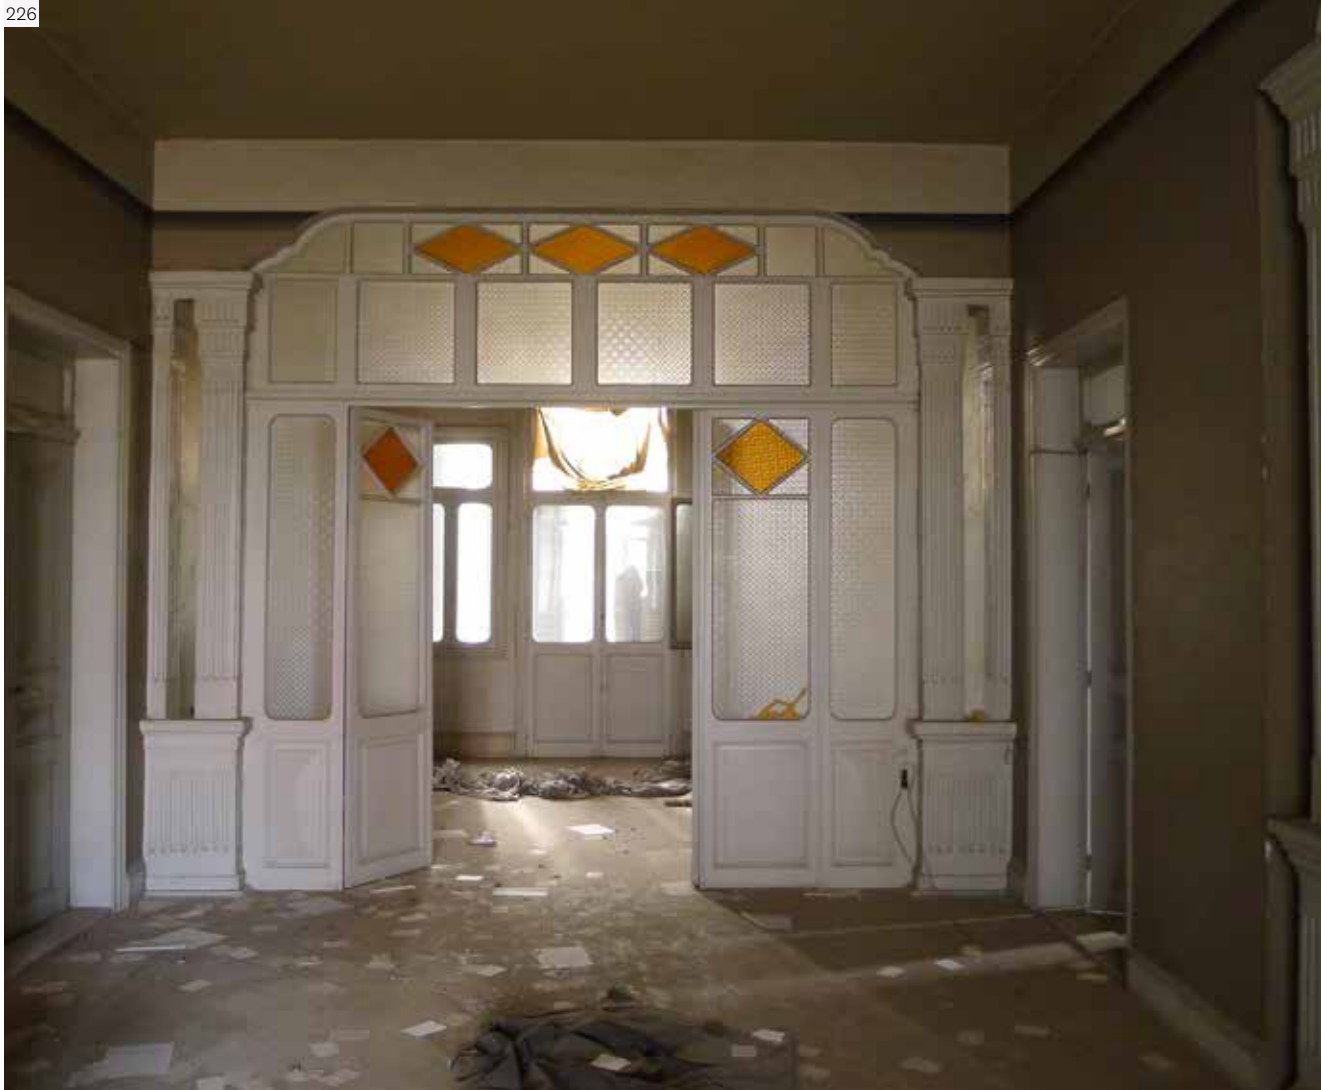
Industrially manufactured in steel and cast iron, hinges, locks, handles, *cremone* bolts, and *espagnolette* are imported from France and Europe.

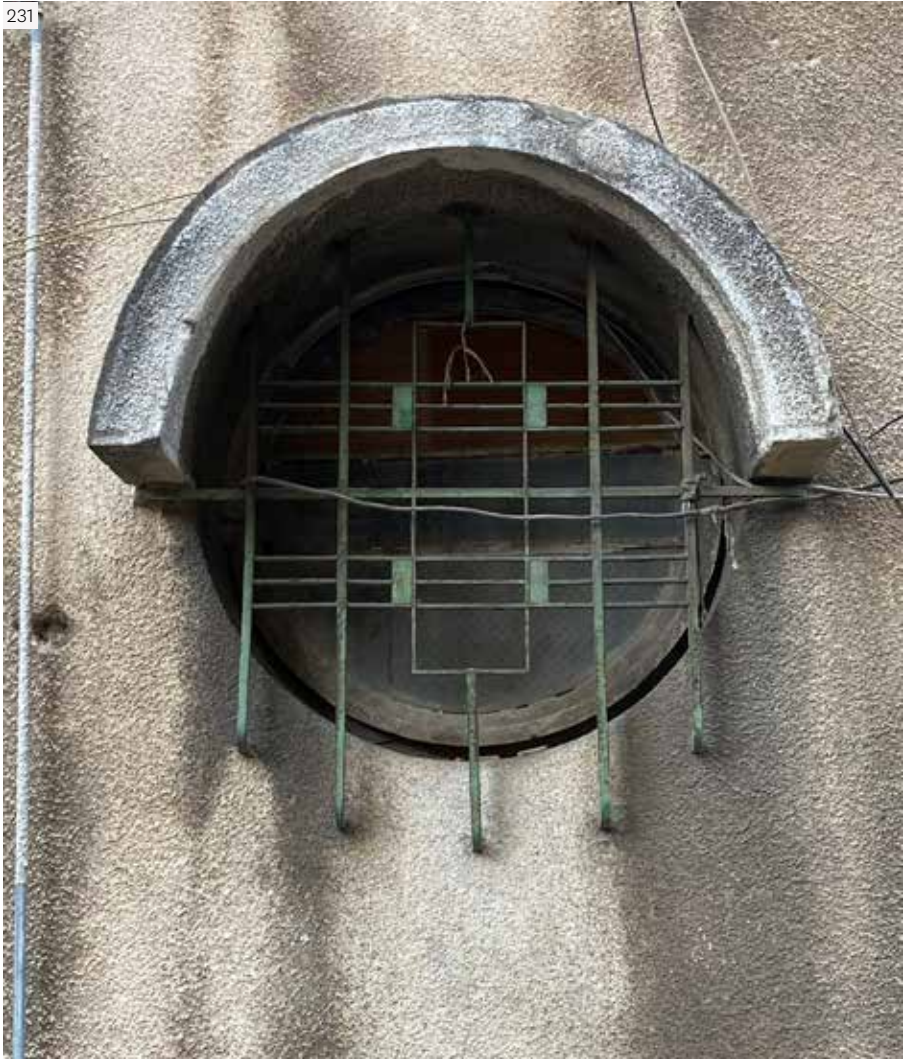
Traditional composition and elaborate ornamentation were abandoned between 1935 and 1965. Straight running moldings at the spandrel and lintel level often accentuate the horizontal design of the windows. Steel joinery is introduced, but wood is still used. These two materials would coexist before being replaced by aluminum in the 1960s.

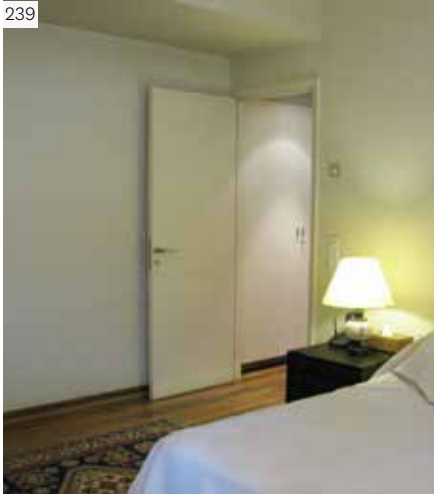
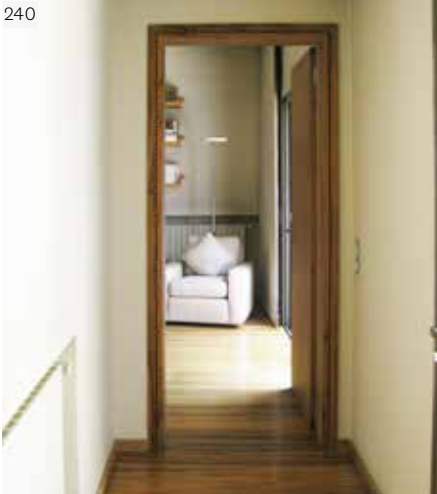
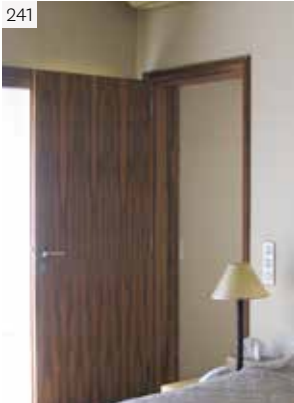
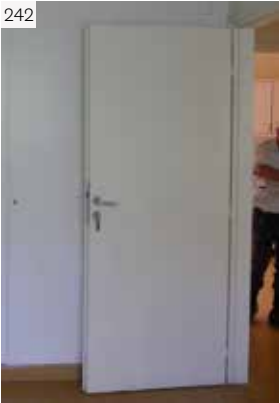
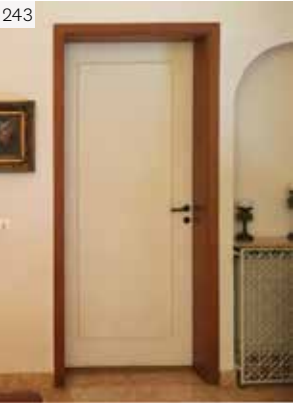
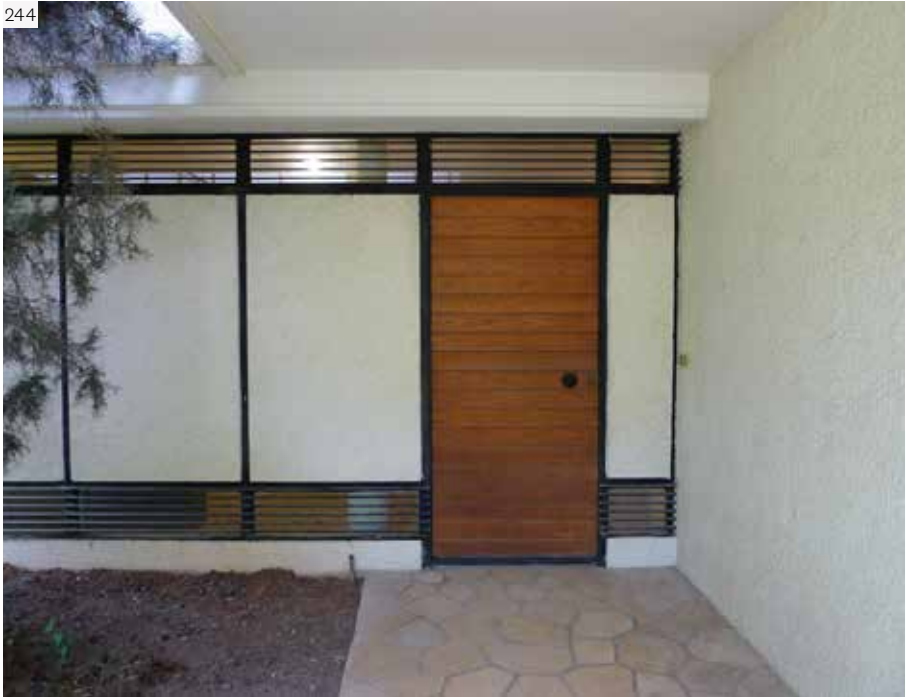
Steel or brass hinges, brass recessed locks, steel, brass or aluminum handles are all imported from industrialized countries, primarily Europe but also the United States.

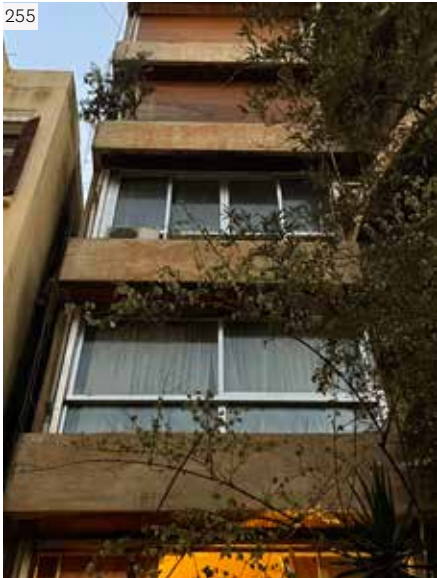
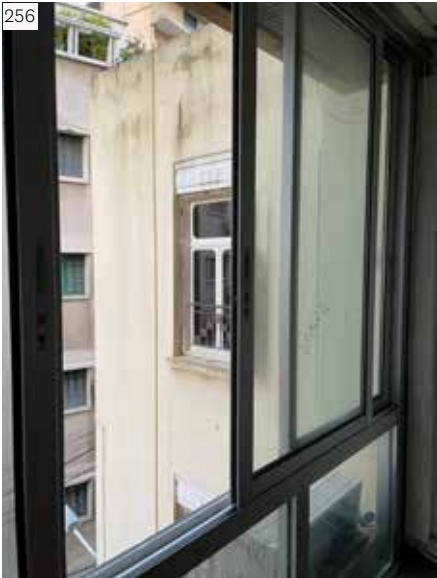
Industrial joinery in anodized aluminum profiles was used in construction in the United States beginning in the 1930s. Pioneering manufacturers (Ajax, SCIALE) introduced the new material in Lebanon at the end of the 1950s. It began to replace the use of wood and steel in 1965, including for the production of roller shutters and bodyguards.

Industrial aluminum has numerous advantages, including being lighter than wood and steel, being weather resistant, not oxidizing, and requiring little maintenance. The profiles are put together with screws and industrialized accessories, and they slide on bearings or open with hinges. The proliferation of aluminum windows, on the other hand, sounded the death knell for artisanal construction, which had already been undermined since 1950.

Primitive aluminum profile joinery suffers primarily from the obsolescence of its accessories (bearings, seals) and their inability to accept double glazing for thermal insulation. If their replacement is required, it is best to select the most recent profile that is closest in section and color, so as not to mismatch the building or harm the character of the work.

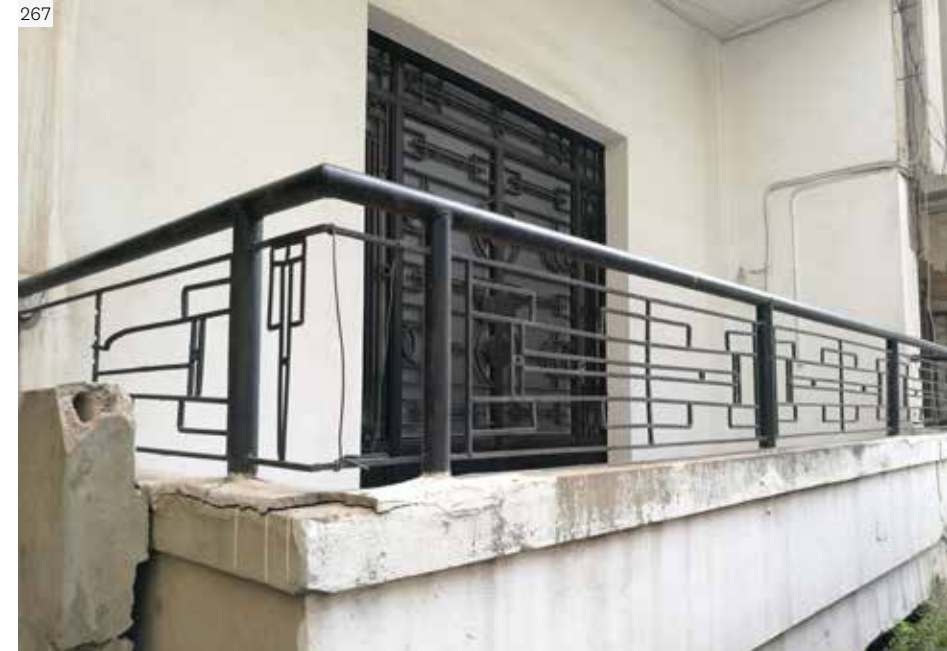
The conservation of wrought iron structures must first consider the oxidation of the material. Whether through manual or mechanical interventions, the stripping of existing paint layers or other types of residues should be the first step of this operation. Impurities such as traces of electric welding at assembly points do not necessarily represent components that must be removed in the intervention. However, sections with sharp edges that inconvenience the tactile experience can be smoothed out. Following this, an anti-rust coating is applied to prepare the work for restoration with the original chromatic definition, if it can be identified. Heavily corroded parts, such as door bases, can be replaced by new parts that faithfully reproduce the original composition. It should be noted, however, that such substitution operations must be reserved strictly as a last-case solution for irrecoverable surfaces only.

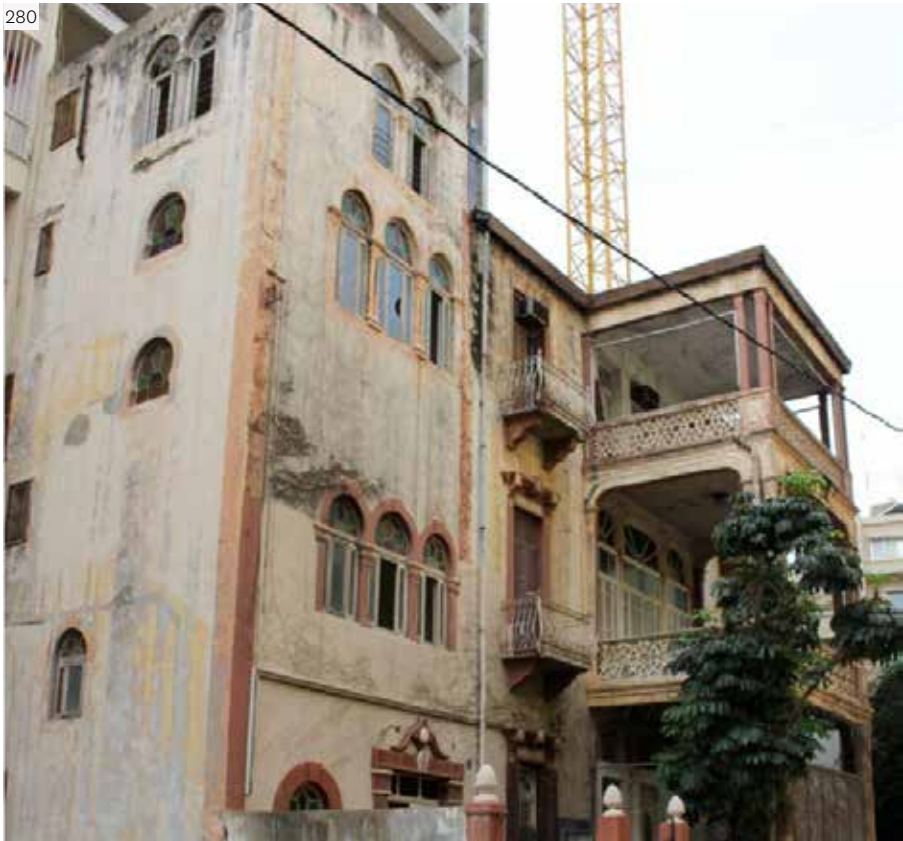
281

These natural stone walls had a thickness ranging from 25 to 35 cm. A layer of lime plaster was applied to the internal and external surfaces (281, 282). The thick wall provided the necessary thermal mass to reduce fluctuations in the surface temperatures of internal walls. This improved indoor thermal comfort. Moreover, exterior wooden shutters were divided to allow wind flow while blocking heat from solar radiation simultaneously, open shutters at high-level windows would allow quality natural light into the spaces (276, 277).

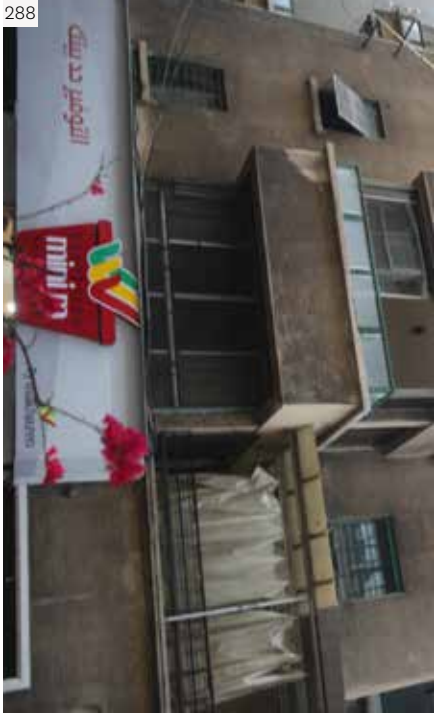
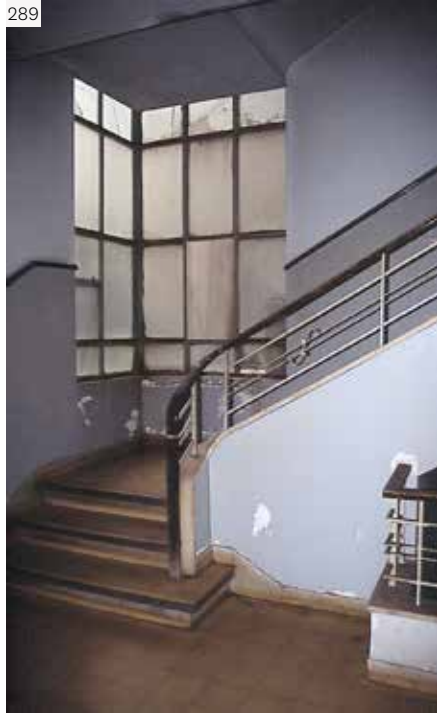
As of the 1930s and throughout the next decades, the use of cement (and concrete) became widespread, and walls were constructed with cast concrete. Including the sand/cement plaster and paint applied to the internal and external surfaces, the total thickness of the average wall ranged from 13 to 15 cm (290). Having a low thermal mass, this type of wall resulted in significant internal surface temperature fluctuations. Such wall behavior makes people feel thermally uncomfortable during the warm/hot months (in Beirut) and the cold months (in the mountains).

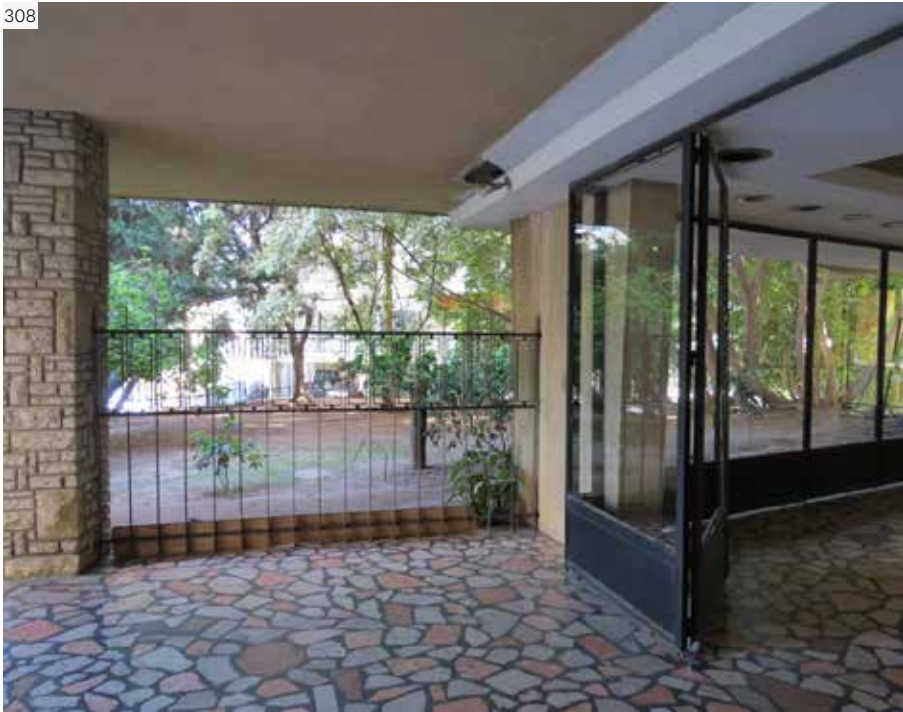
Planters, pavements, ponds, and other elements were built with natural materials such as limestone, basalt, and marble (310). It is recommended that the same or an equivalent material be used during restoration in terms of performance and specifications.

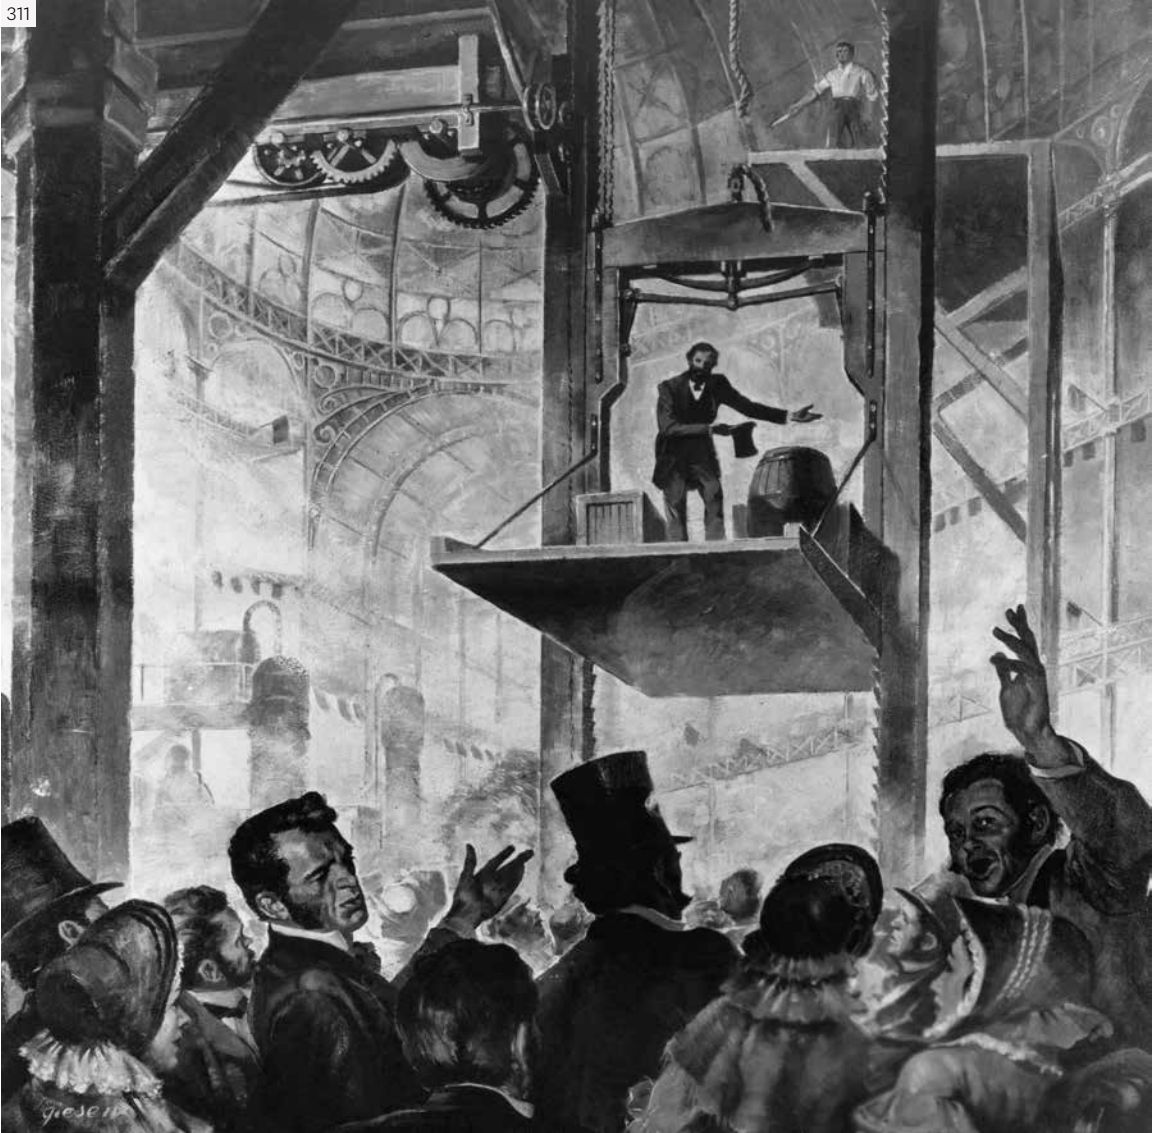
Elisha Otis demo of his free-fall prevention mechanism, Crystal Palace, 1854.

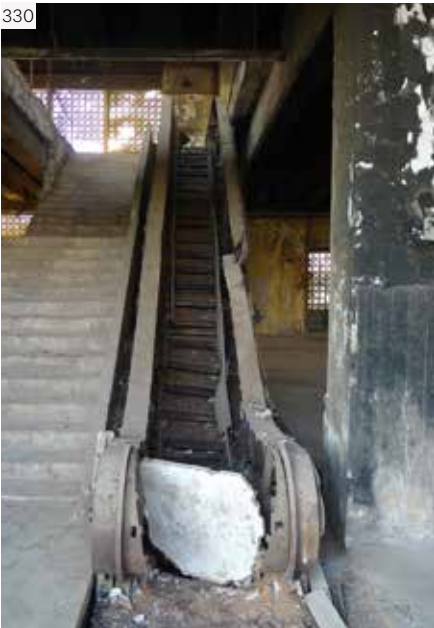
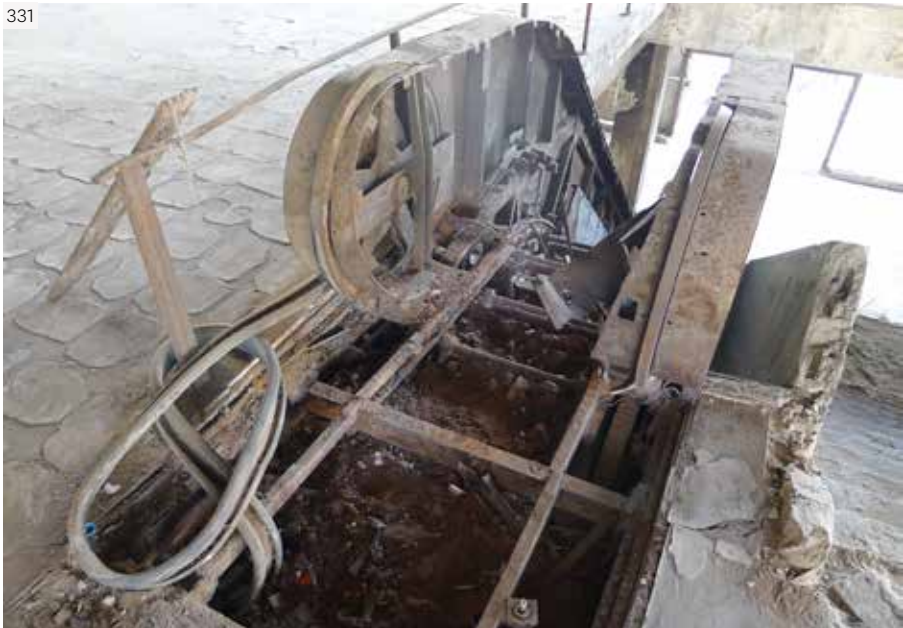
In 1967, Spinneys inaugurated its first department store in Beirut. That structure was designed by Polish architect Karol Schayer in partnership with Lebanese architect Nadim Majdalani and featured a Schindler escalator installed to facilitate customers' circulation between its floors. The remains of this escalator are still present on the premises of the abandoned building (329, 330, 331).
